Impacts of the 27 July 2019 Magnitudes (Mw) 5.4, 5.9, and 5.8 Itbayat, Batanes Earthquakes

DOST-PHIVOLCS Quick Response Team

Casualties and damages due to ground shaking

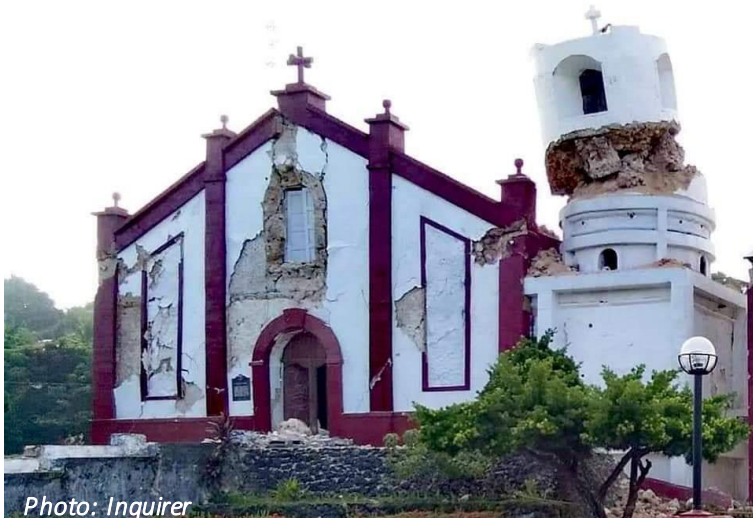
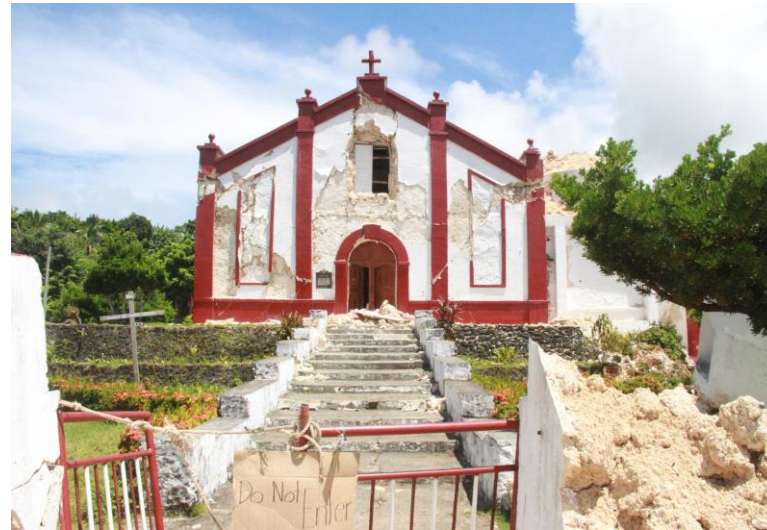
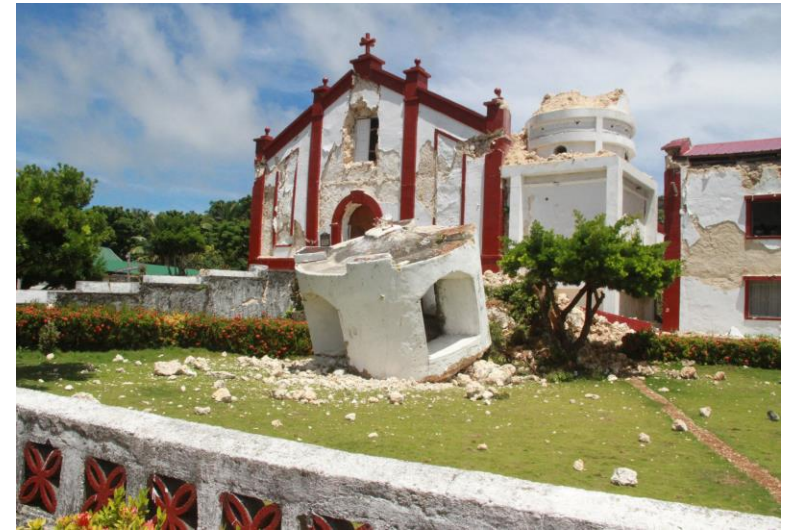
Nuestra Señora del Rosario Parish Church's damage was first reported after the M5.4 earthquake event. The church's bellfry titled after the M5.9 earthquake event (left) and finally collapsed during the M5.8 event (center, right).

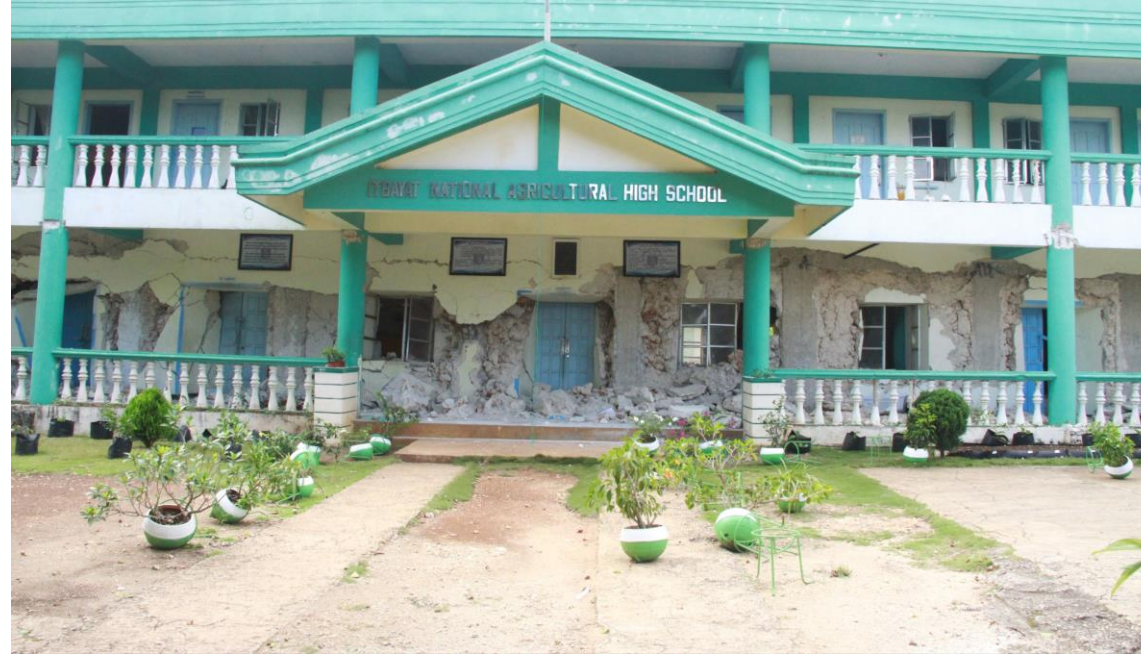
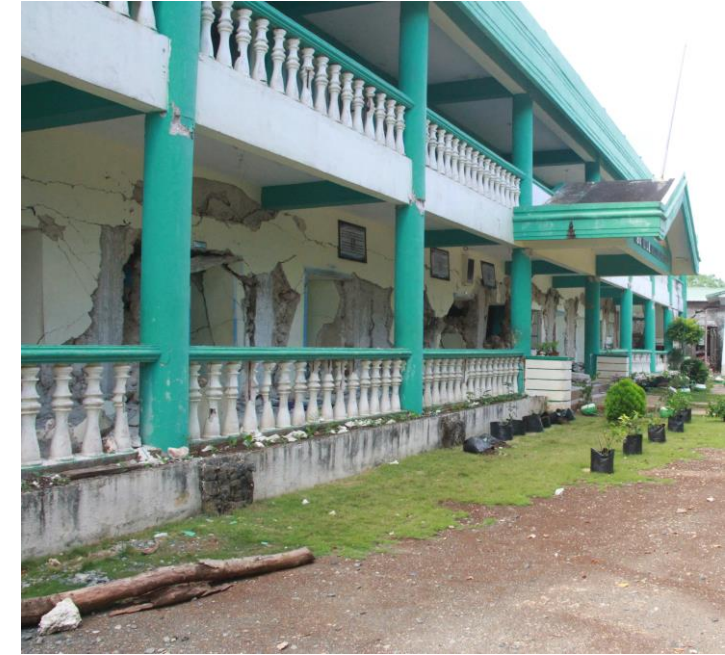
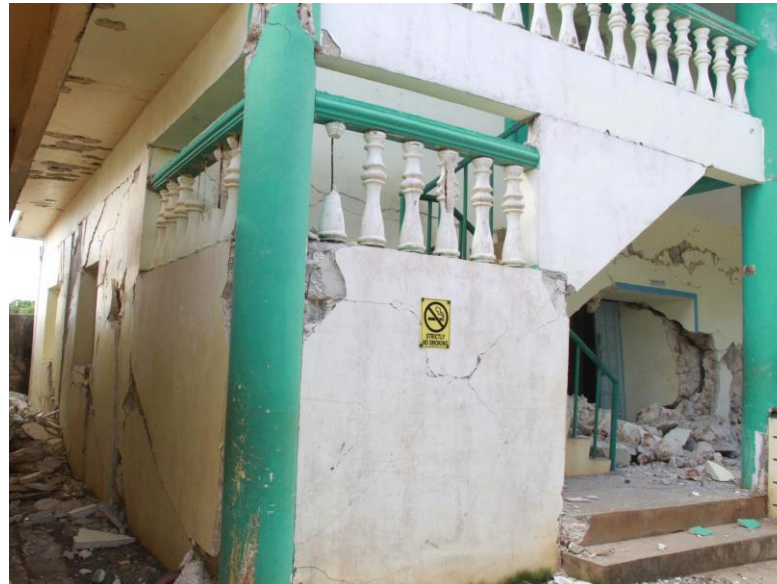
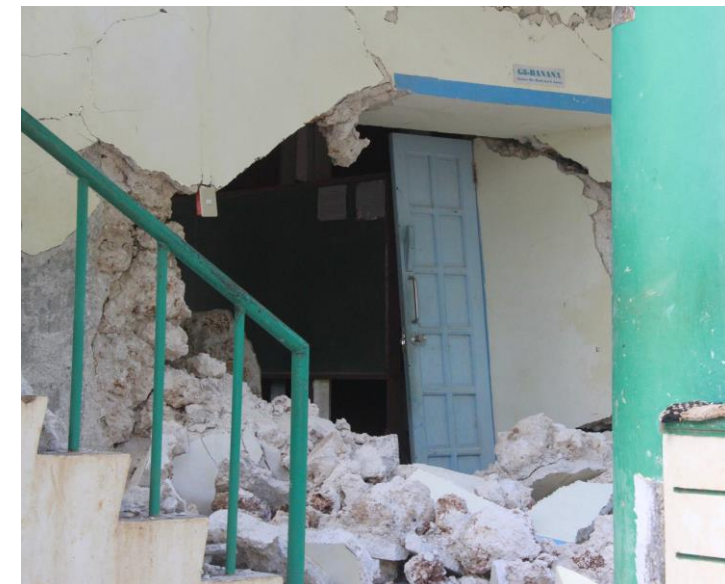
Itbayat National Agricultural High School Buildings sustained major damage.

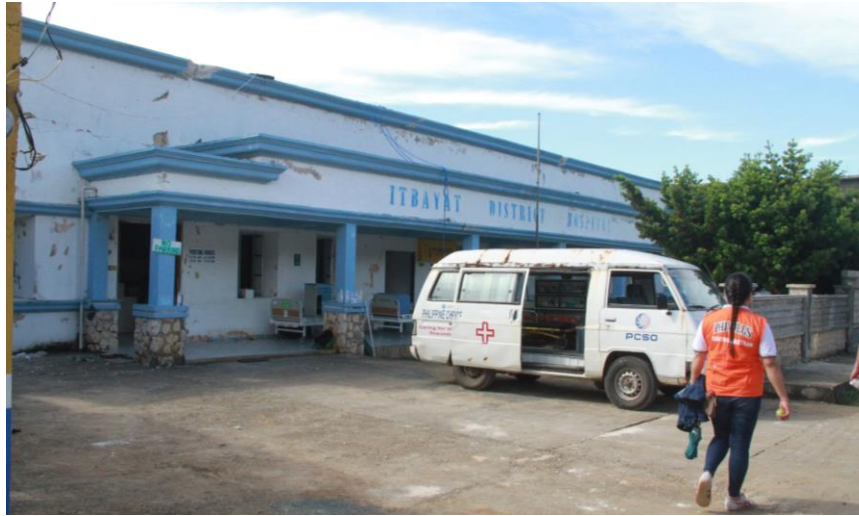
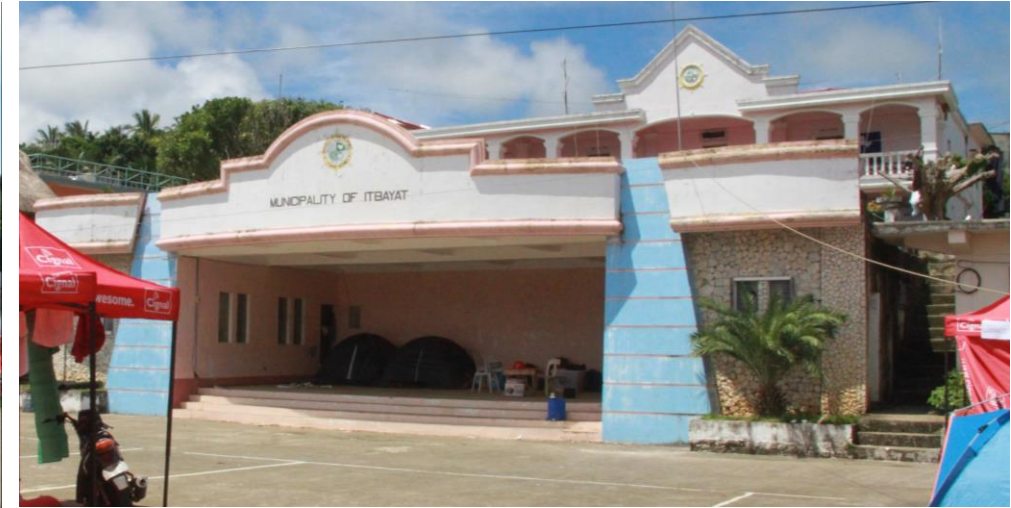
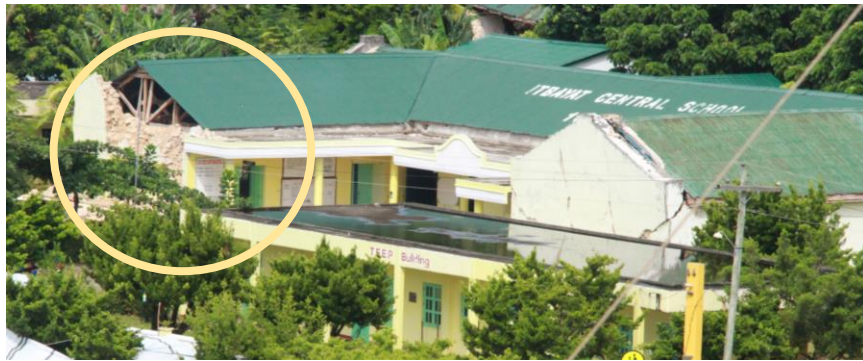
Itbayat District Hospital, Municipal Health Office, Municipal Hall assessed as safe with minor damage.

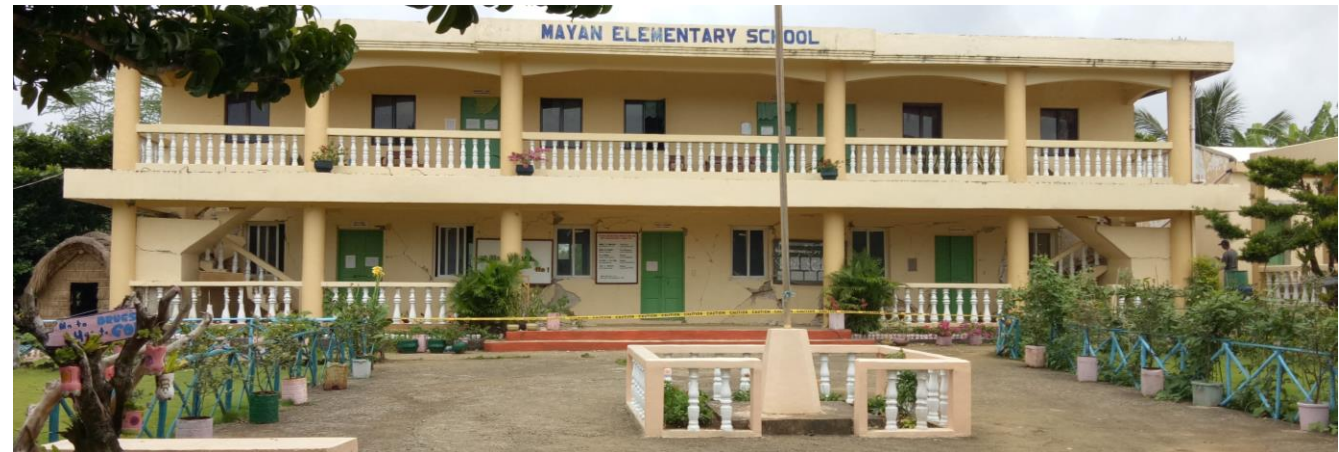
DPWH assessed Mayan Elementary School and Itbayat Central School buildings as totally damaged.

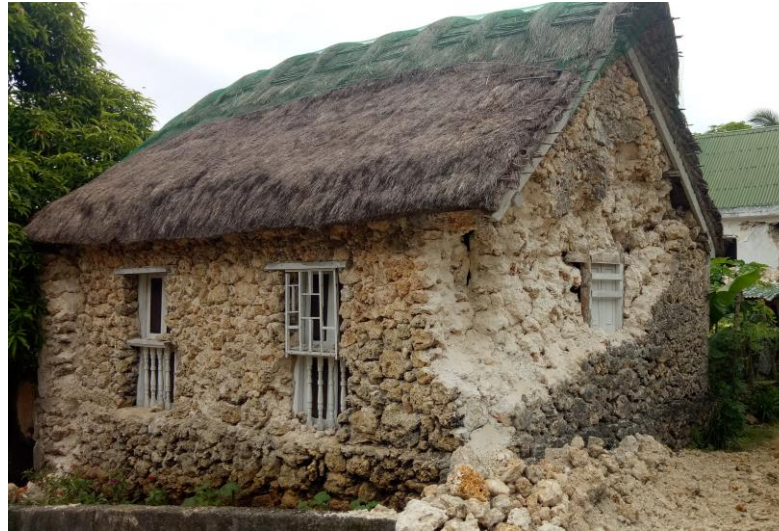
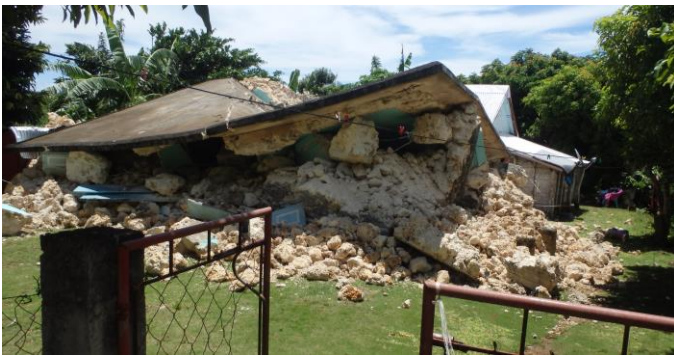
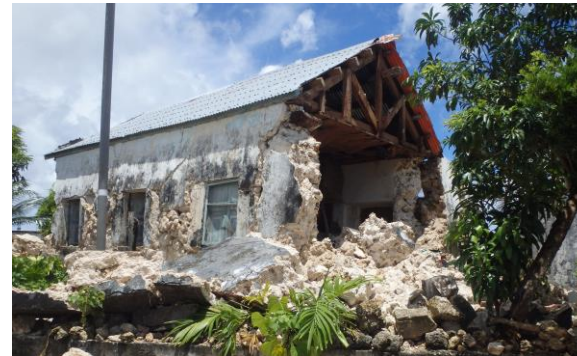
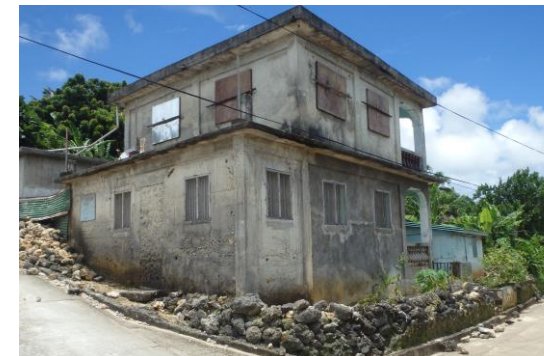
Ivatan houses are composed of massive limestone, bind together by lime with thick cogon grass as roofing.

Houses made of local and semi-local concrete suffered minor damages.

In Brgy. Santa Maria, several Ivatan houses collapsed during the M5.4 and M5.9 earthquake events. Five were reported dead after being buried by collapsed house.

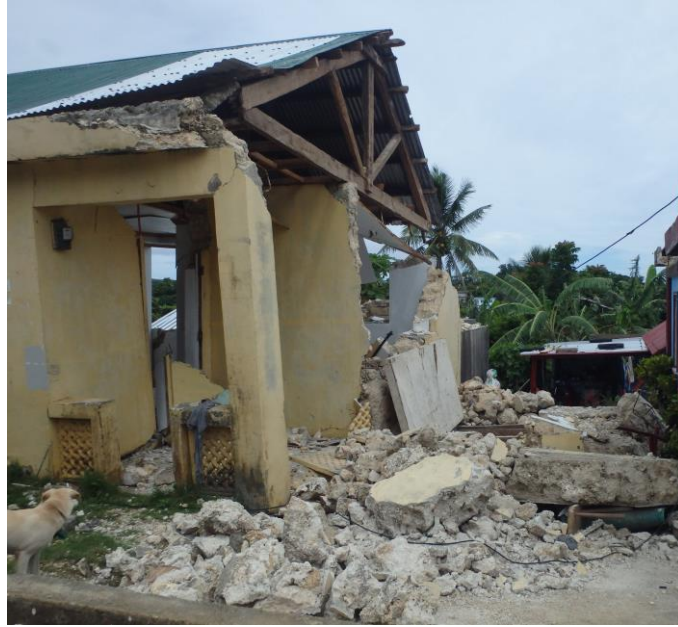
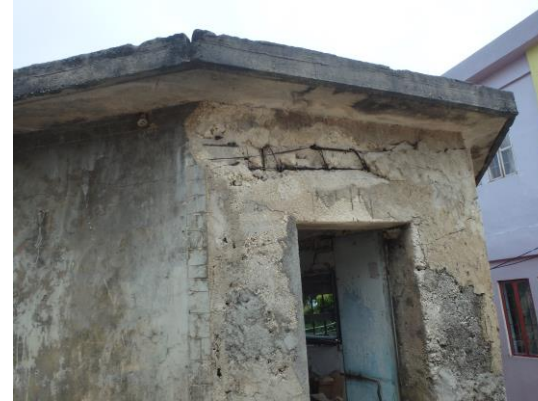
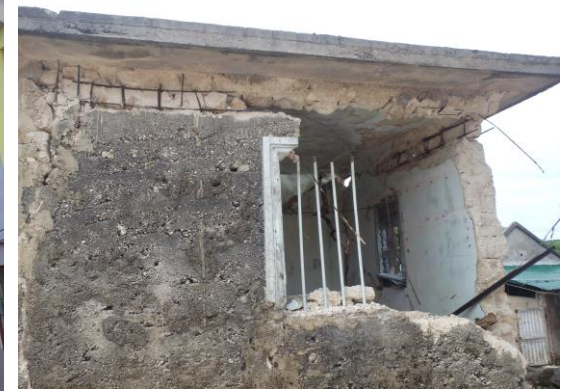
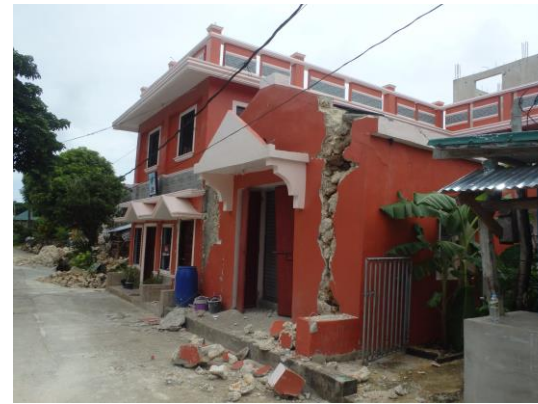
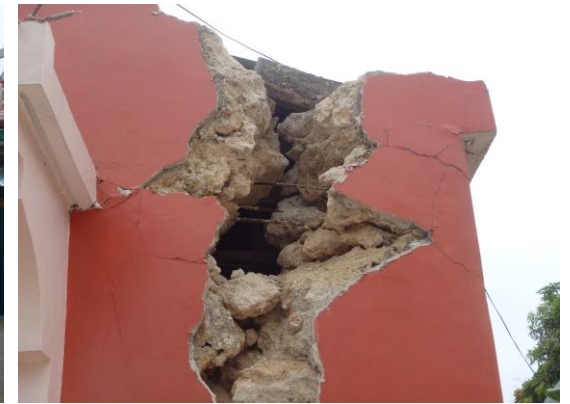
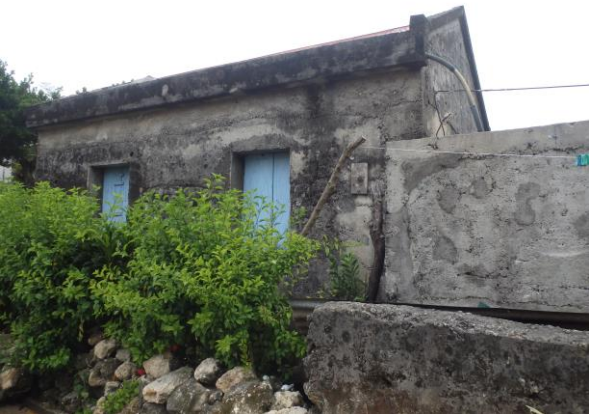
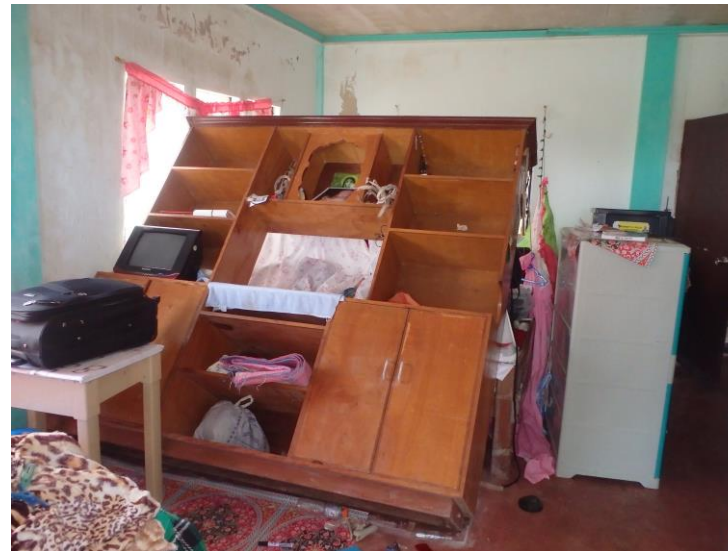
Two (2) reported dead due to a collapsed Ivatan house during the M5.9 earthquake event.

Semi-traditional house (Ivatan house made of cement) sustained minor damage and safe for reoccupation

Reinforced houses made of local concrete sustained major damage after the three moderately sized earthquakes. Heavy furnitures toppled during the M5.9 earthquake event.

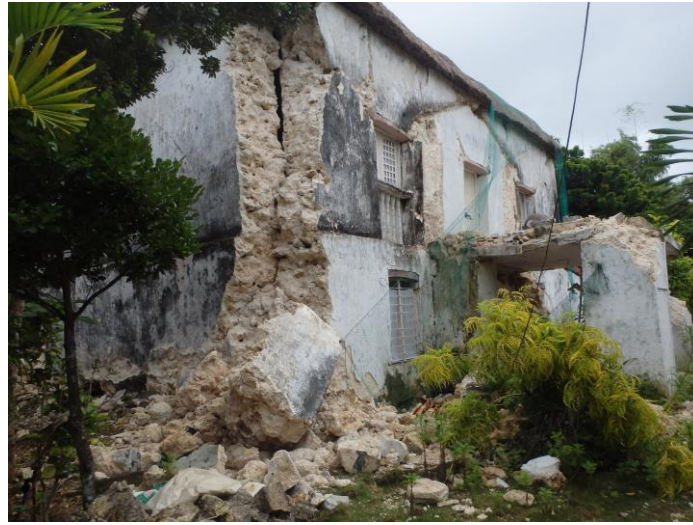
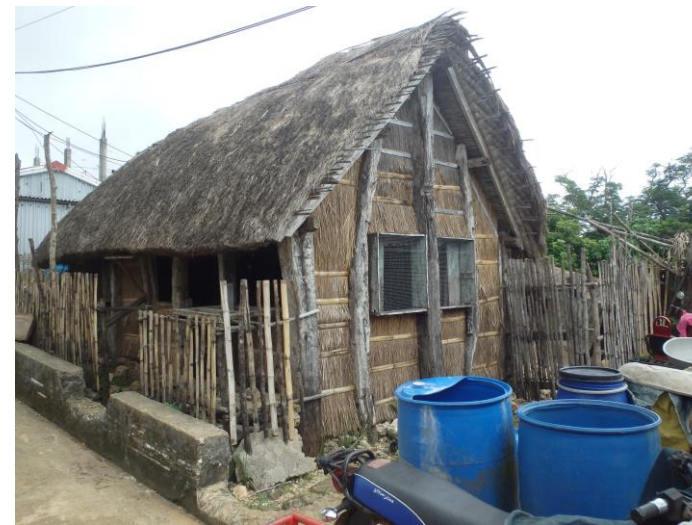
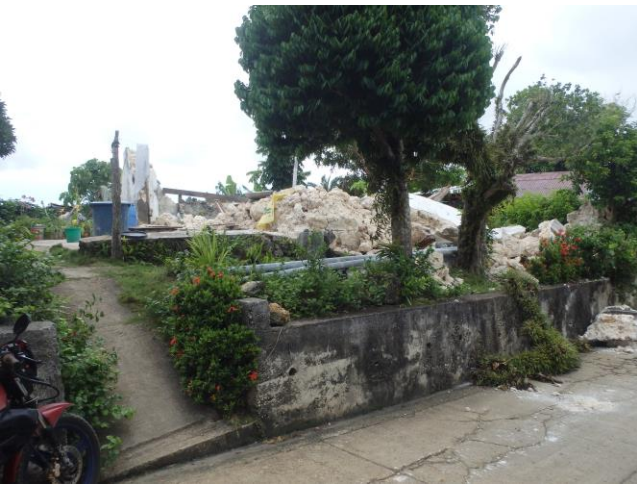
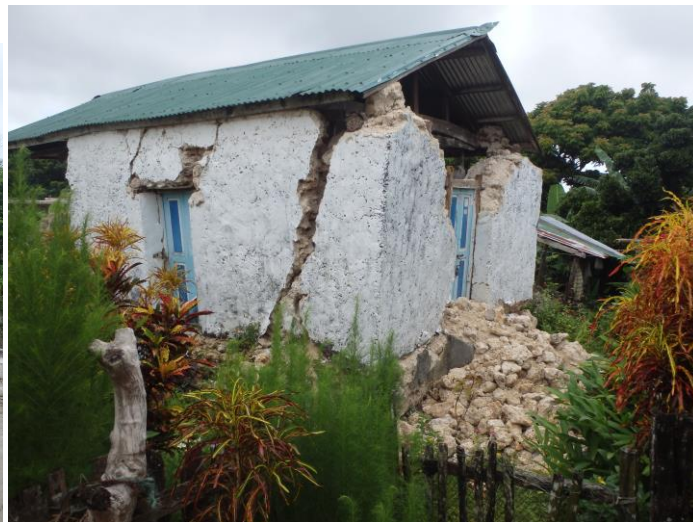
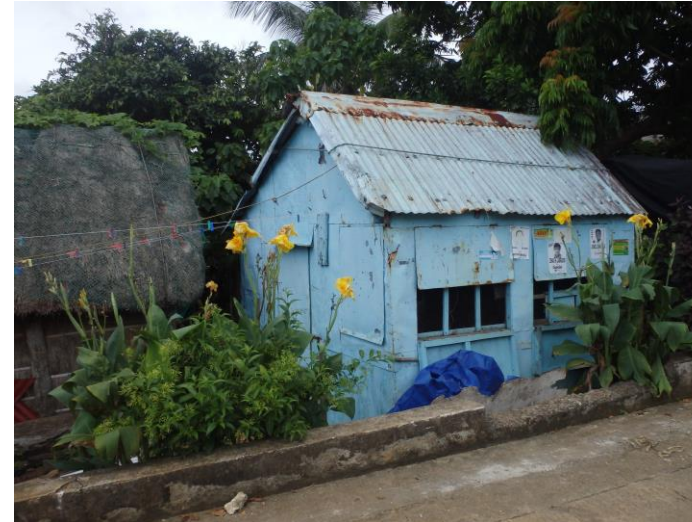
Houses made of light materials like wood and nipa did not suffer damages after the series of earthquakes.

In Brgy. Santa Maria, Ivatan houses made of limestone boulders collapsed during the M5.4 and M5.9 earthquake events. Two (2) were reported dead after being buried by collapsed house.

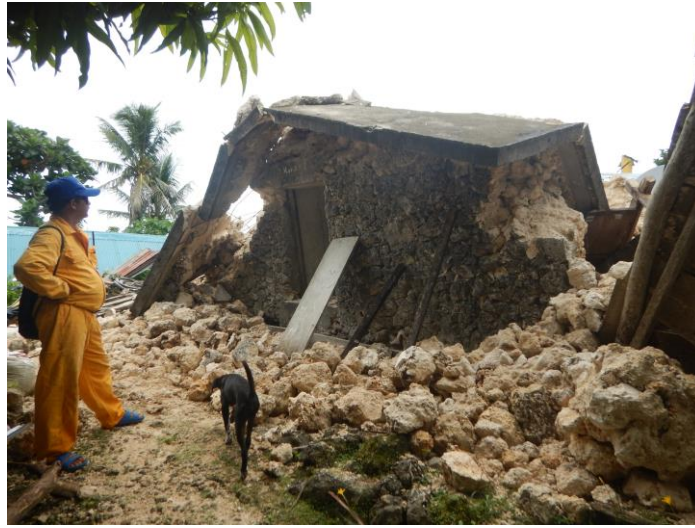
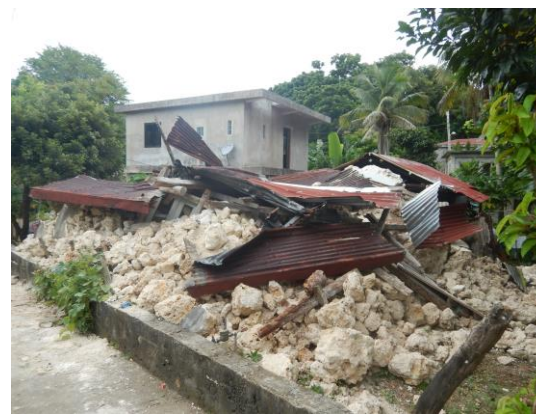
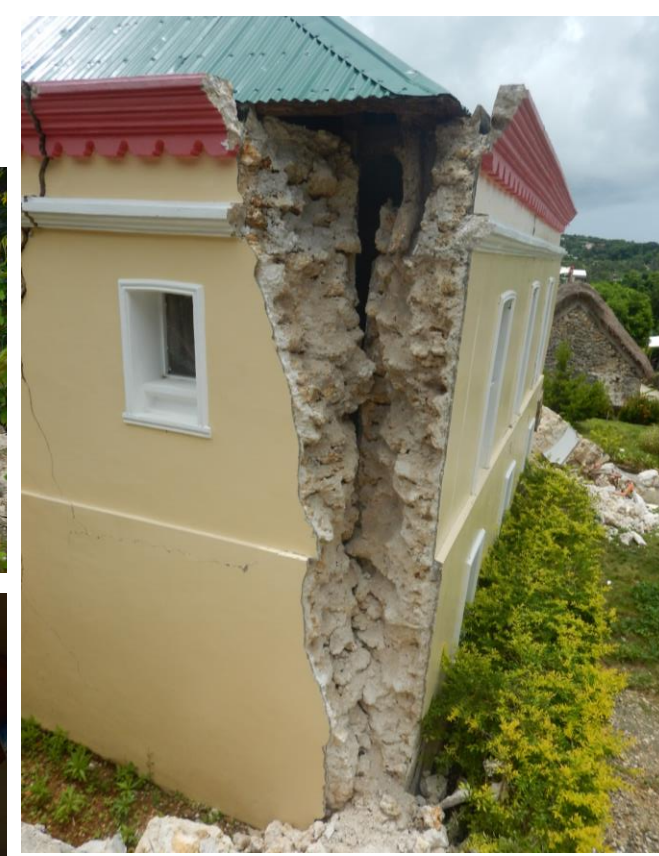
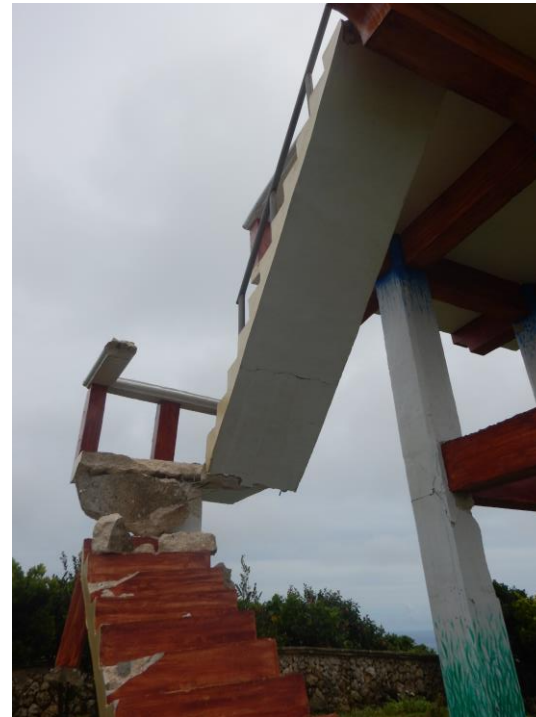
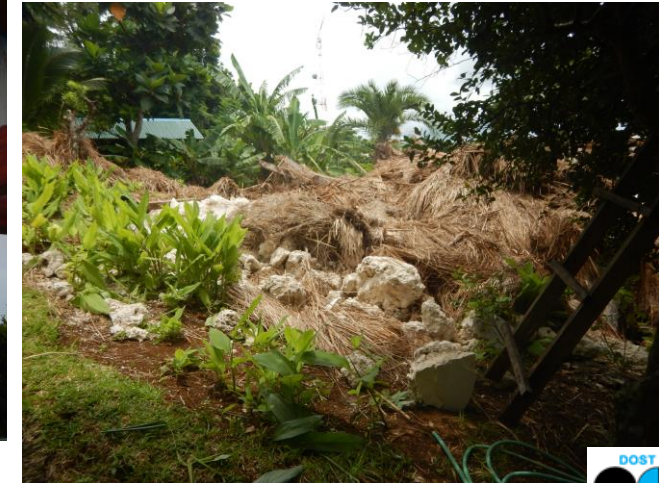
Totally collapsed Ivatan houses in Brgy. Santa Rosa. Some newly build semi-traditional Ivatan houses sustained major damages.

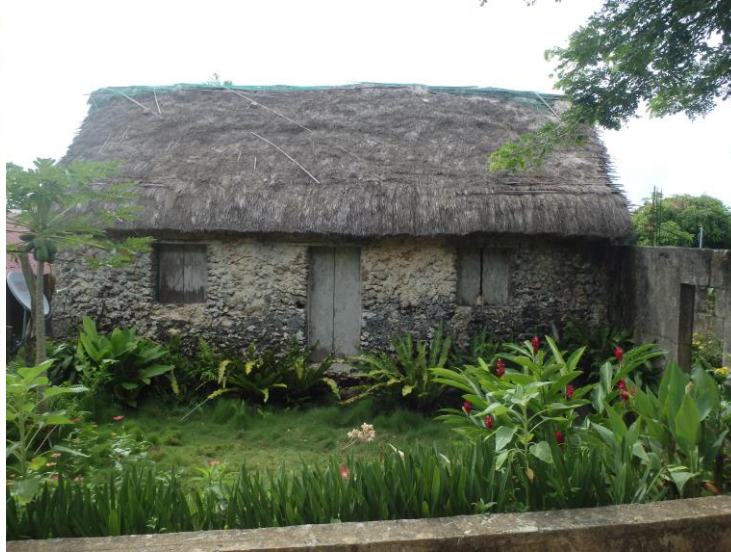
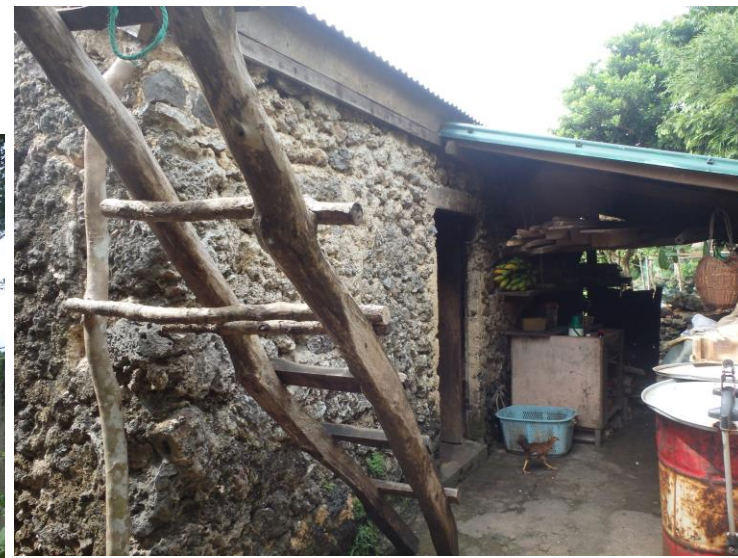
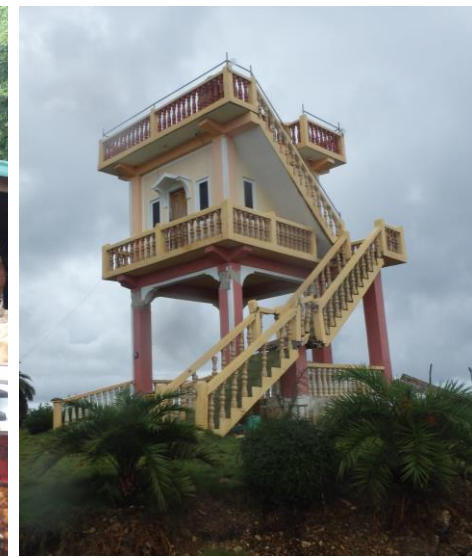
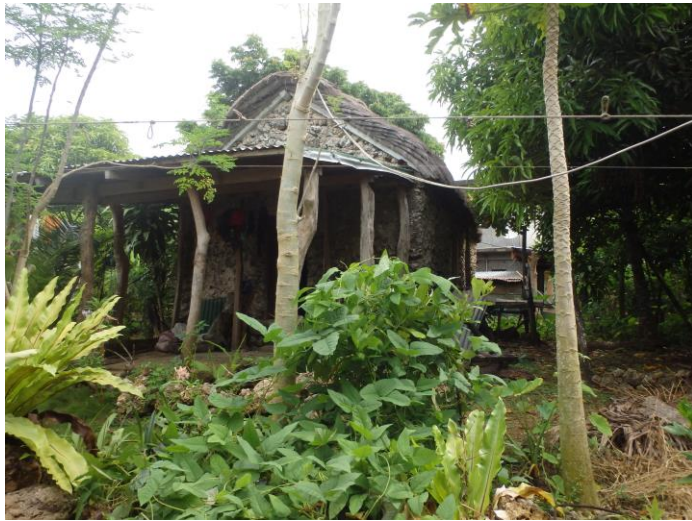
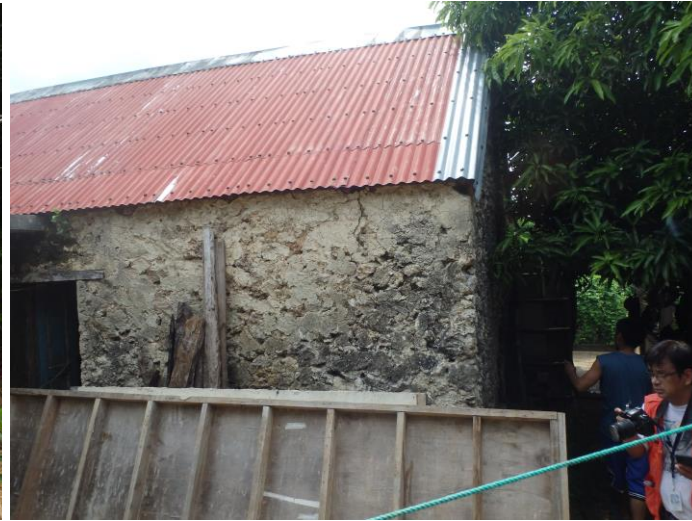
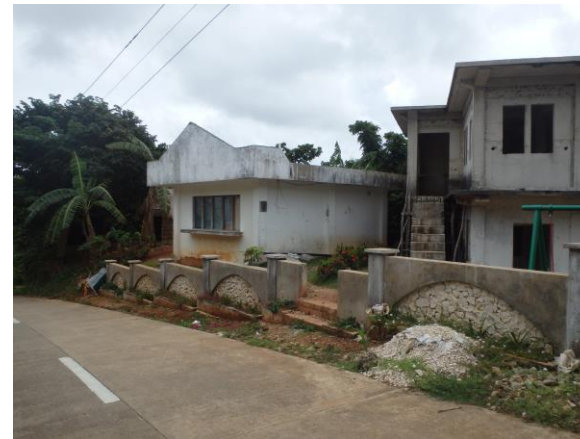
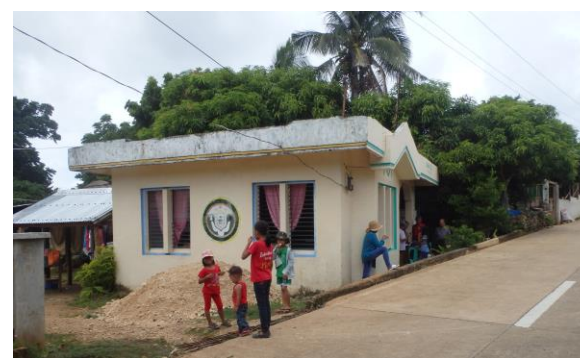
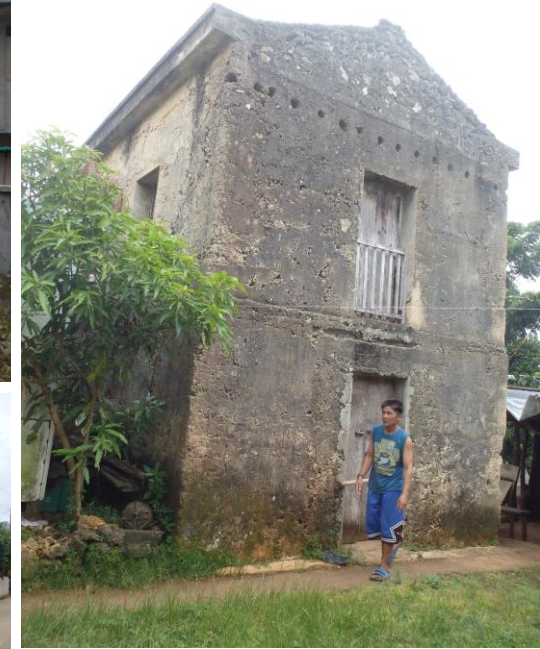
Majority of the houses, even Ivatan Houses, in Brgy. Raele were not damaged by the series of earthquakes. Some of the houses and structures suffered minor damages only.

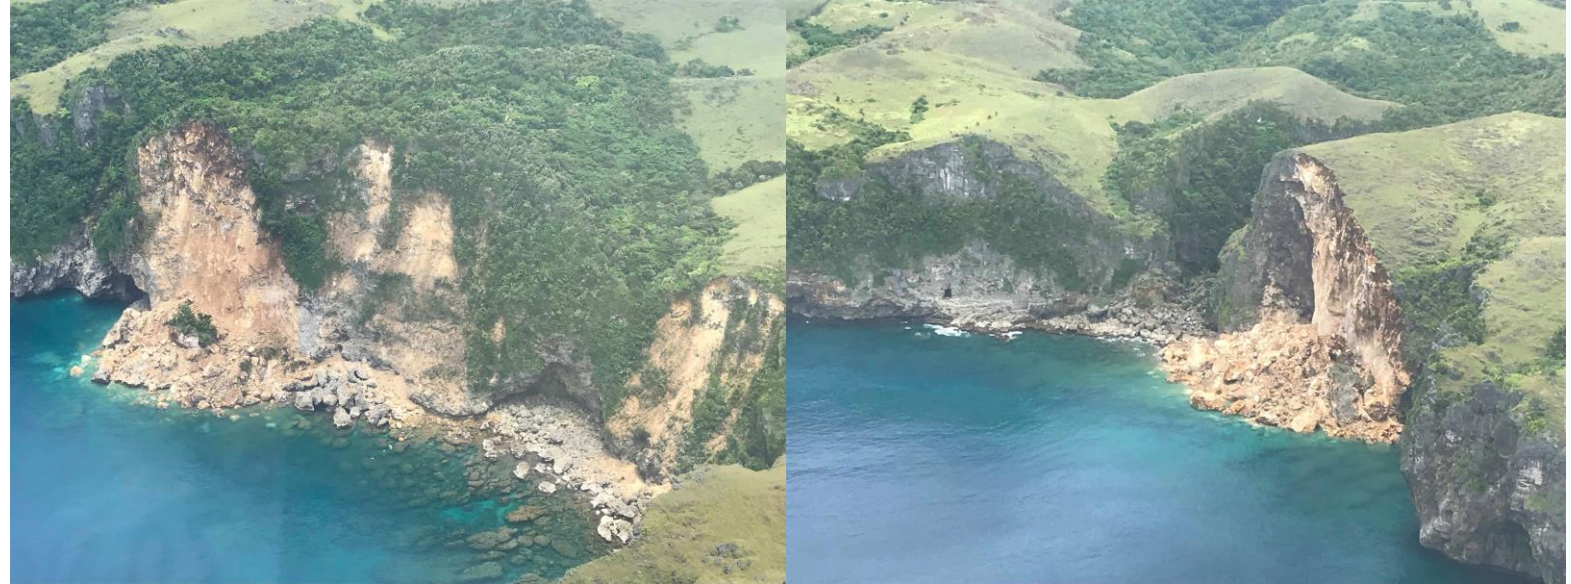
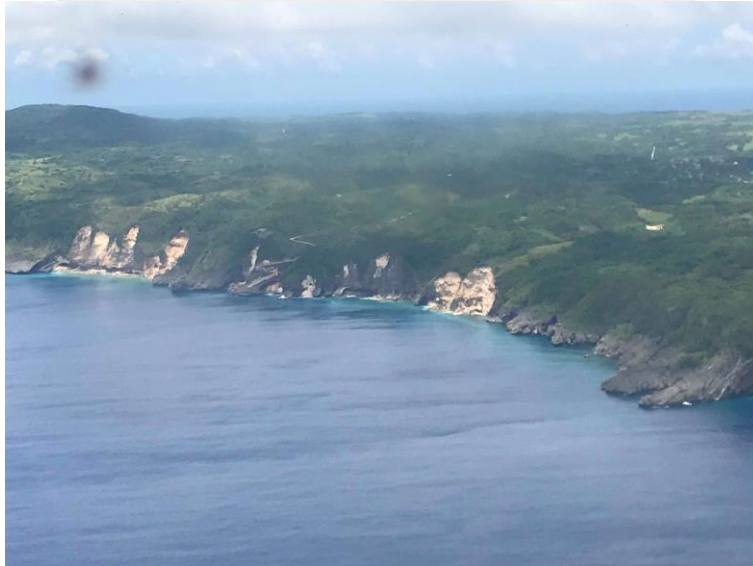
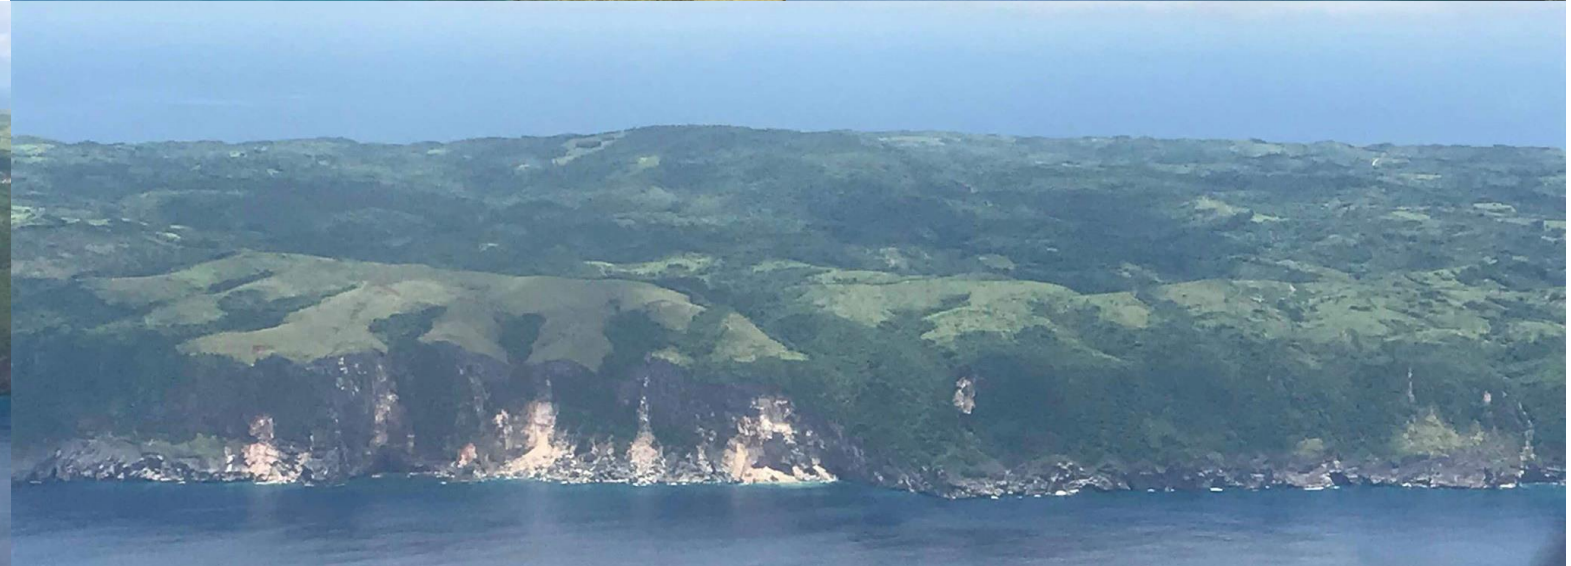
Landslides observed at Brgy. Santa Rosa and San Rafael.

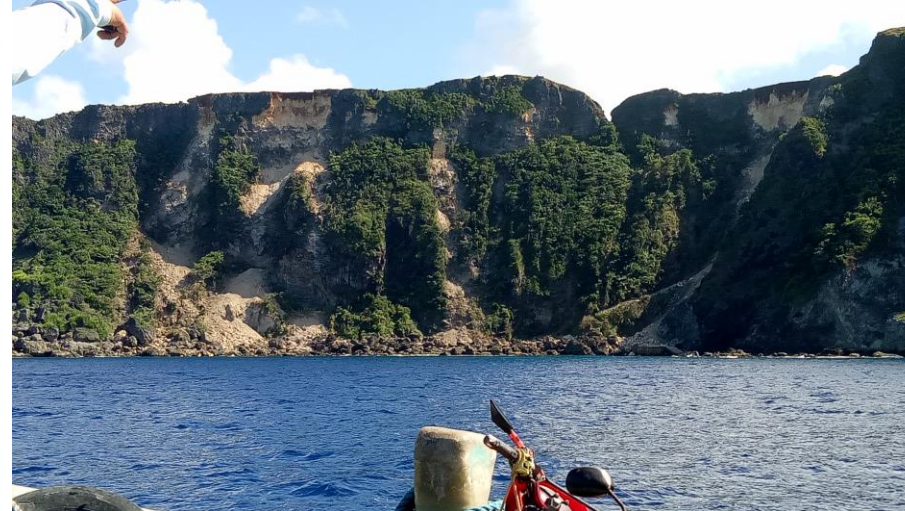
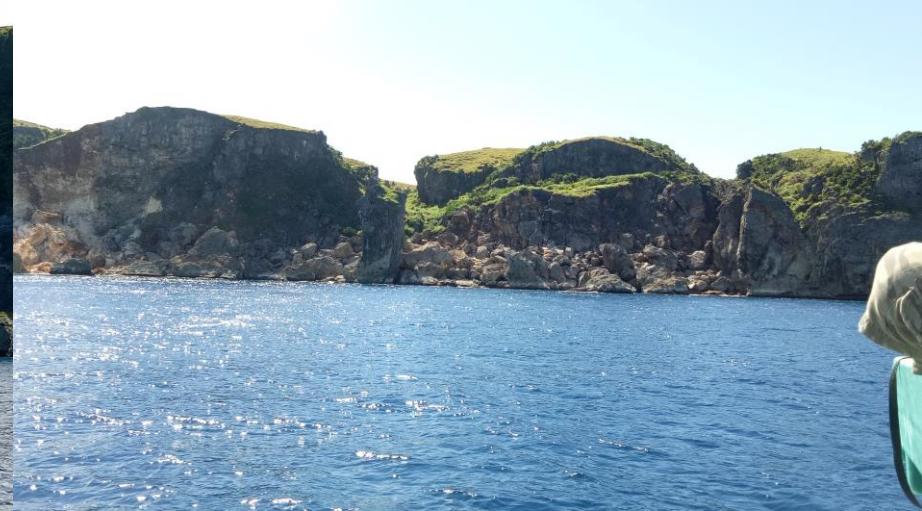
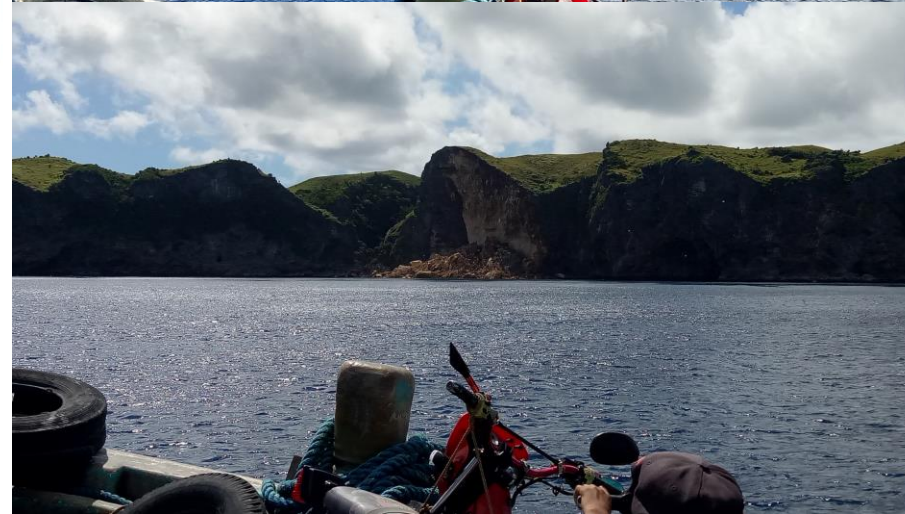
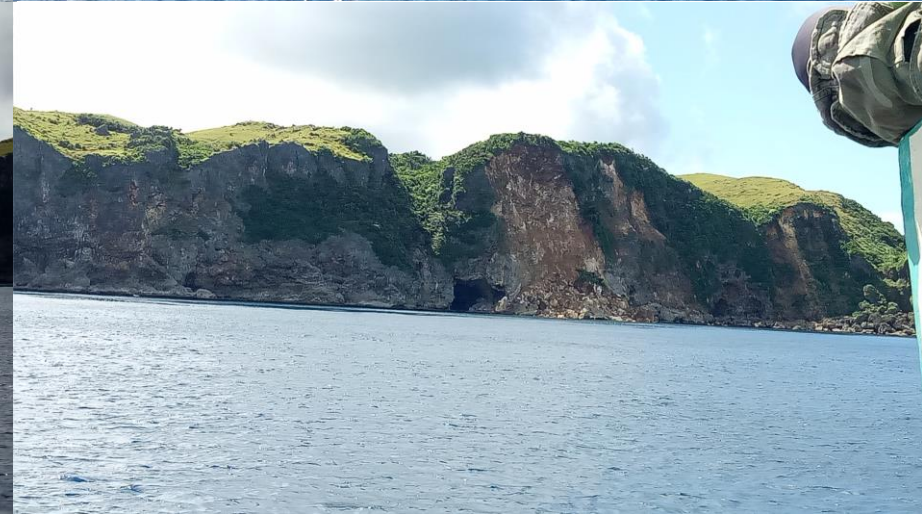
Landslides observed at Sitio Kaxbengan and Tumanyis, Brgy. Raele. Landslides are widely observed along limestone cliffs in Itbayat.

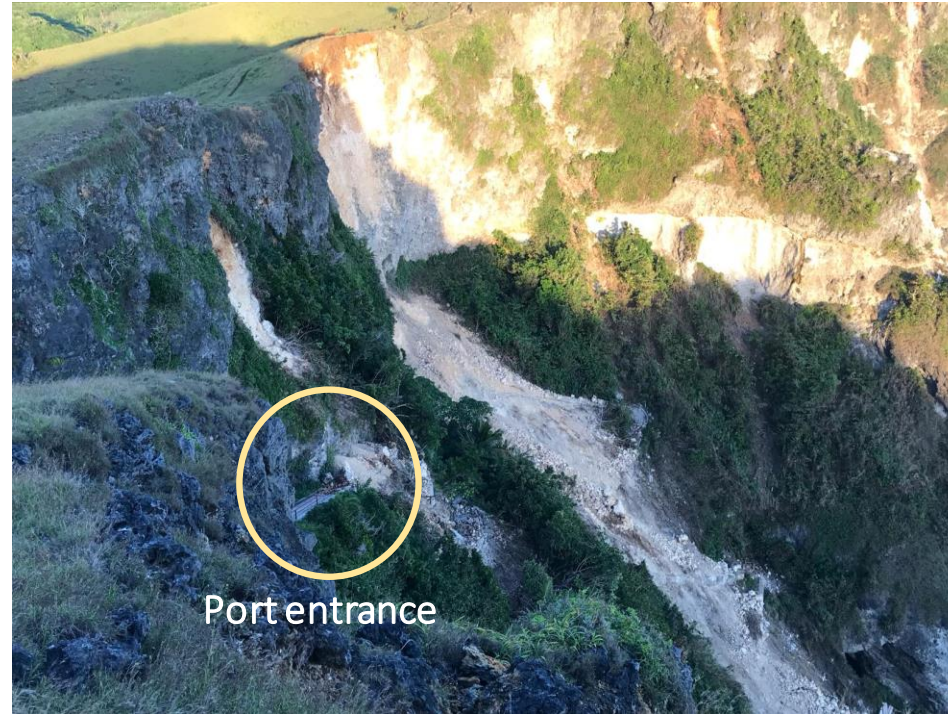
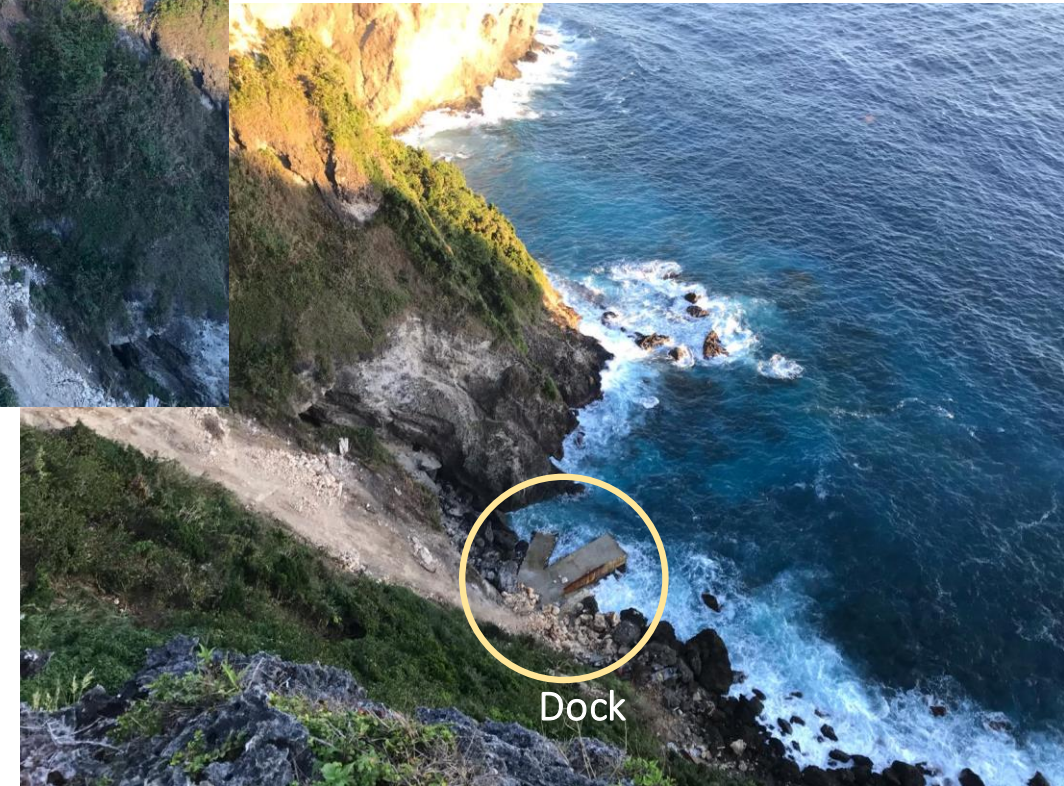
Landslides covered the road going to Mauyen Port located at Brgy. Raele.

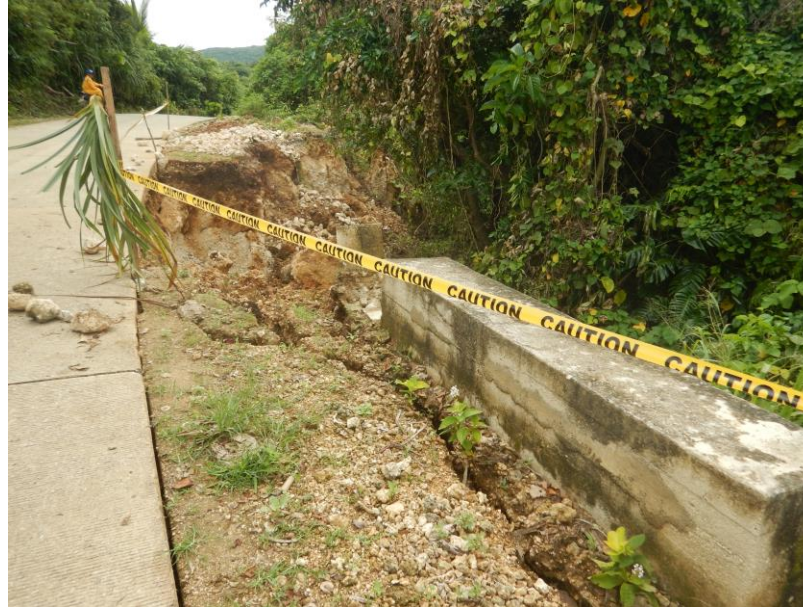
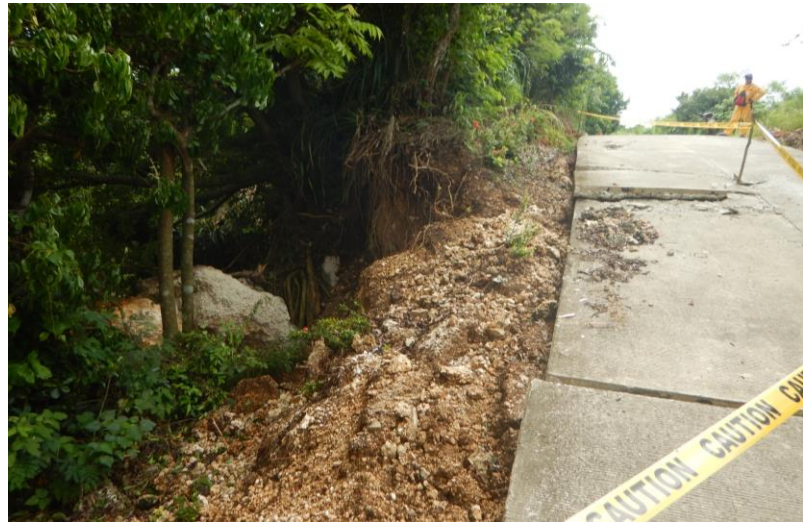
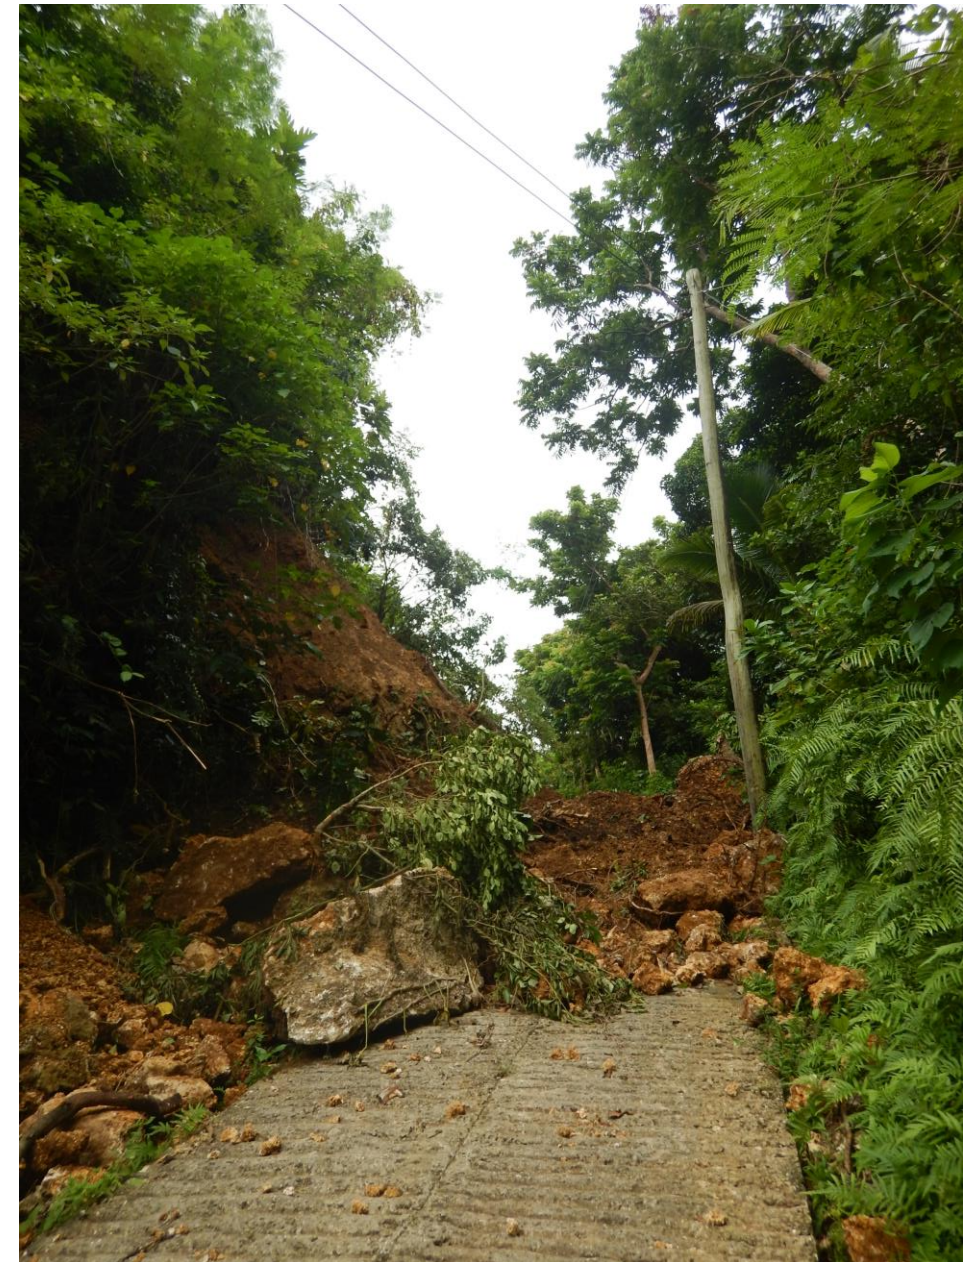
Earthquake-induced landslides and road slips along roads in Brgy. Sta. Maria, Itbayat. Roads buckle and some road barriers collapsed.
