The October 2019 Cotabato Earthquake Sequence: Parameters and impacts

DOST-PHIVOLCS Quick Response Team

The October 2019 Series of Earthquakes in Cotabato and Vicinity

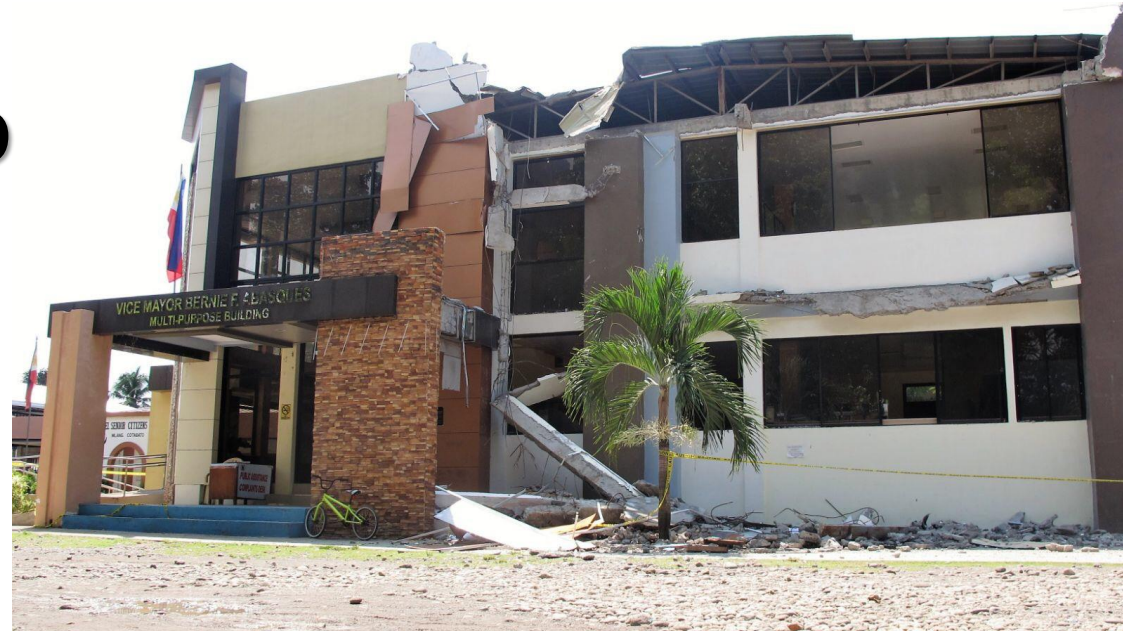
Damaged SB Hall in M'lang, Cotabato

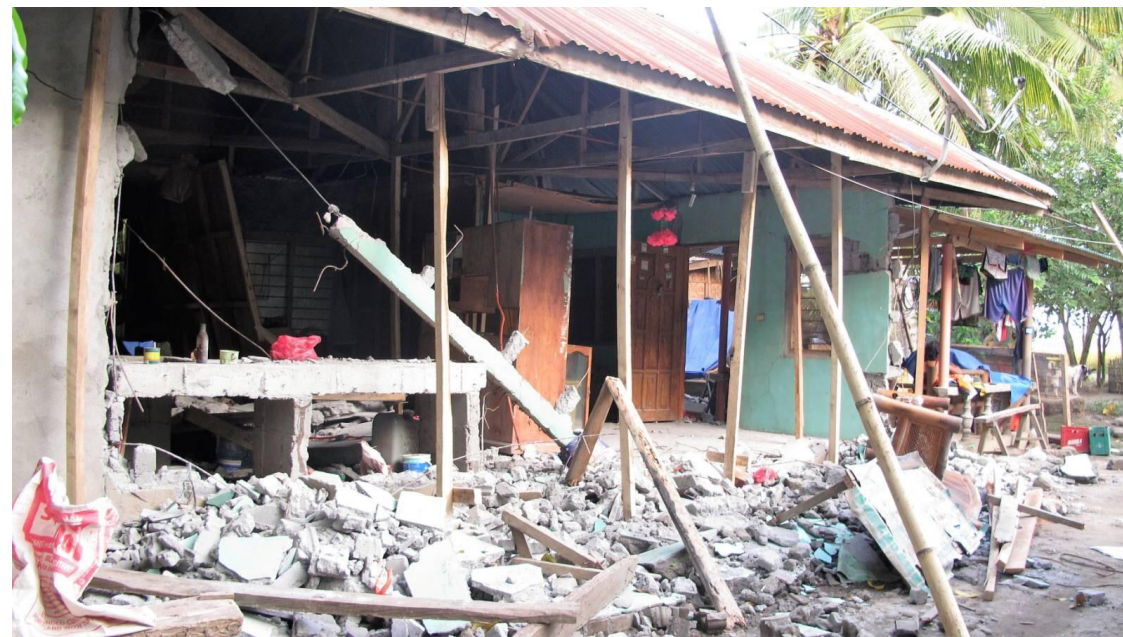
Totally collapsed wall of a house in Brgy. Bagontapay, M'lang (lumber post were installed post-shaking to prevent total collapse of the roof)

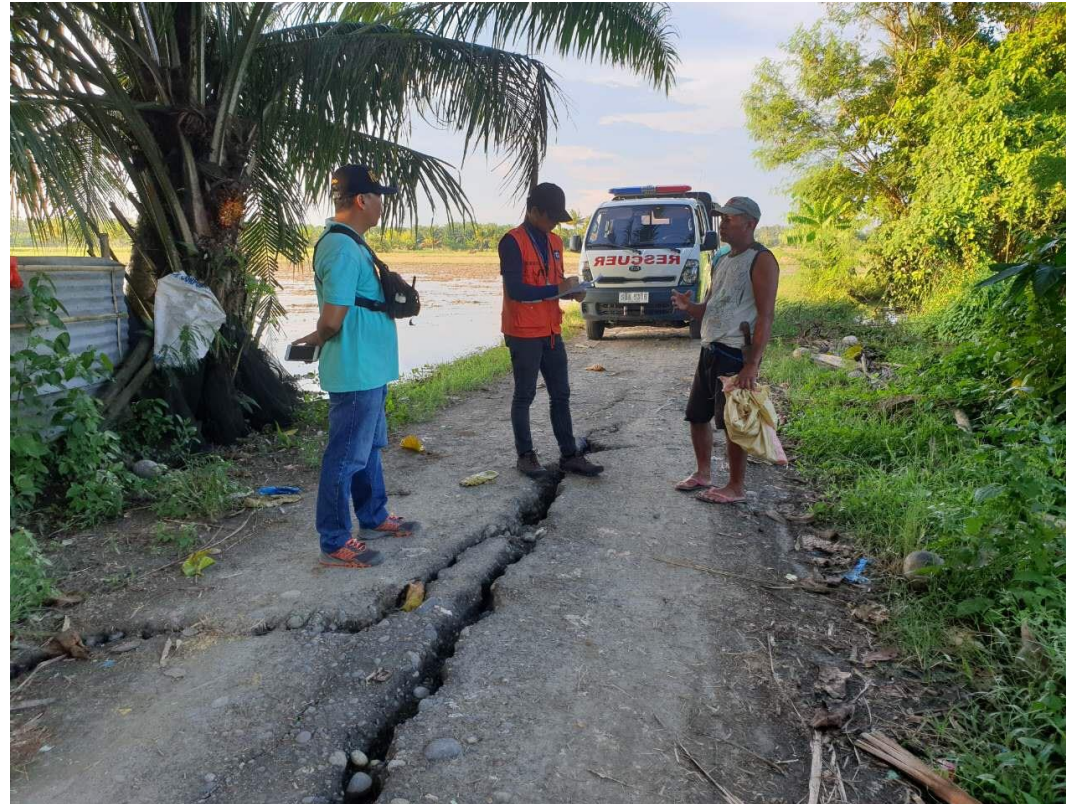
Purok 8, Brgy. Lipaga, M'lang, Cotabato

Lateral spread and sandboil

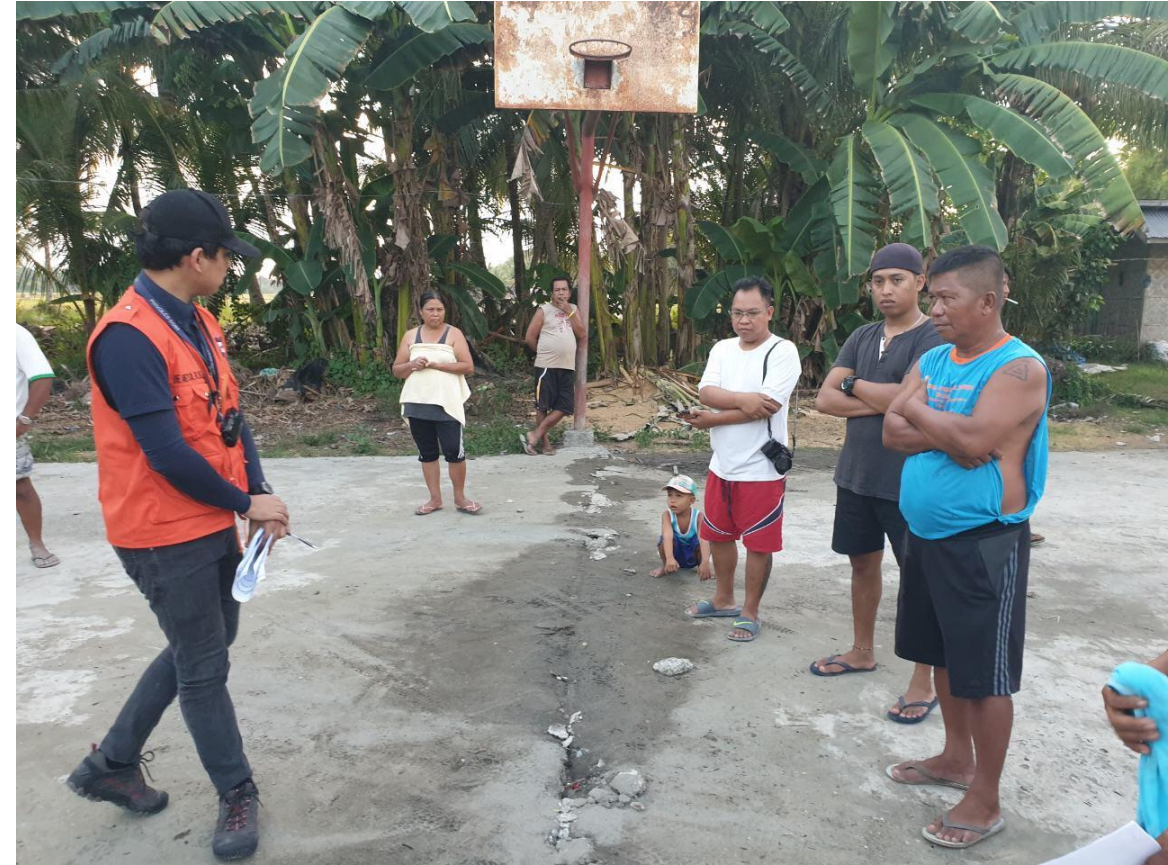
Purok 8, Brgy. Lipaga, M'lang, Cotabato

Linear crack formed dividing the basketball court with occurrence of sandboils

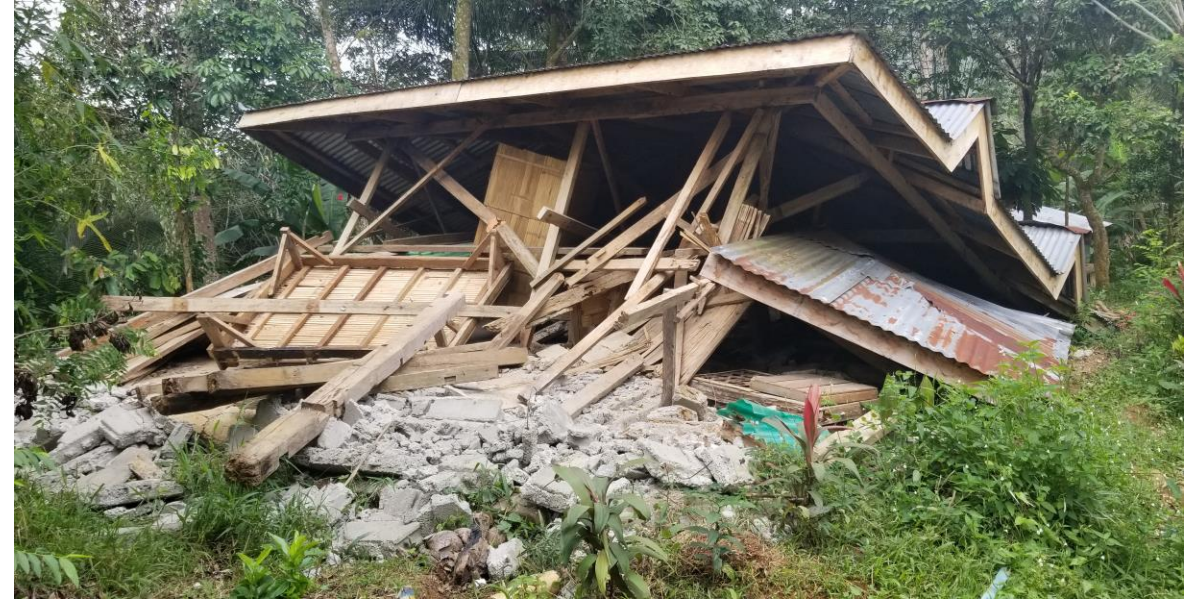
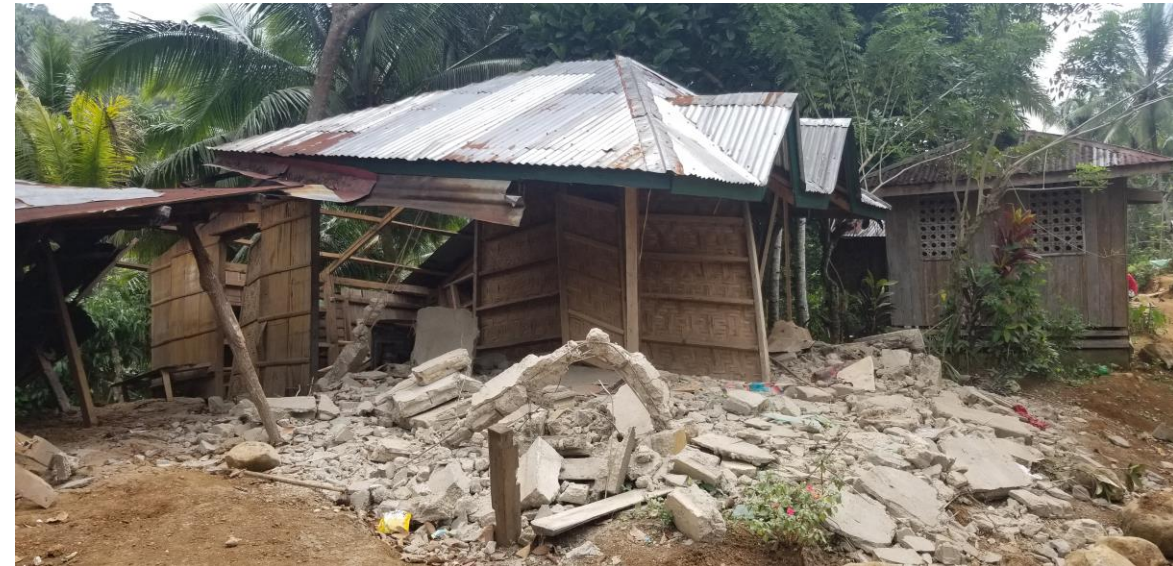
Sitio Labidangan, Brgy. Upper Bala, Magsaysay, Cotabato

Out of 74 houses (wooden and semi-concrete houses), 25 houses were totally damaged and 36 heavily damaged because of poor construction and was affected by tension cracks.

1. Bgy. Upper Bala (Sitio Labidangan)
2. Bgy. Malawanit (Purok 6)

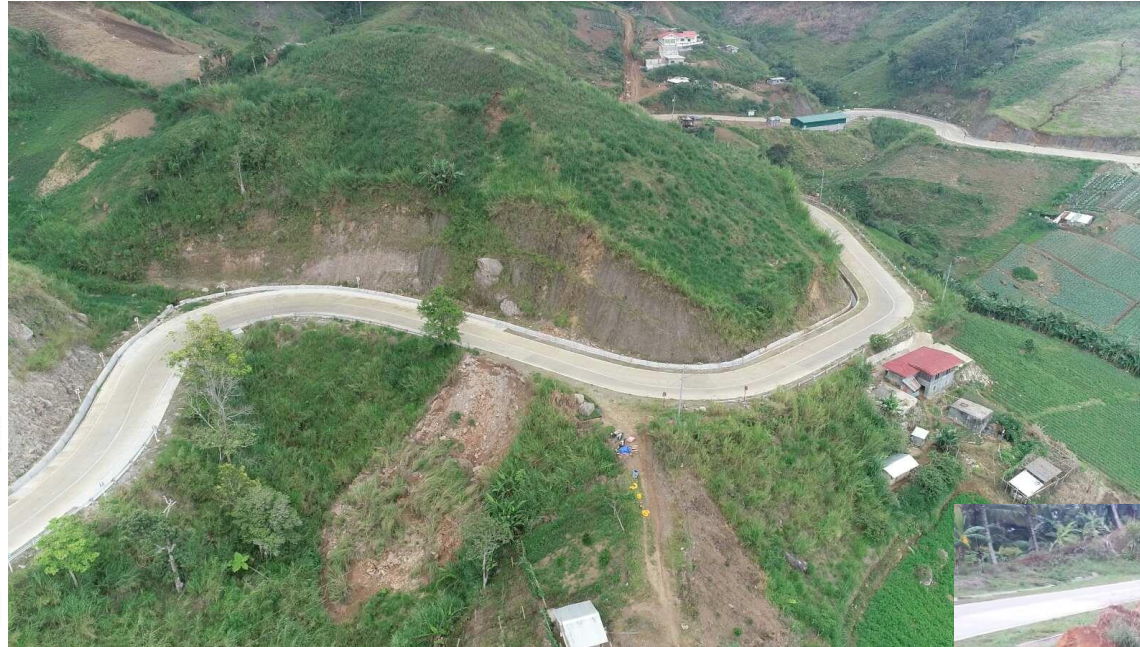
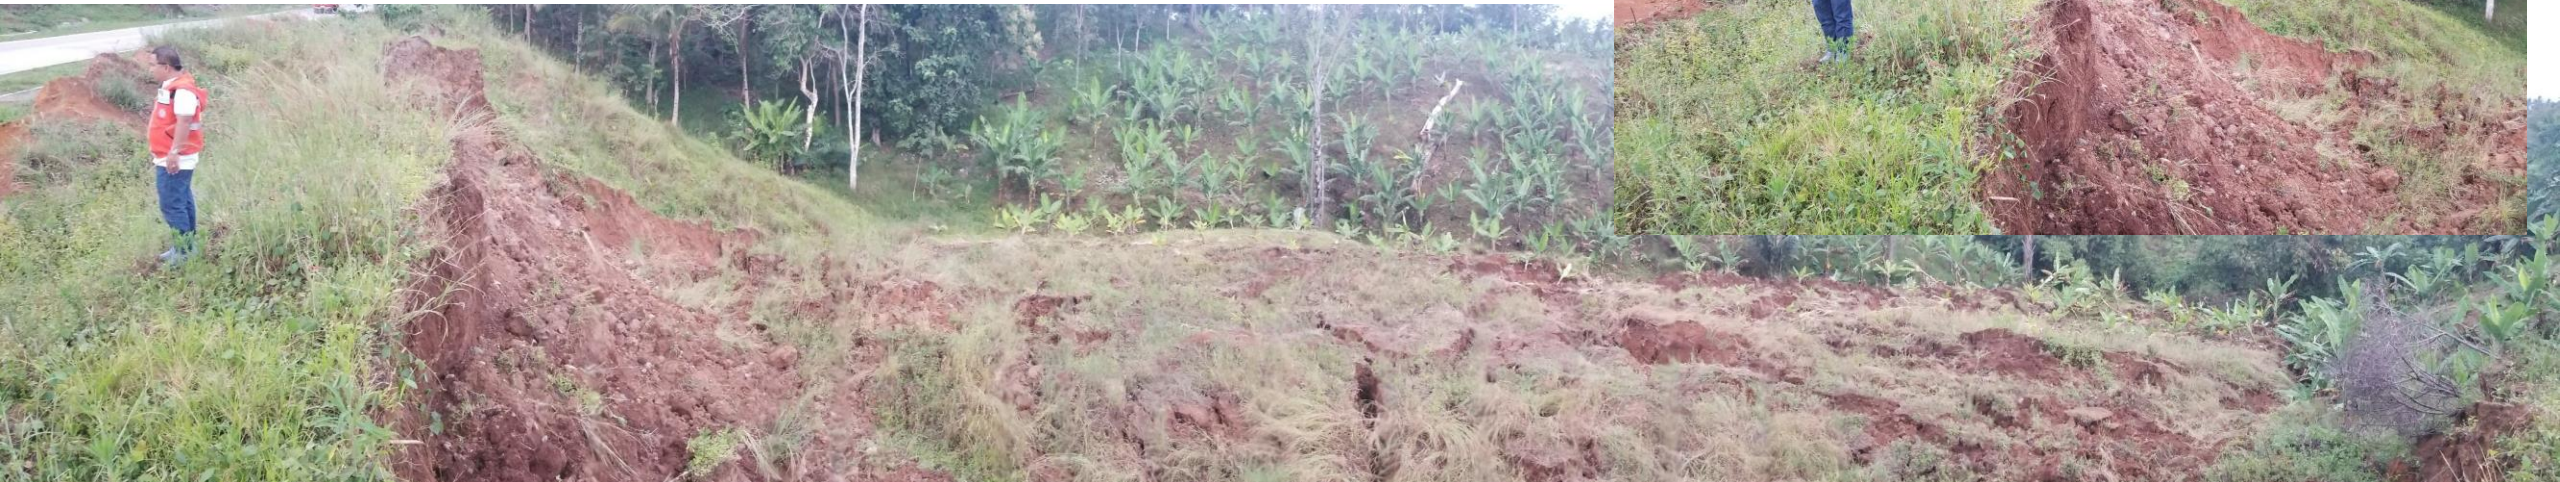
Purok Venus, Brgy. Managa, Bansalan, Davao del Sur

Shallow-seated landslide crown is approx. 8 m away from the national road with presence tension cracks.

1. Bgy. Altavista (Sitio Sunop)
2. Bgy. Managa (Purok Pananag B)
3. Bgy. Anonang (Sitio Malupo)

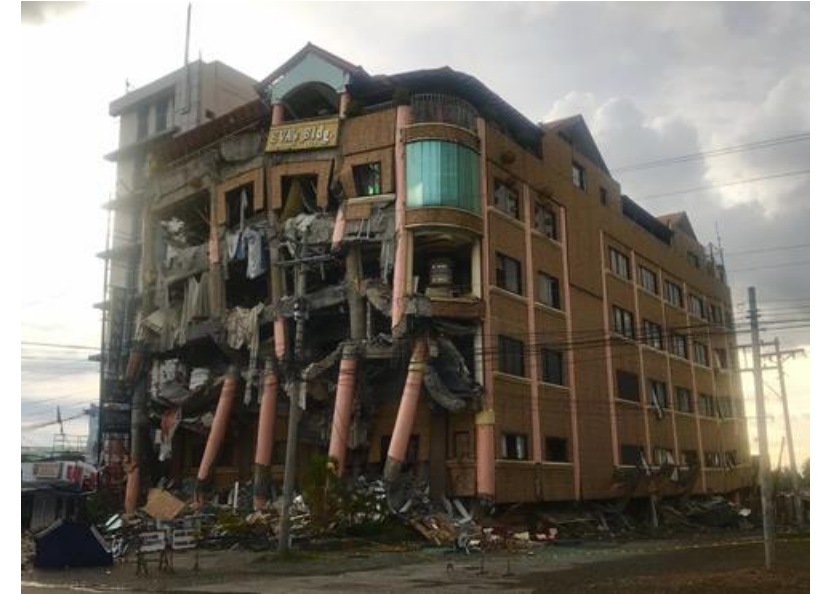
Eva's Building damaged during the October 31 2019 M6.5 event. Photo by the PHIVOLCS QRT (10312019)

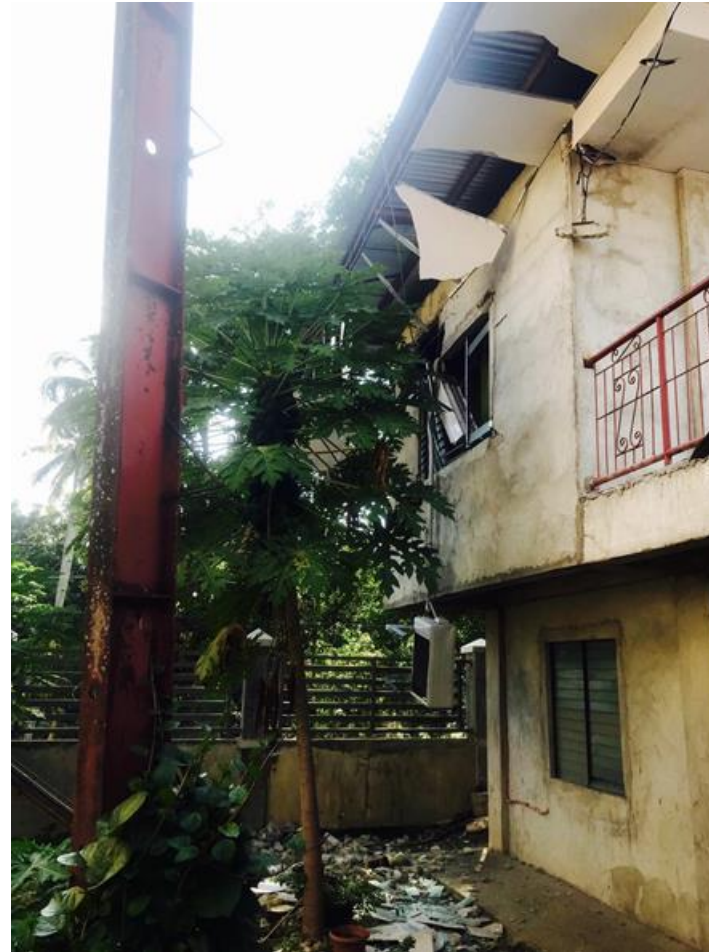
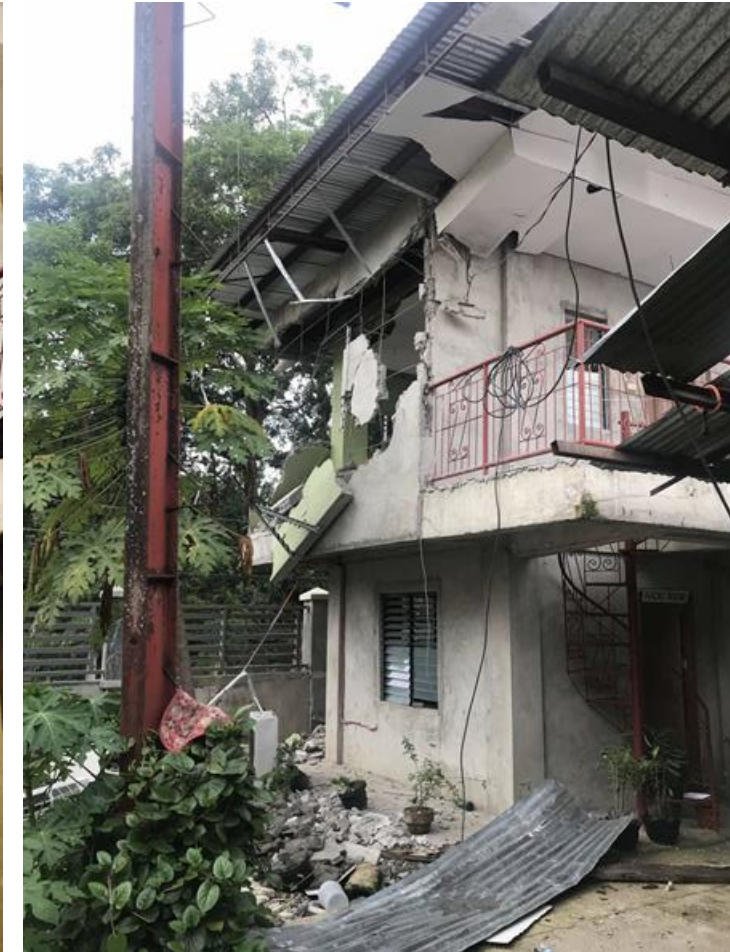
Makilala DRRMO after the 16 October 2019 M6.3 (left) and 29 October 2019 M6.6 (right) earthquakes

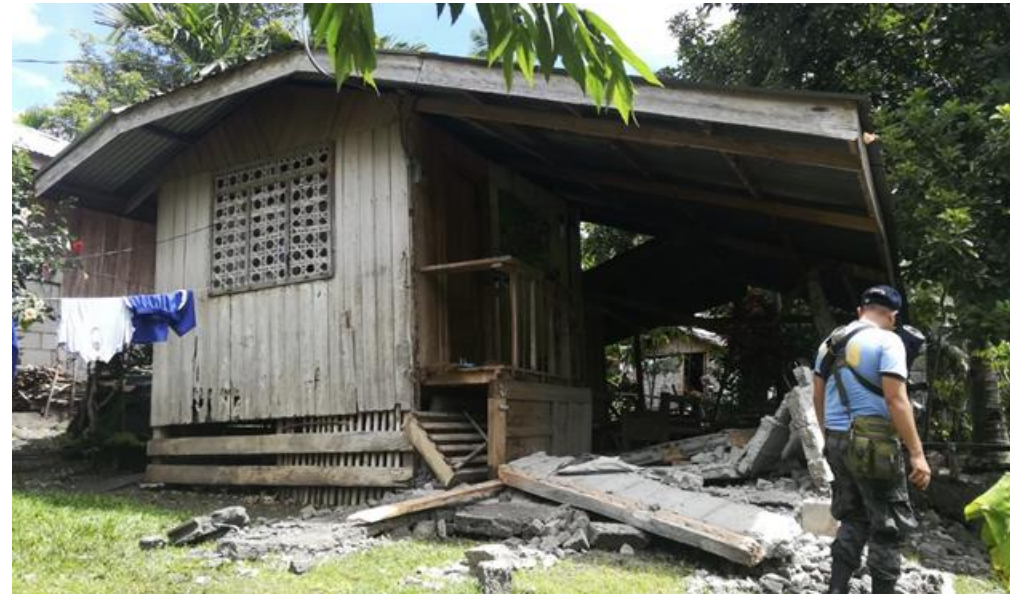
Major damage with collapsed CHB wall in mixed-material house in Brgy. Asinan, Matanao

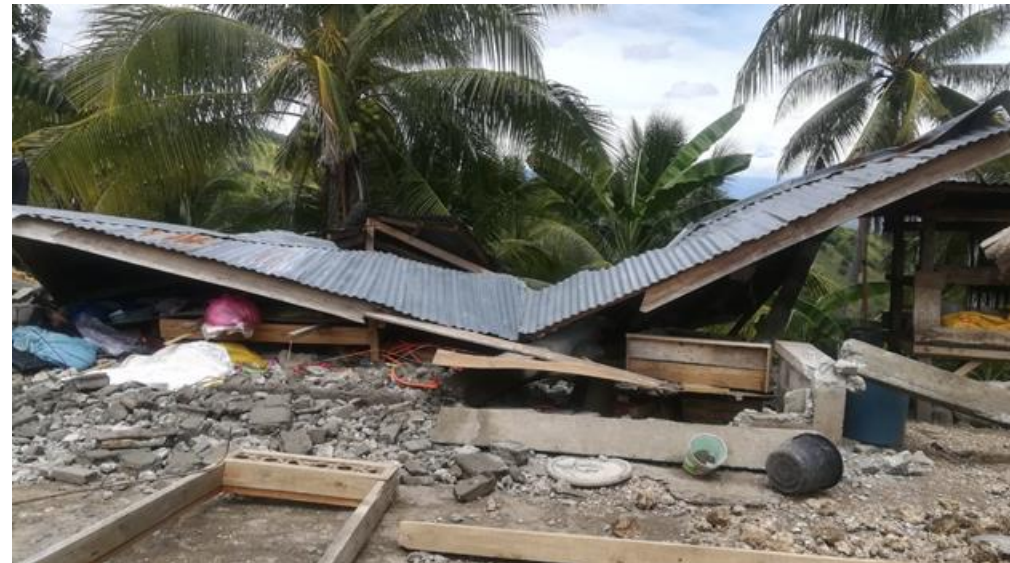
Completely collapsed CHB house that was constructed on a steep area in Brgy. Asinan. Tension cracks were also observed in front of this house.

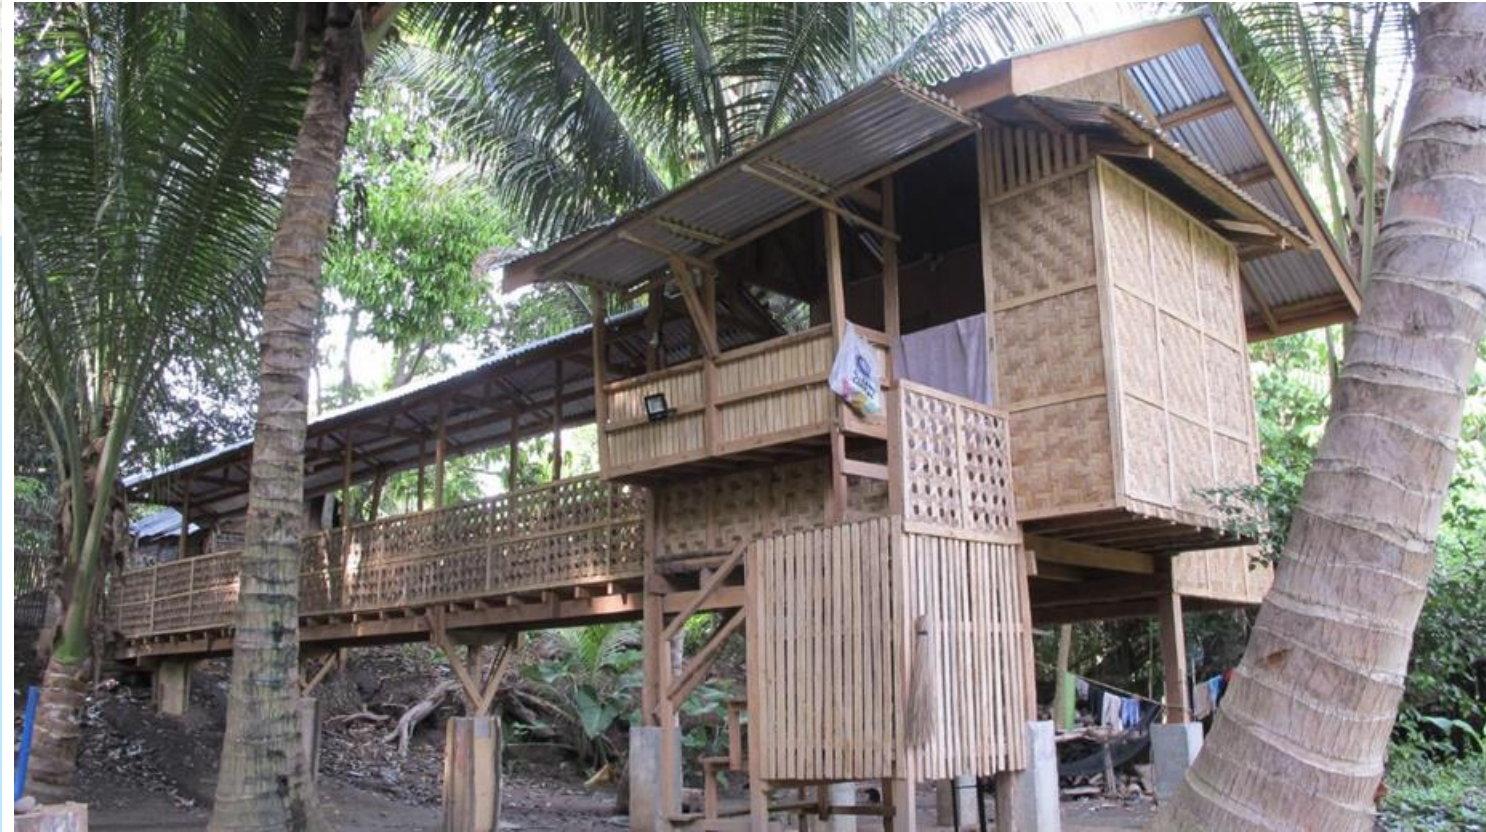
Wooden house built near the liquefied area in Poblacion, Matanao was able to withstand both the M6.6 and M6.5 quakes

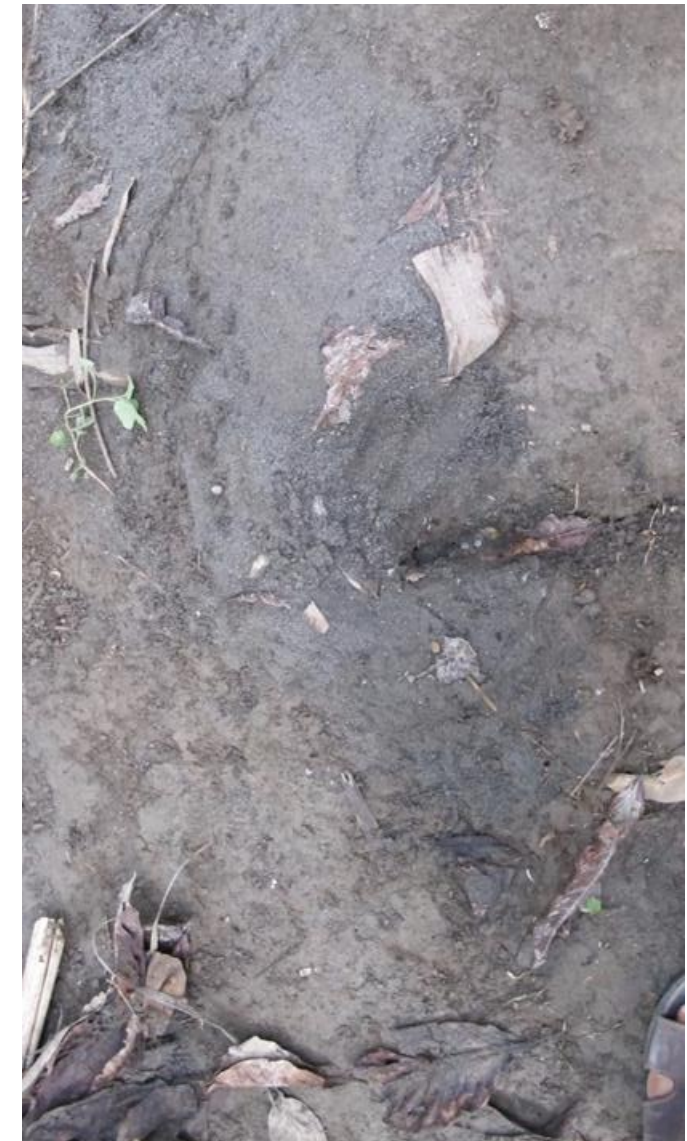
Sandboils observed in Brgy. Tamlangon after the M6.6 earthquake

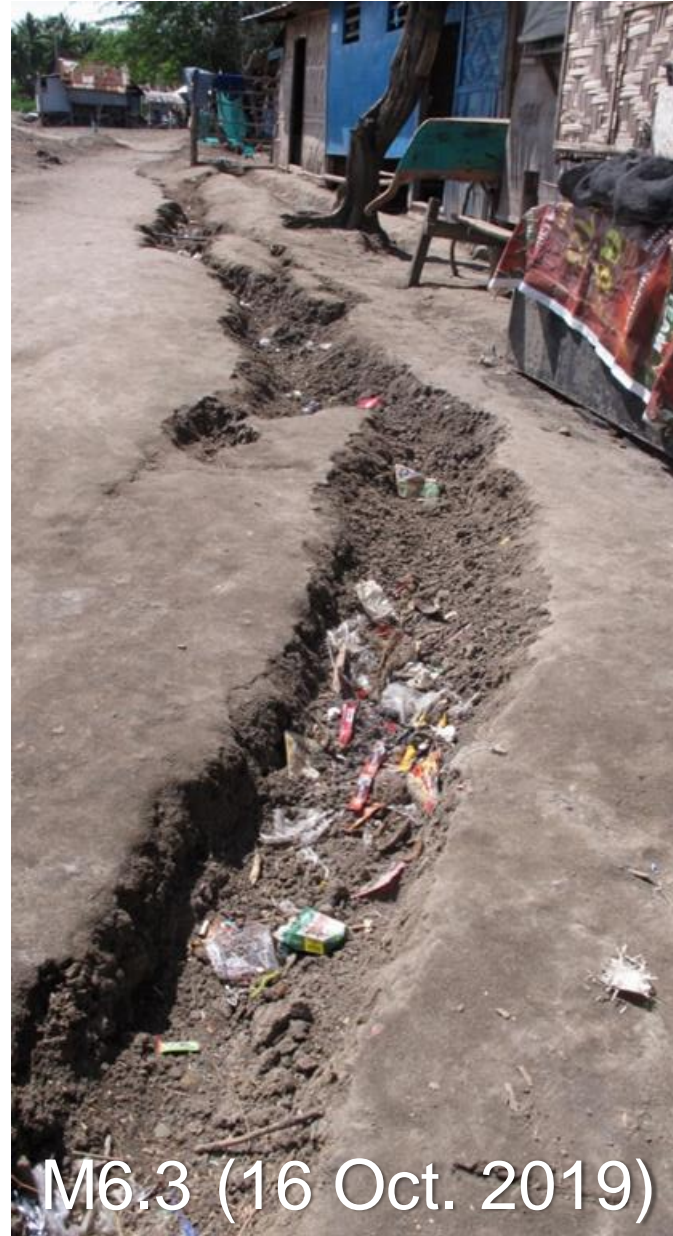
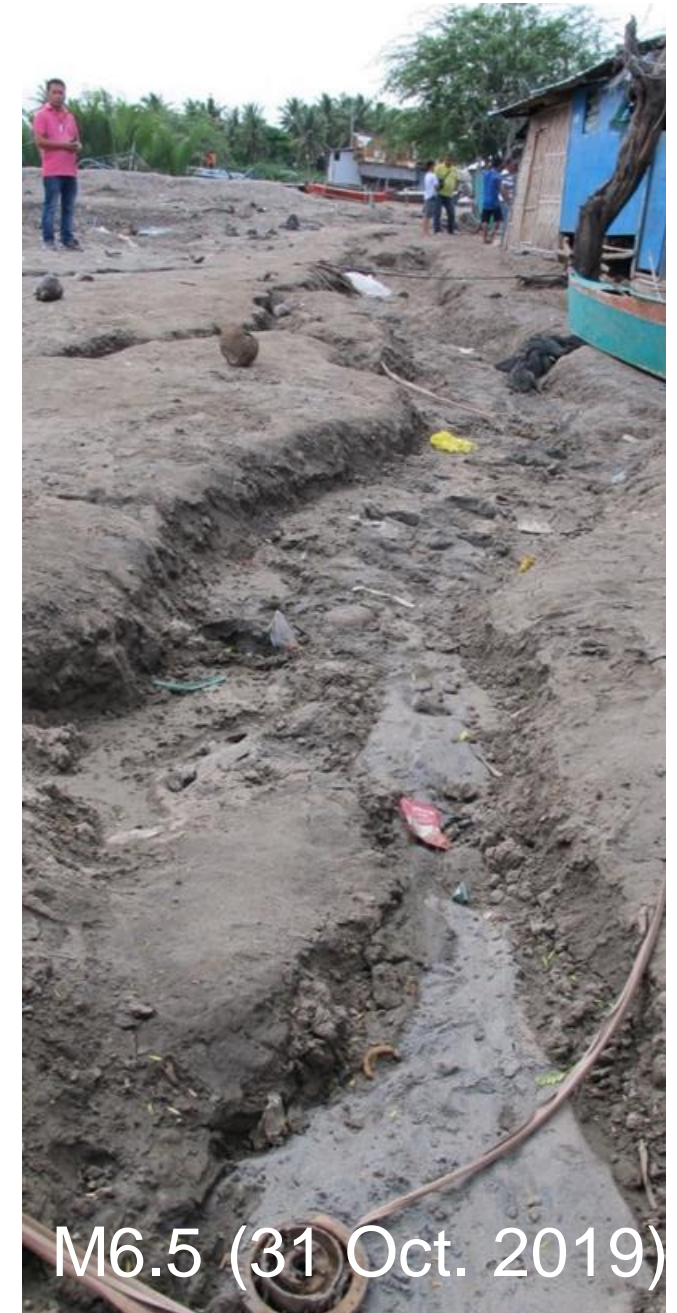
Lateral spreading in
Brgy. Aplaya, Hagonoy,
Davao del Sur

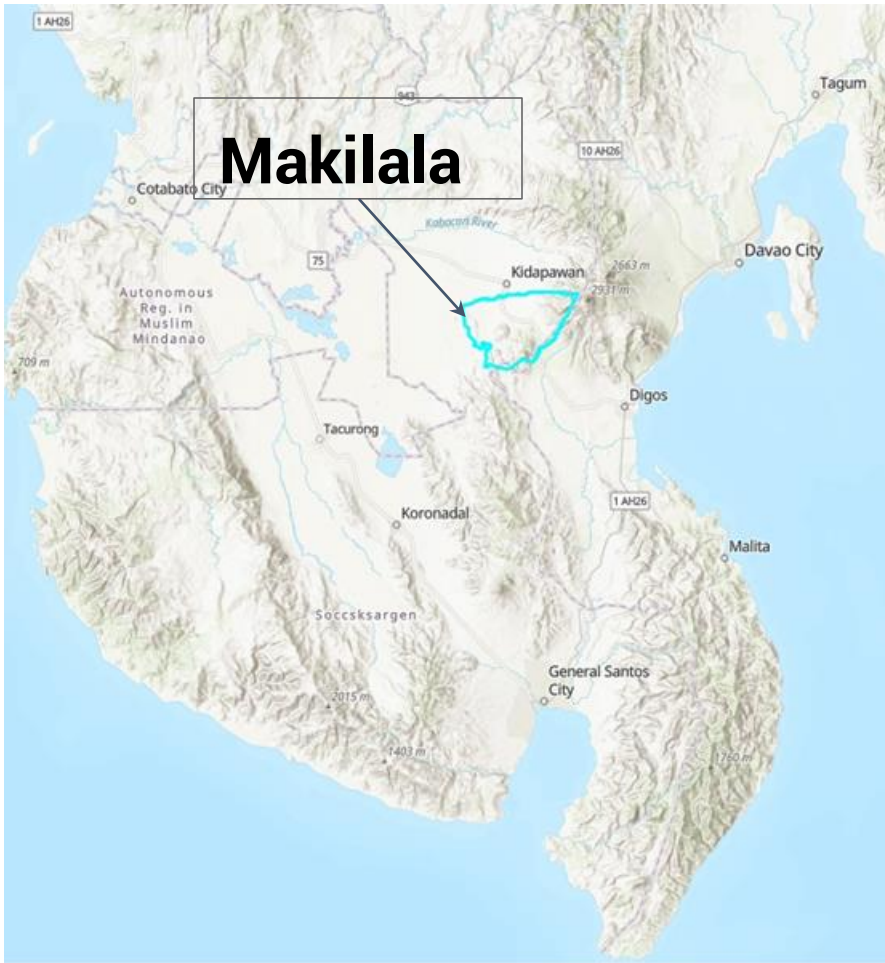
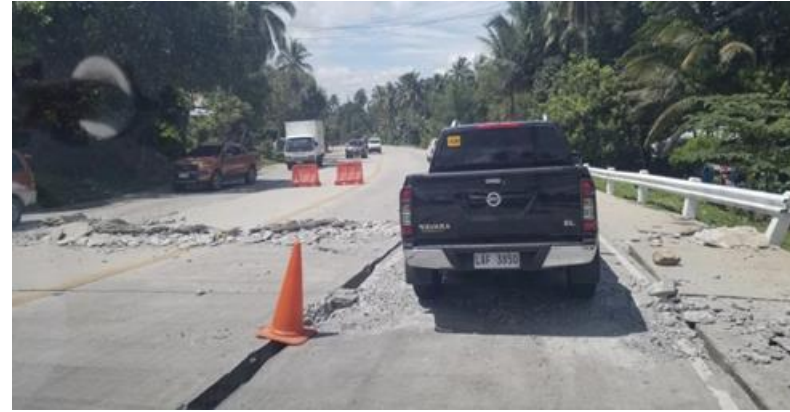
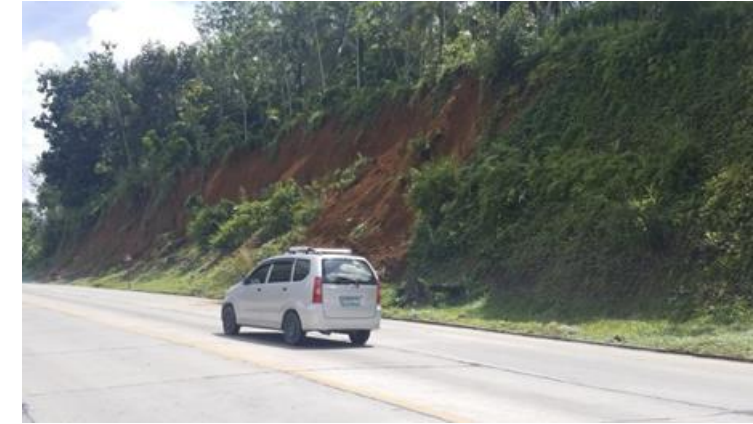
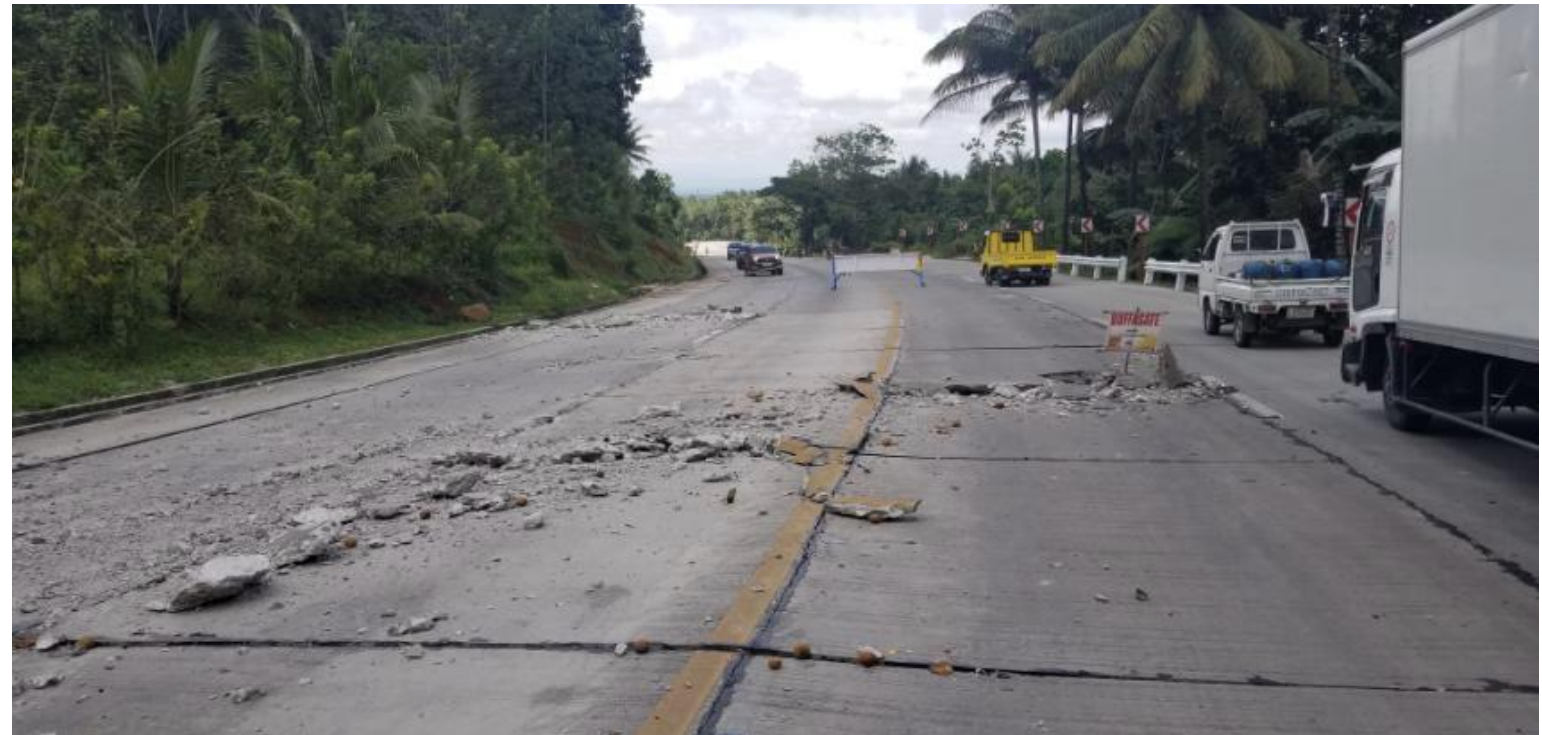
These segments of the national road in Brgy. Kisante, Makilala, Cotabato were damaged after the M6.5 event

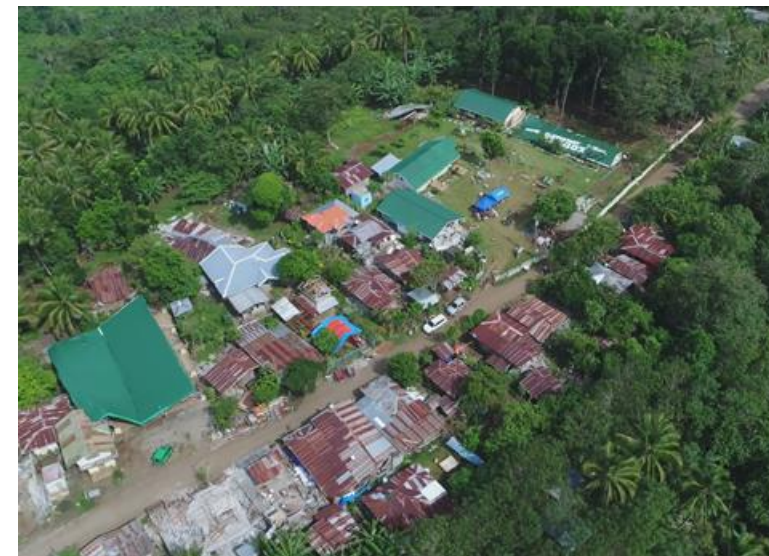
Drone photo taken by
PHIVOLCS QRT at Bgy. Daig,
Tulunan

1. Bgy. Daig (Purok 1 / Center)
2. Bgy. Bacong (selected houses near Bgy. Hall)

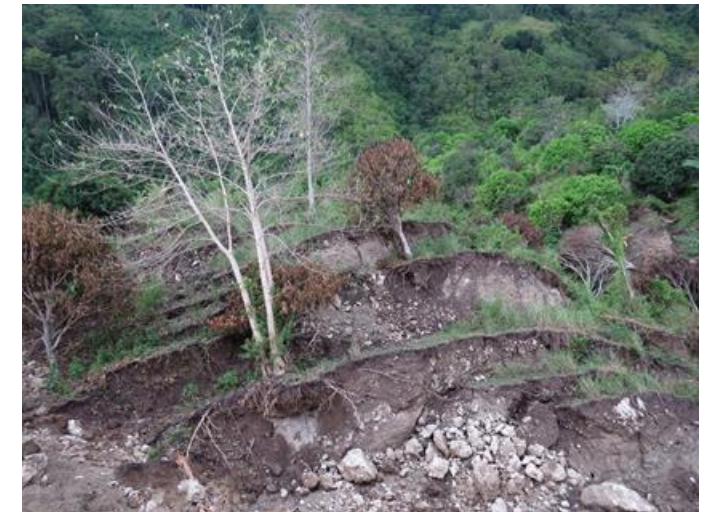
Drone shot in Purok Pananag B,
Bgy. Managa, Bansalan
