The September 2018 Naga landslide: Analysis and lessons learned

Nathan Azriel S. Veracruz^{1,2*}, Sandra G. Catane¹, John Romel R. Flora¹,
Chatty Mae M. Go¹, Rochelle E. Enrera¹, and Erizza Rose U. Santos^{1,2}

¹Engineering Geology Laboratory, National Institute of Geological Sciences, University of the Philippines Diliman

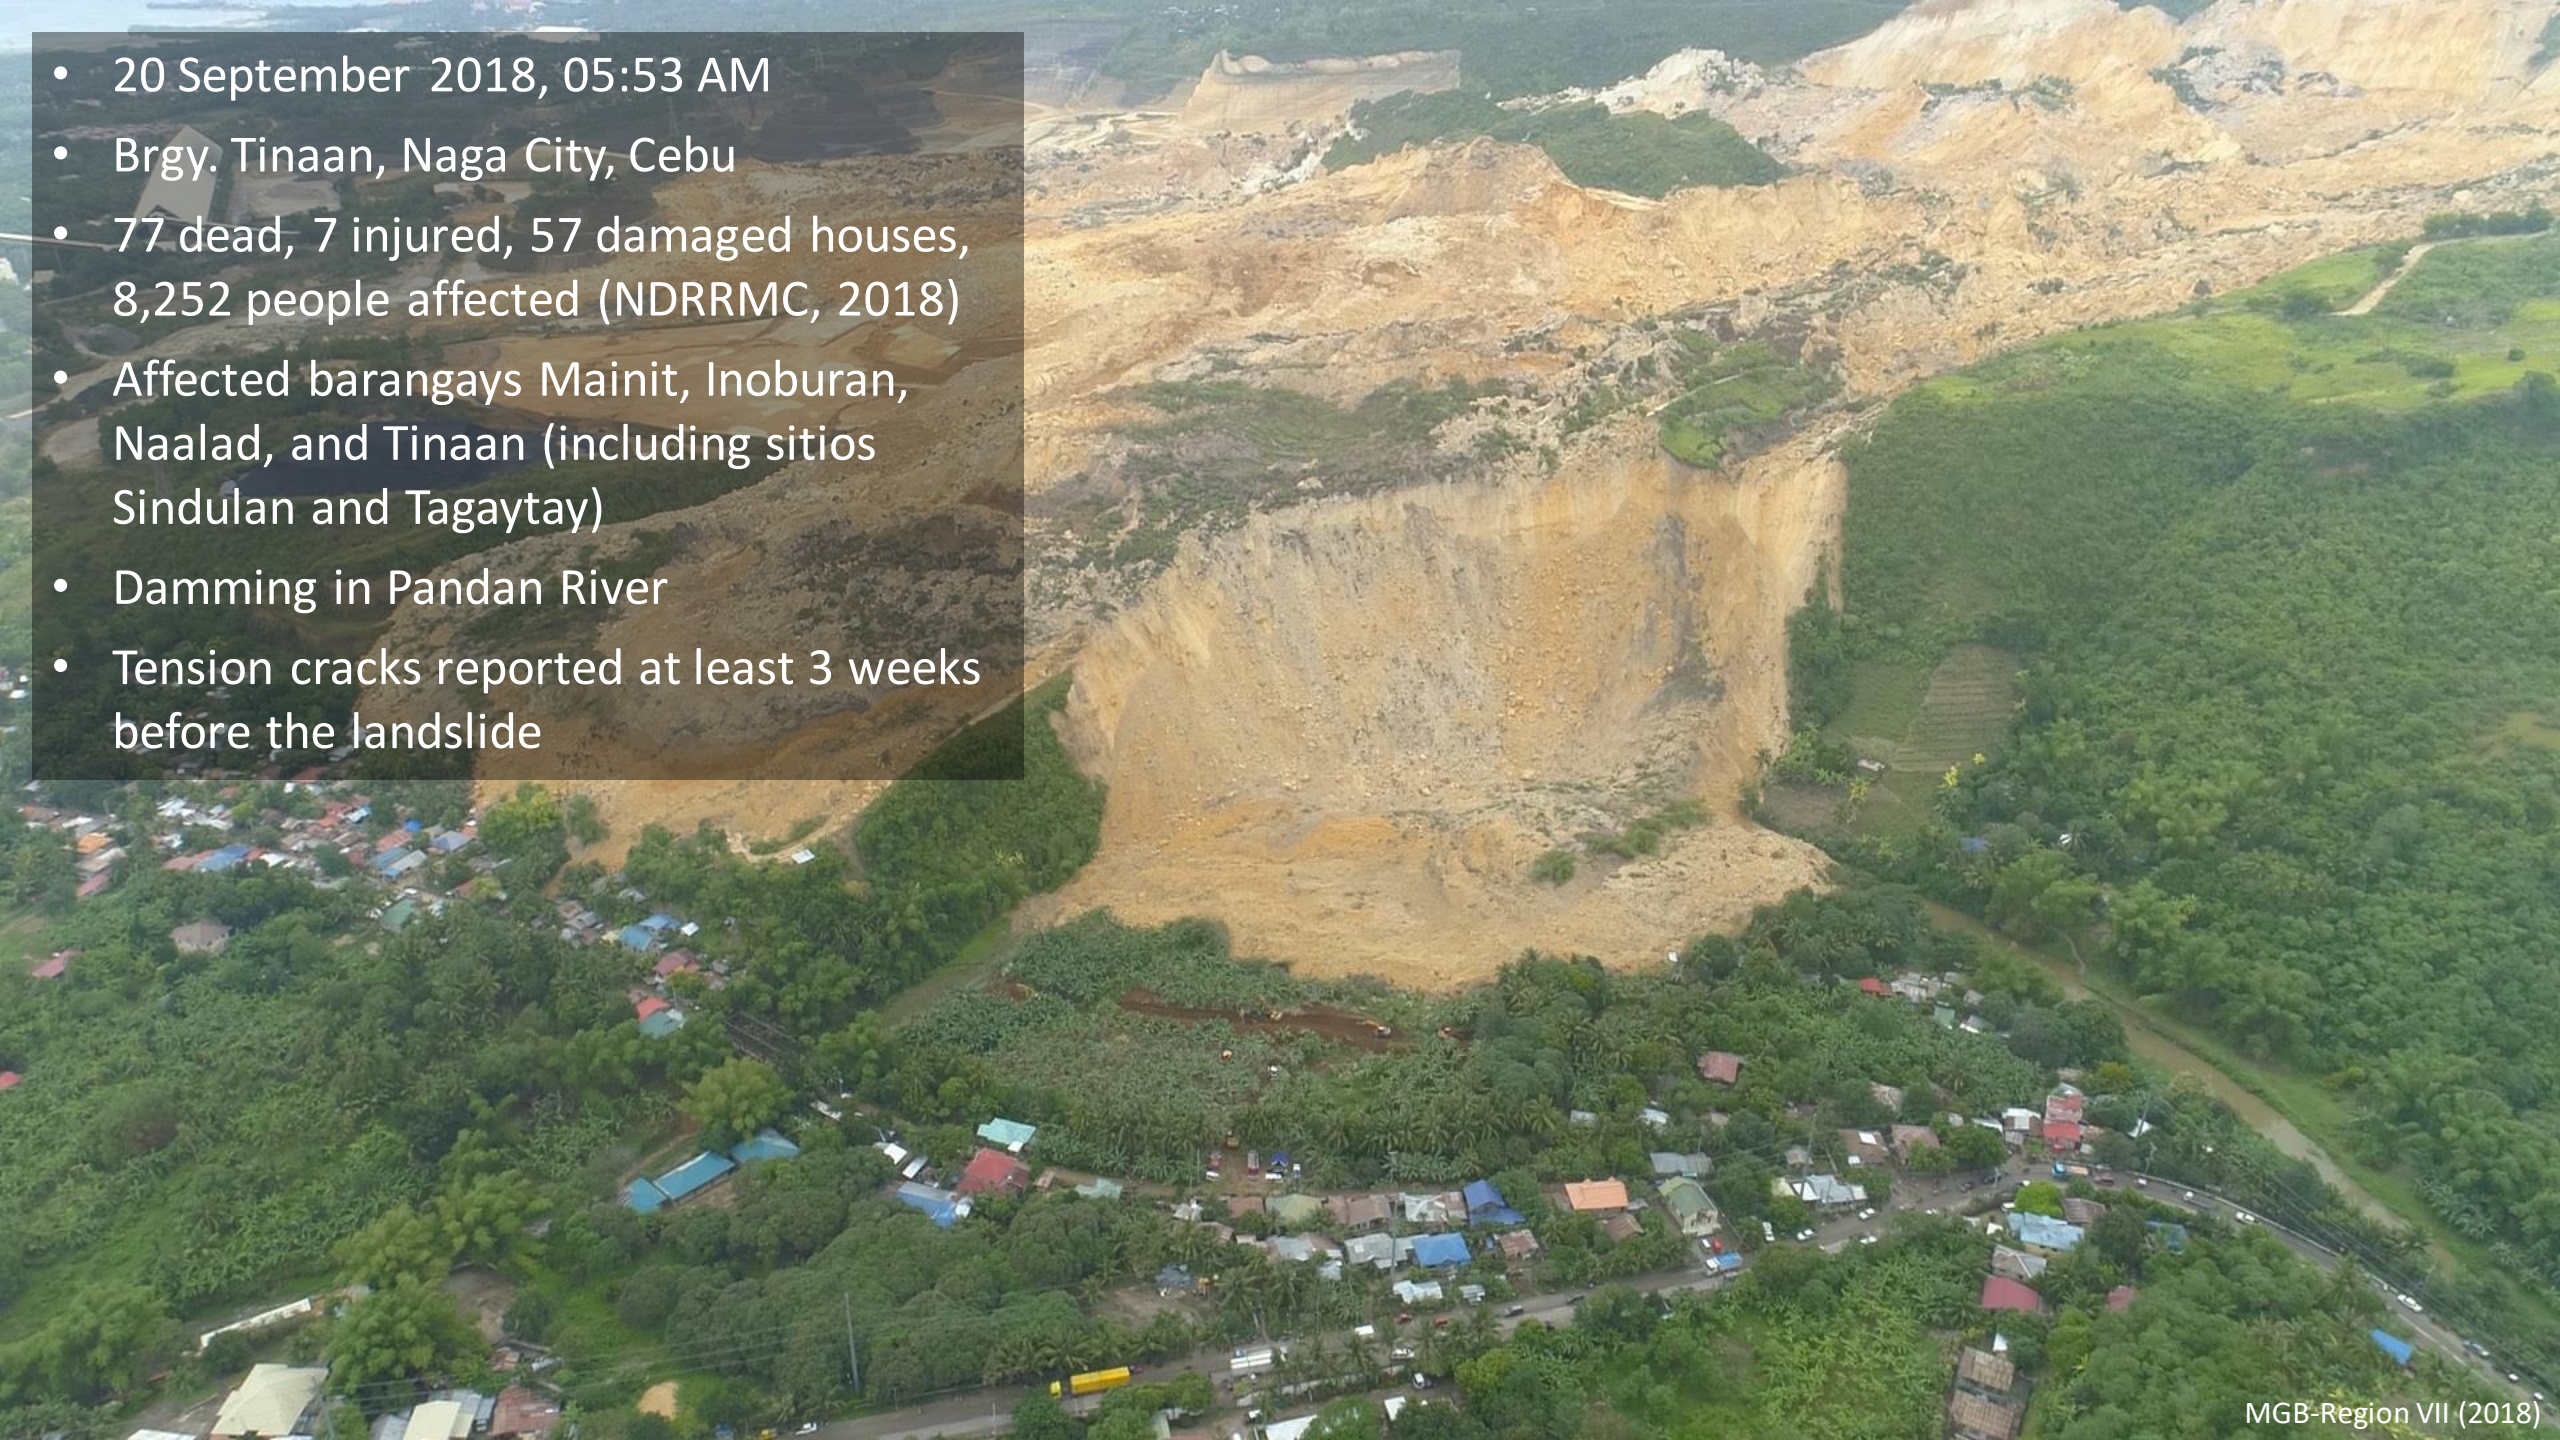
- 20 September 2018, 05:53 AM
- Brgy. Tinaan, Naga City, Cebu
- 77 dead, 7 injured, 57 damaged houses, 8,252 people affected (NDRRMC, 2018)
- Affected barangays Mainit, Inoburan, Naalad, and Tinaan (including sitios Sindulan and Tagaytay)
- Damming in Pandan River
- Tension cracks reported at least 3 weeks before the landslide

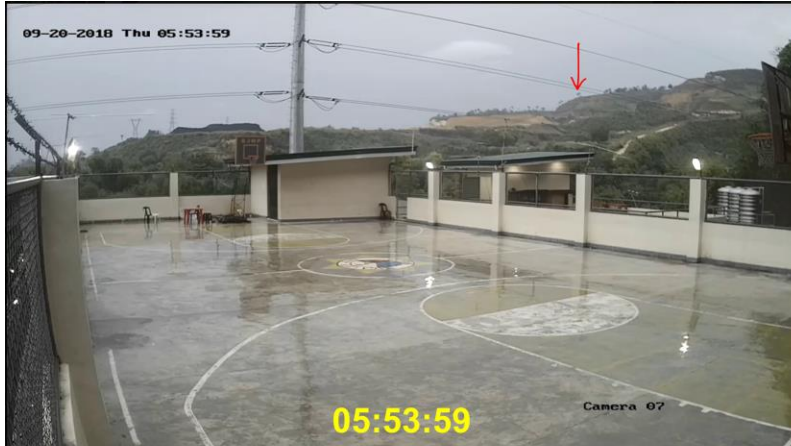
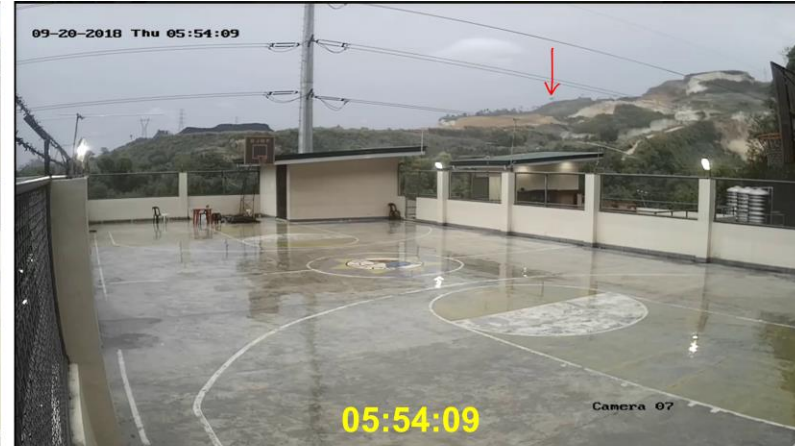
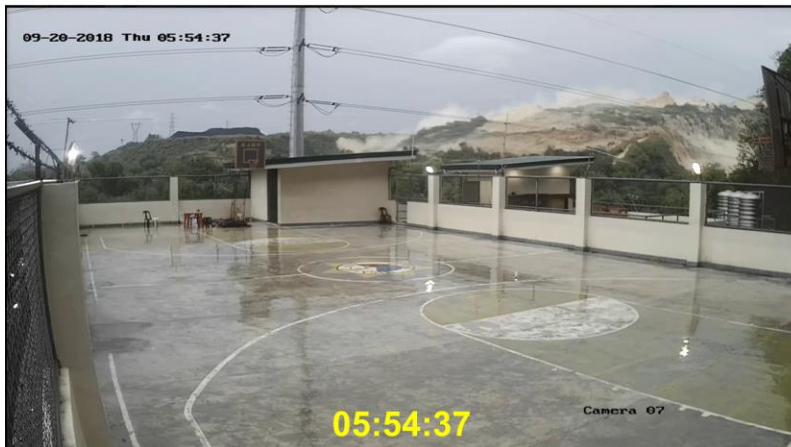
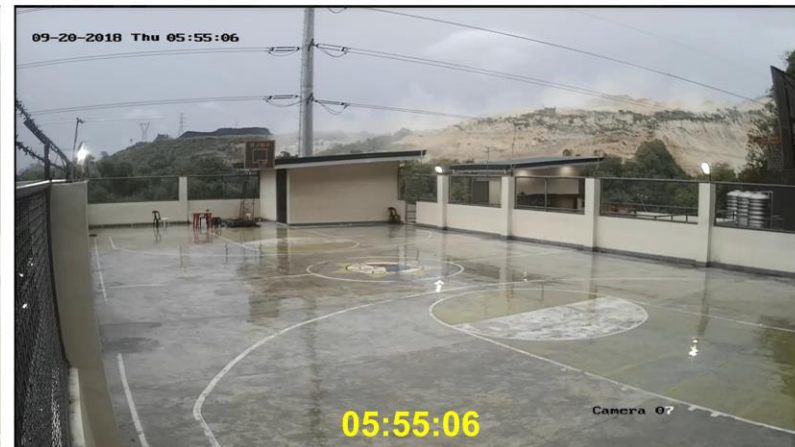
- Lasted for 67 s
- Landslide moved en masse and then split into two major directions

Frames from the CCTV footage of BJMP

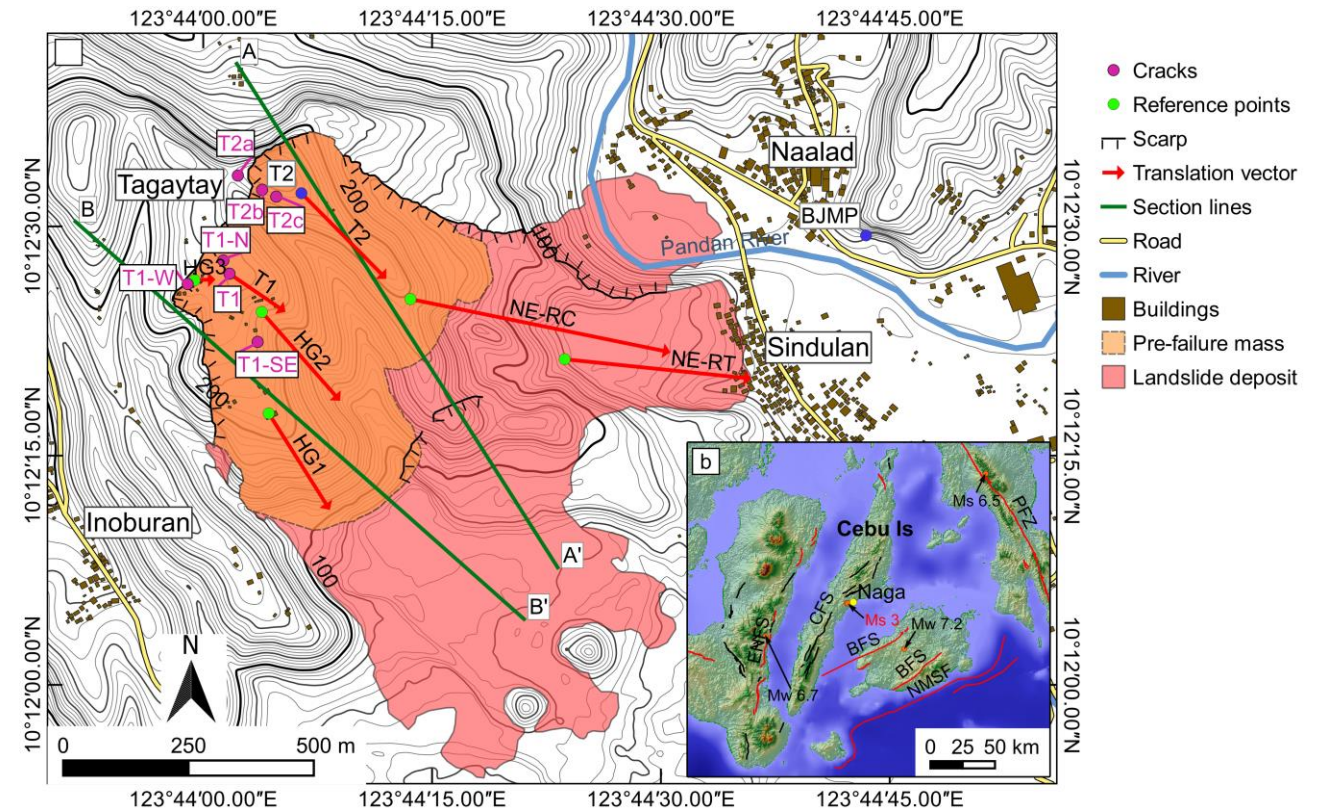
- 2007: intermittent ground cracks and rockfalls
- 2016: small tension cracks

Tension cracks	Orientation	29 August 2018			18 September 2018			Mean net HD (cm)	Deformation rate (cm/day)
		L (m)	HD (cm)	VD (cm)	L (m)	HD (cm)	VD (cm)		
T1	35°, 80° SE	45	8–10	~ 0	Increased	19–19.5	11–11.5	10.25	0.51
T1-W	10-20°, 90°	1–1.5	1–3	~ 0	18–19	16–17	Not reported	14.5	0.73
T1-SE	NW strike	1–1.5	< 1–3	~ 0	Not reported			–	–
T1-N	35°, 90°	Not reported			> 50	19–19.5	24–25	19.25	–
T2a, T2b, T2c	10-65°, 90°	1–1.5	3–6	~ 0	Increased	14–14.5	3–6	9.75	0.49

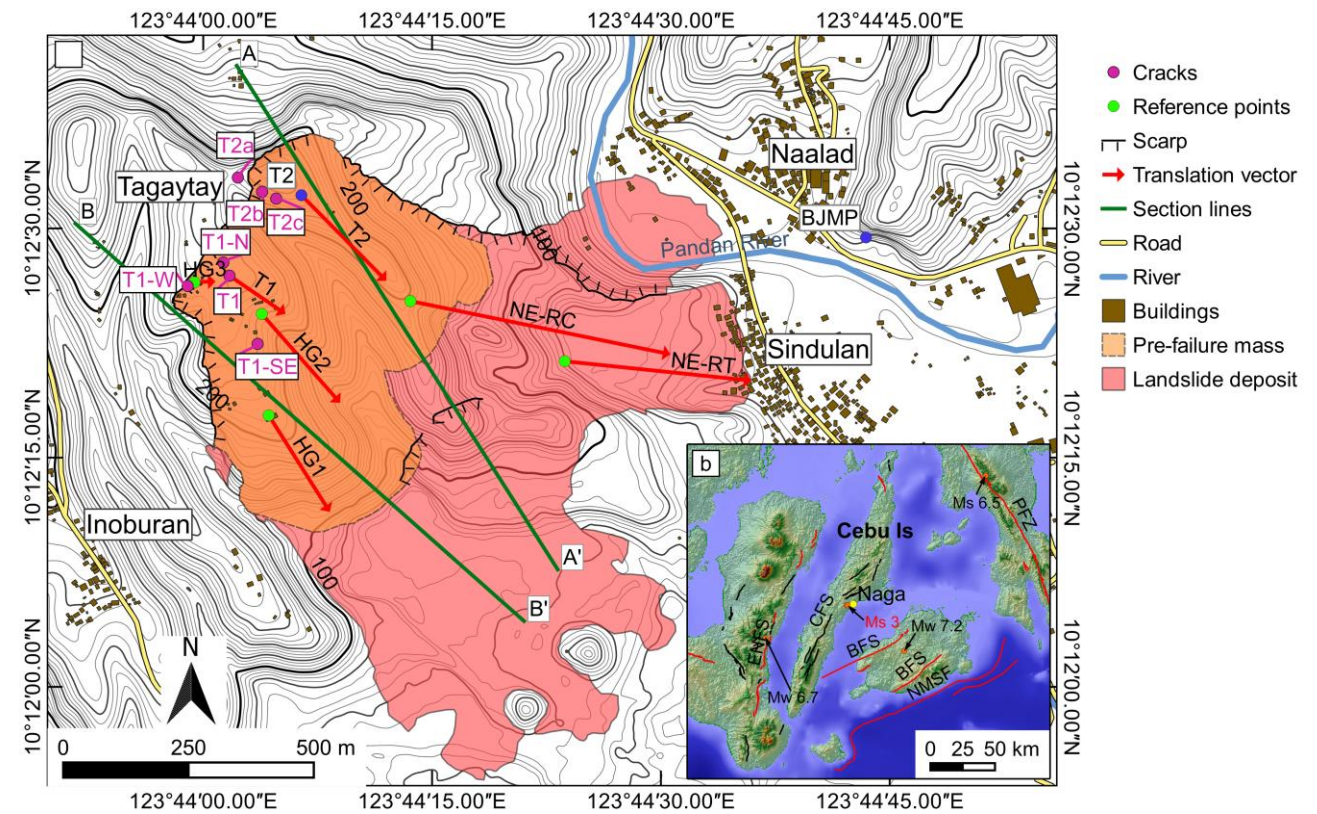
- Predominantly NE-trending cracks
- Progressive widening of cracks → tensional failure → shear strength reduction

Tension cracks	Orientation	29 August 2018			18 September 2018			Mean net HD (cm)	Deformation rate (cm/day)
		L (m)	HD (cm)	VD (cm)	L (m)	HD (cm)	VD (cm)		
T1	35°, 80° SE	45	8–10	~ 0	Increased	19–19.5	11–11.5	10.25	0.51
T1-W	10-20°, 90°	1–1.5	1–3	~ 0	18–19	16–17	Not reported	14.5	0.73
T1-SE	NW strike	1–1.5	< 1–3	~ 0	Not reported			–	–
T1-N	35°, 90°	Not reported			> 50	19–19.5	24–25	19.25	–
T2a, T2b, T2c	10-65°, 90°	1–1.5	3–6	~ 0	Increased	14–14.5	3–6	9.75	0.49

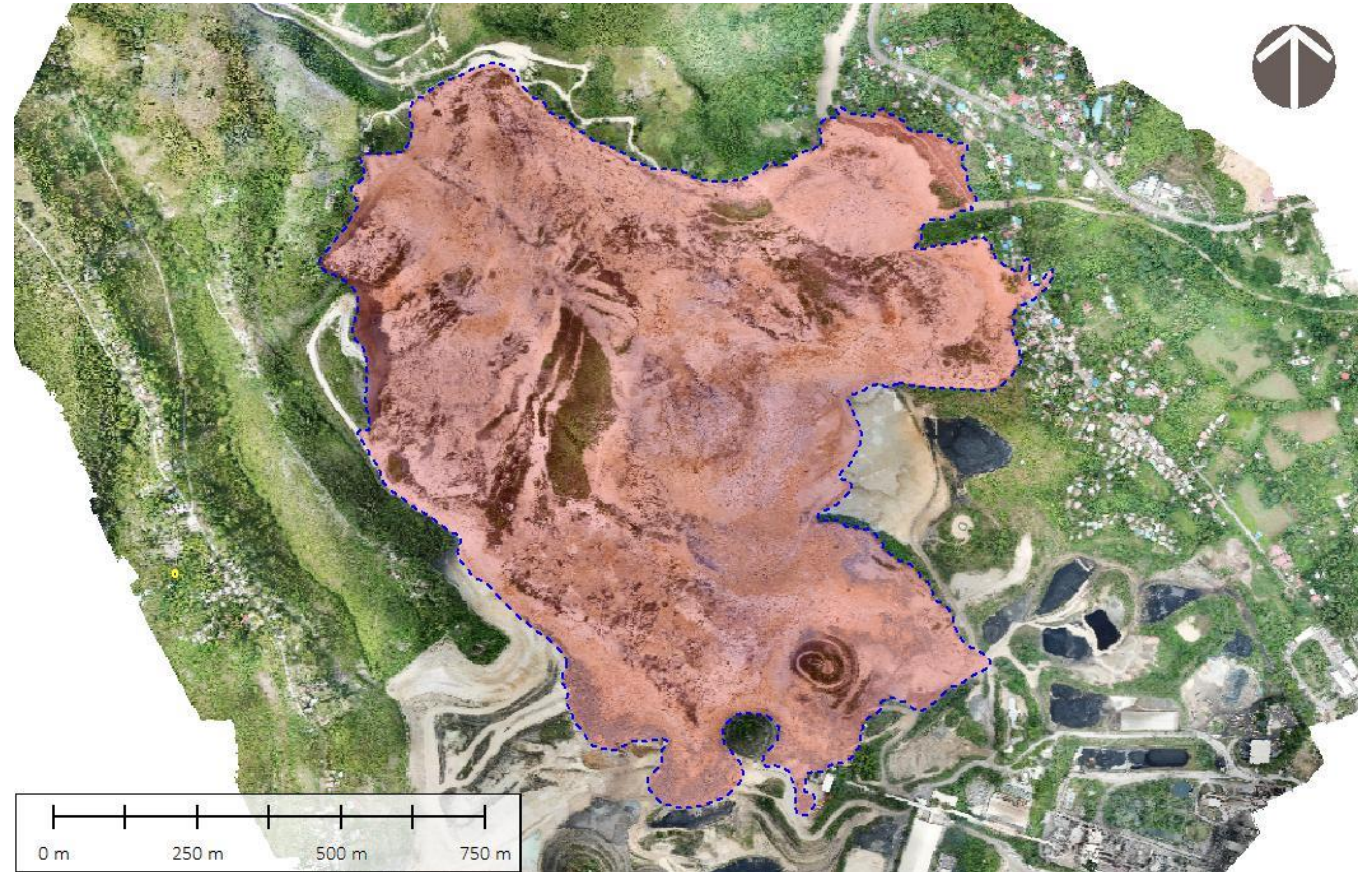
- Area: $\sim 9.5 \times 10^5 \text{ m}^2$ ($\sim 95 \text{ ha}$)
- Volume: $\sim 27 \text{ M m}^3$
- Velocity: 0.63–7.91 m/s (very rapid to extremely rapid)
- Runout: 1.34 km
- Head scarp: 480-m-long, $\sim 50\text{-m}$ -high, $55\text{--}75^\circ$ steep
- Underlain by limestones of the Plio-Pleistocene Carcar Formation
 - Thinly to thickly bedded calcarenites and calcirudites
 - Gently SE-dipping (low-angle) and daylighting
 - Poorly cemented and very porous

Post-landslide orthomosaic from Ariel Lazarte

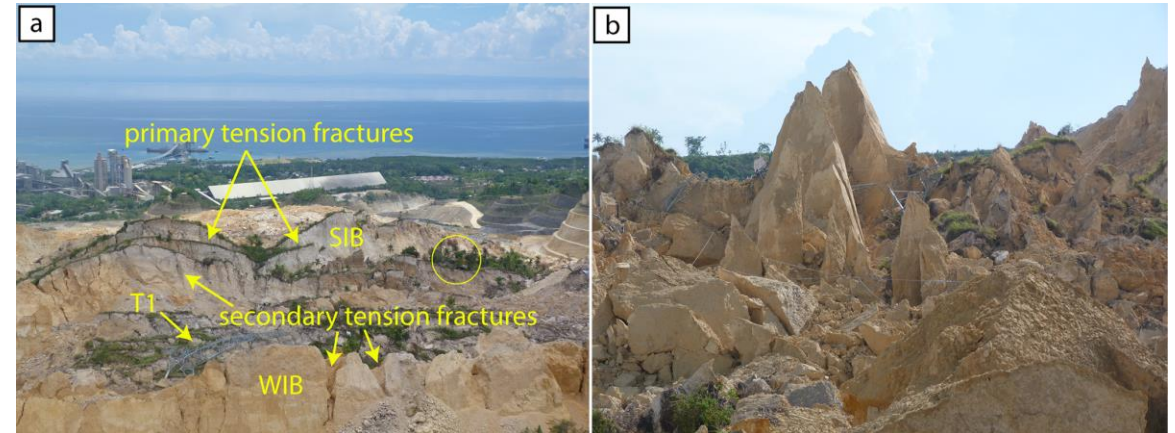
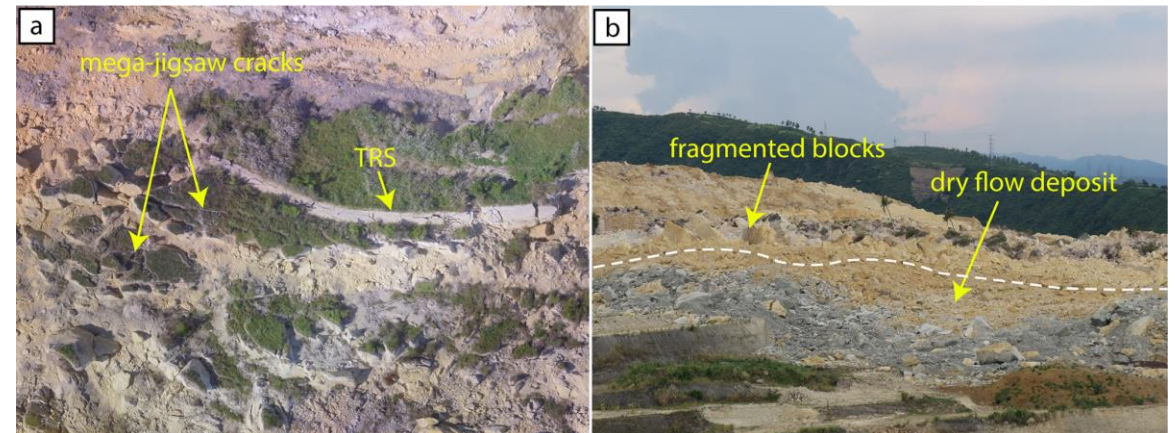
- Successive detachment of multiple blocks along a series of tension cracks
- Primary and secondary tension fractures
- Slab-like and wedge-like blocks
- Landslide deposit facies: intact blocks, fragmented blocks, dry flow deposits, rockfall deposits, collapsed blocks → variable processes within a single landslide
- Most blocks retained their upright positions → predominant translational mechanism

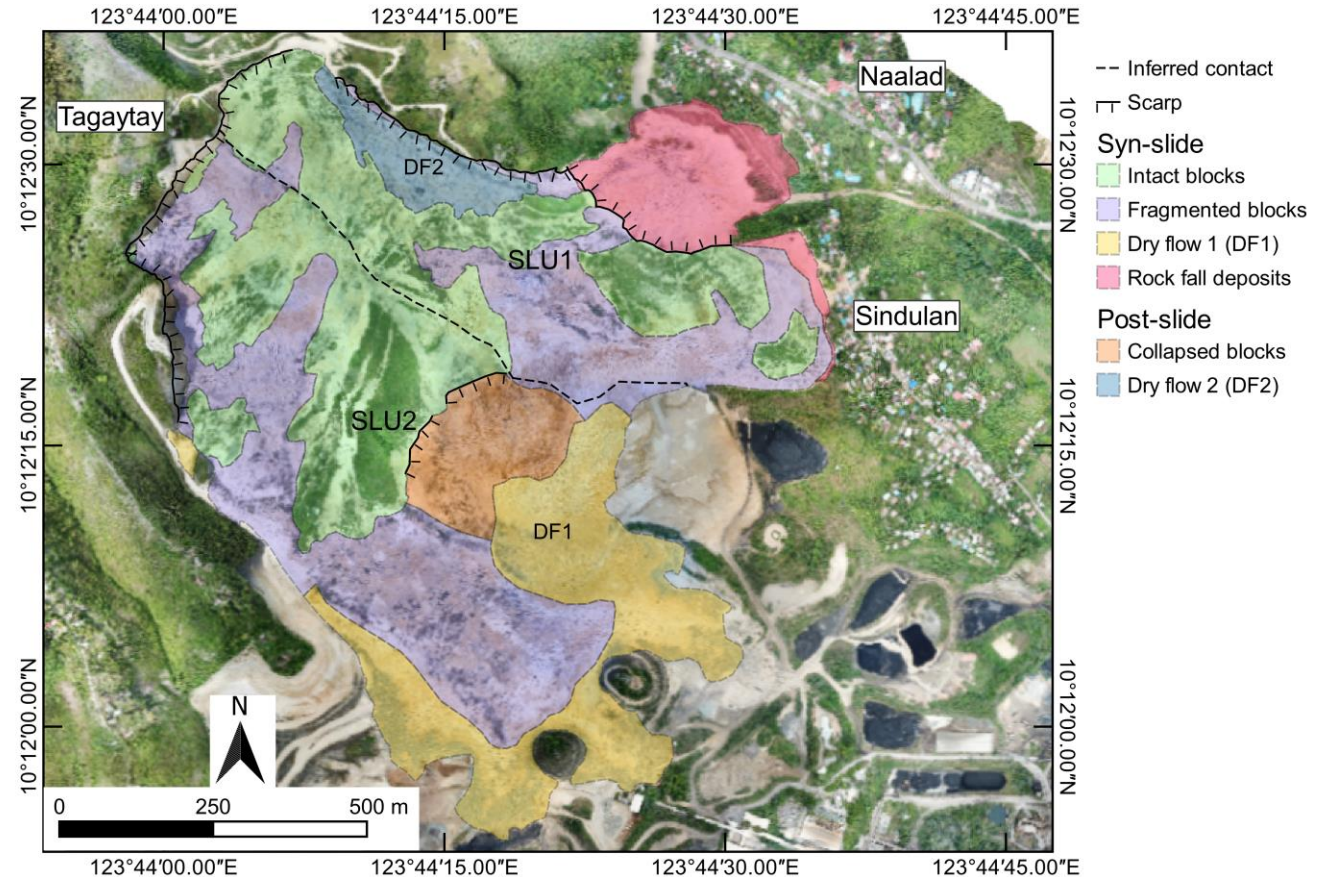
- Successive detachment of multiple blocks along a series of tension cracks
- Primary and secondary tension fractures
- Slab-like and wedge-like blocks
- Landslide deposit facies: intact blocks, fragmented blocks, dry flow deposits, rockfall deposits, collapsed blocks → variable processes within a single landslide
- Most blocks retained their upright positions → predominant translational mechanism

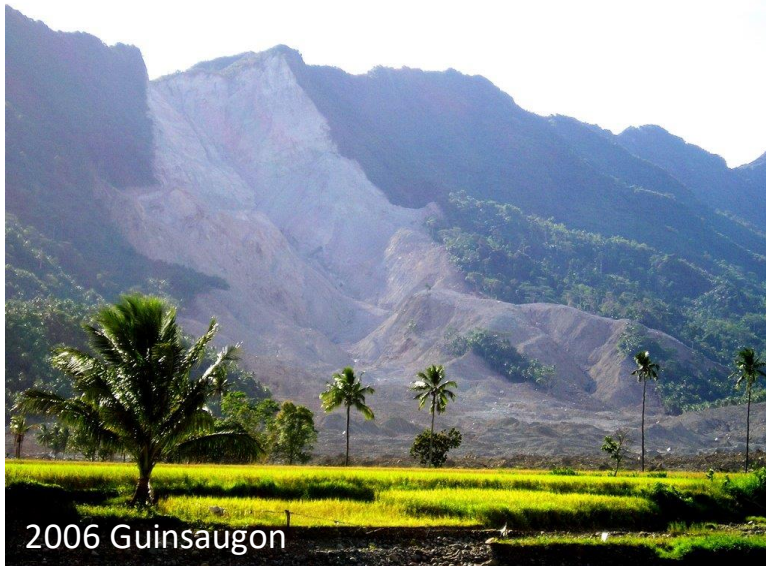
2006 Guinsaugon (Catane et al., 2007, 2008)	2018 Naga
Area	3.2 km ²	9.5 km ²
Volume	14–18 M m ³	27 M m ³
Maximum velocity	120–130 m/s	7.9 m/s
Runout	4.1 km	1.34 km
Mechanism	rockslide-debris avalanche	translational block slide

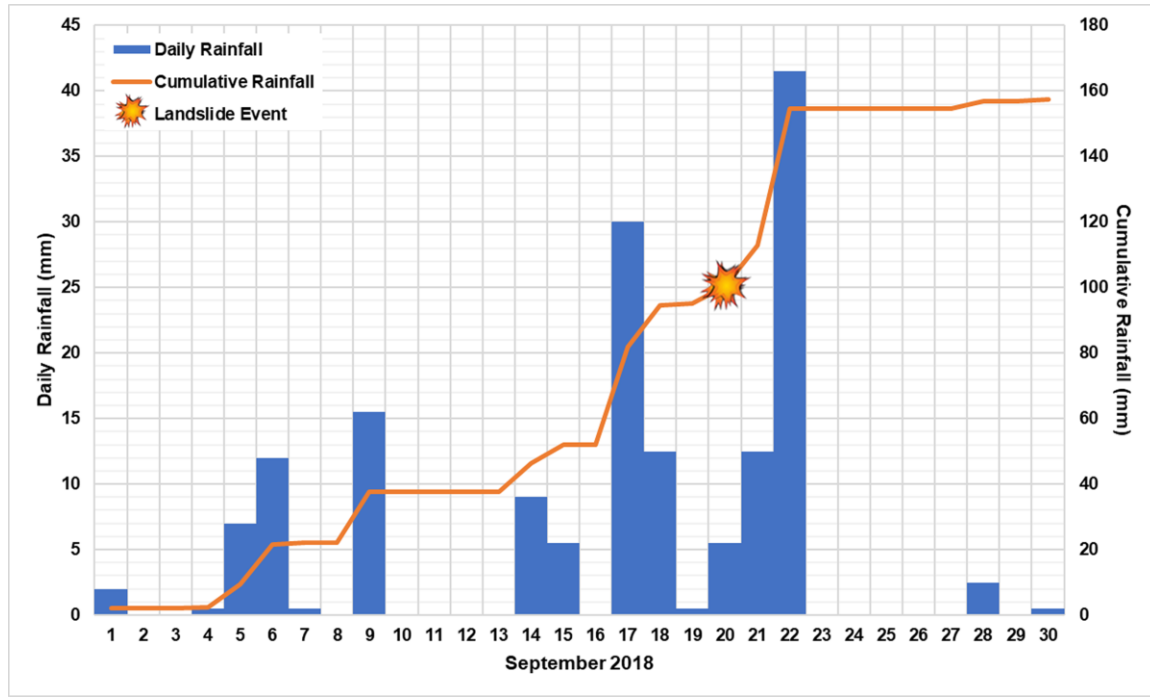
Rainfall data from DOST-ASTI rain gauge located 900 m NW of the landslide

- 15 September: Typhoon Ompong made landfall in Cagayan about 900 km NNW of Naga City
- 17 September: 30 mm maximum daily rainfall
- 20 September, 04:00-05:45 AM: 4.5 mm instantaneous rainfall
- 1-20 September: 99.5 mm cumulative rainfall
- Far below the global threshold of 100 mm/day
- Rainfall is unlikely to have triggered the landslide

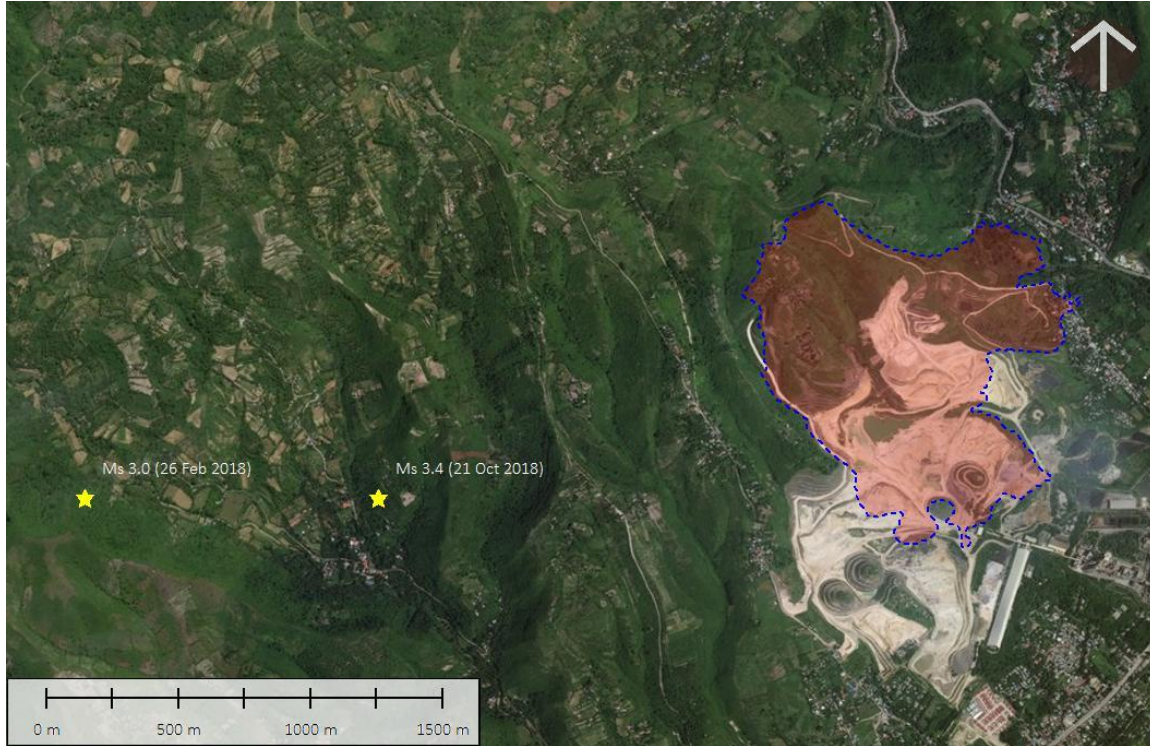
- 26 February 2018, 06:36 AM
 - Ms 3.0 shallow (32 km) earthquake about 2.8 km SW of the landslide
 - No reports of earthquake intensity and landslide precursors
- No earthquakes immediately prior or during the landslide
- 21 October 2018, 07:04 PM
 - Ms 3.4 shallow (10 km) earthquake about 1.8 km SW of the landslide
 - PEIS IV was reported
 - No reports of landslide reactivation
- Earthquake is unlikely to have triggered the landslide

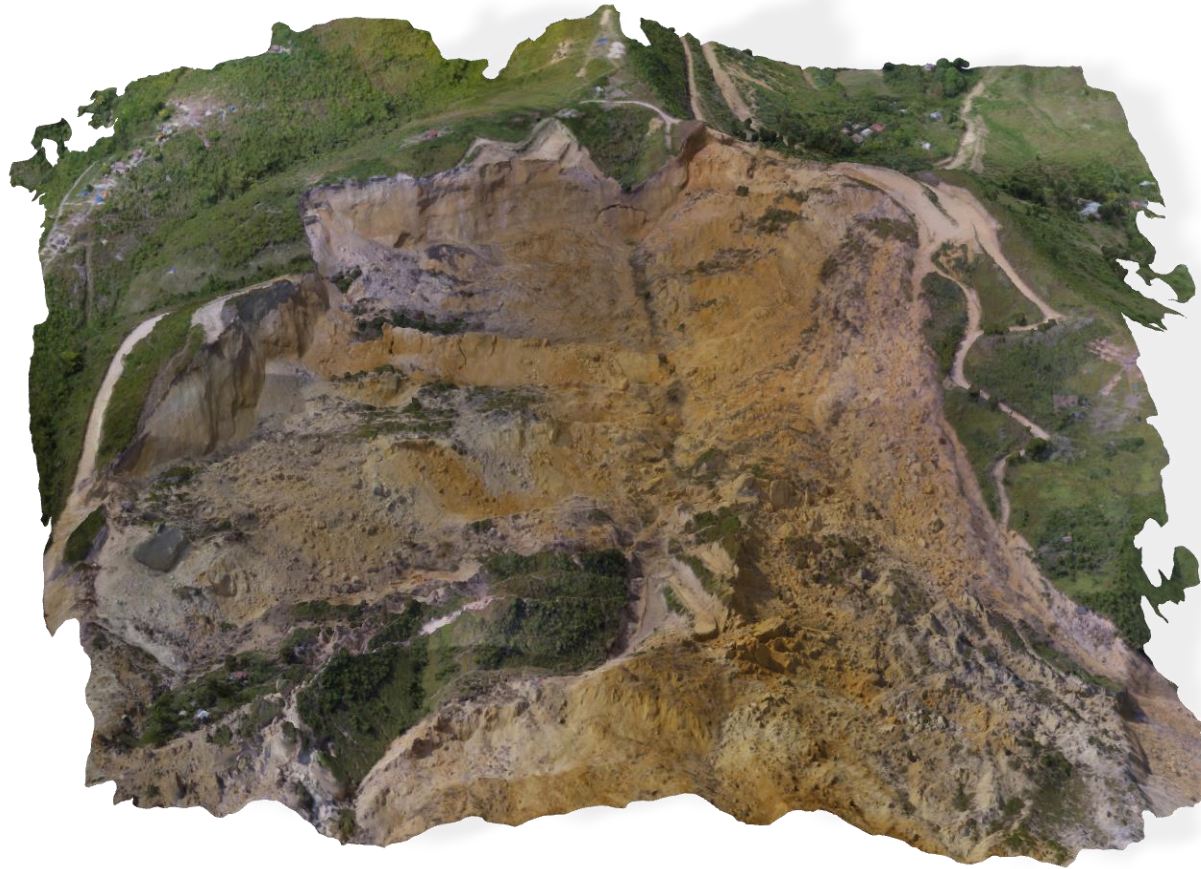
- Steep cut slopes associated with extraction activities
 - Change the load distribution on potential slip surfaces
 - Change the hydrologic conditions of the slope
 - Expose potential slip surfaces
 - Withdraw support at the toe
- Investigate the effect of cut slopes through probabilistic slope stability analyses

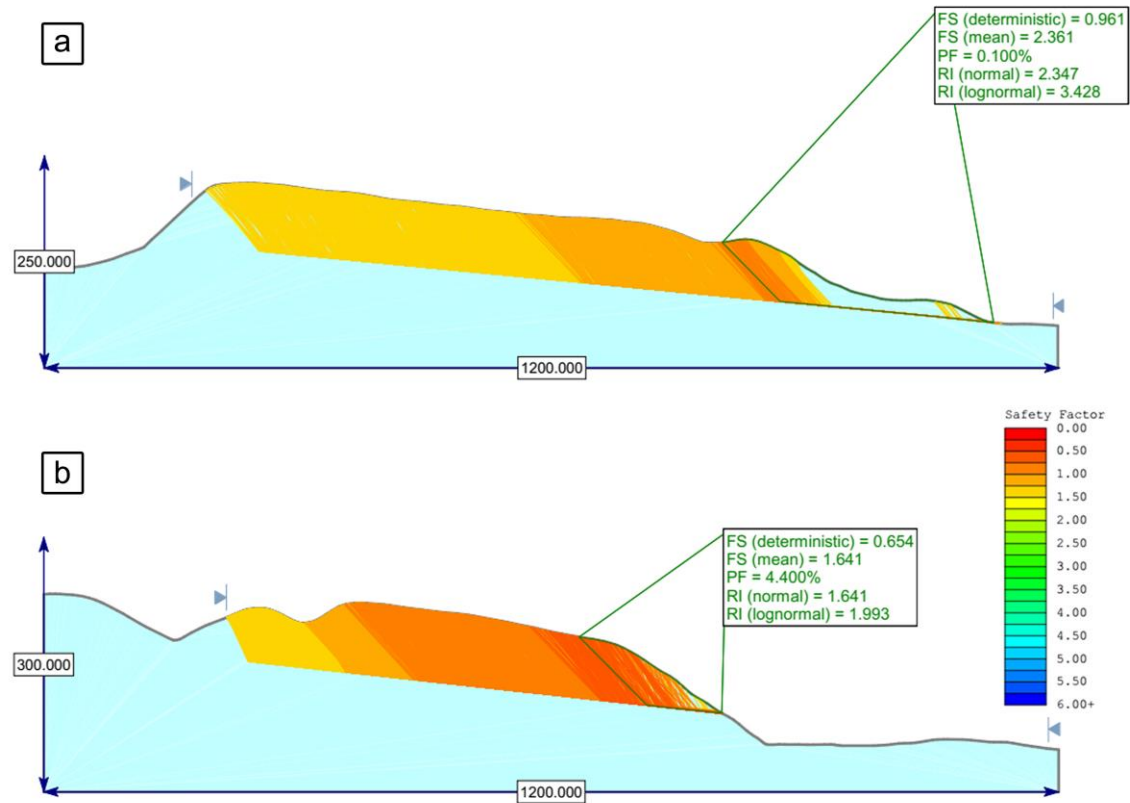
- 2D limit equilibrium analyses
 - Daylighting bedding planes as potential slip surfaces
 - Assumptions: homogenous material, unsaturated condition
 - Estimated material strength parameters:
 - Unit weight = 17–23 kN/m³
 - Intact UCS = 5–25 MPa
 - GSI = 36–54
 - Intact rock constant = 5–15
 - Disturbance factor = 1.0

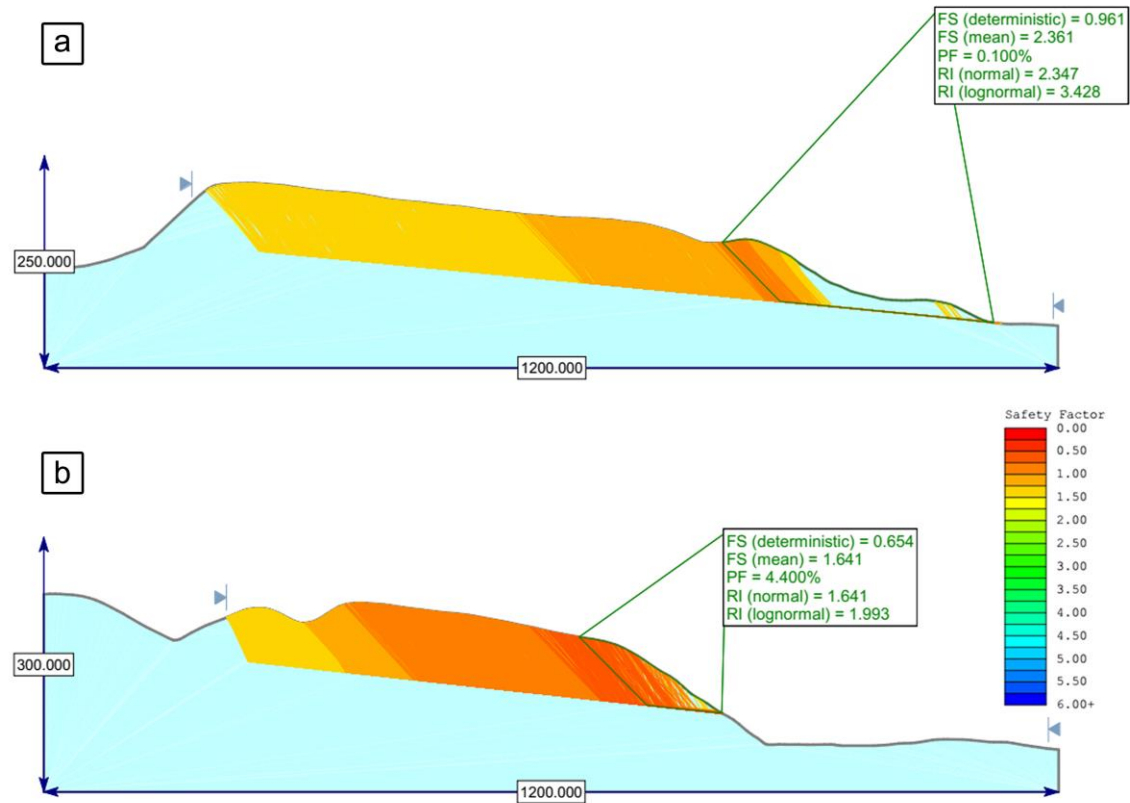
- 2D limit equilibrium analyses
 - Factors of safety:
 - (a) 0.969–3.96
 - (b) 0.668–2.798
- Slopes may already be marginally stable
- Additional removal of support by extraction activities → increase in shear stress
- Further exposure of potential slip surfaces from cut slopes → decrease in shear strength

- Review cut slope designs and extraction methods
- In any extraction activities, full-time monitoring by geologists and geotechnical engineers is essential

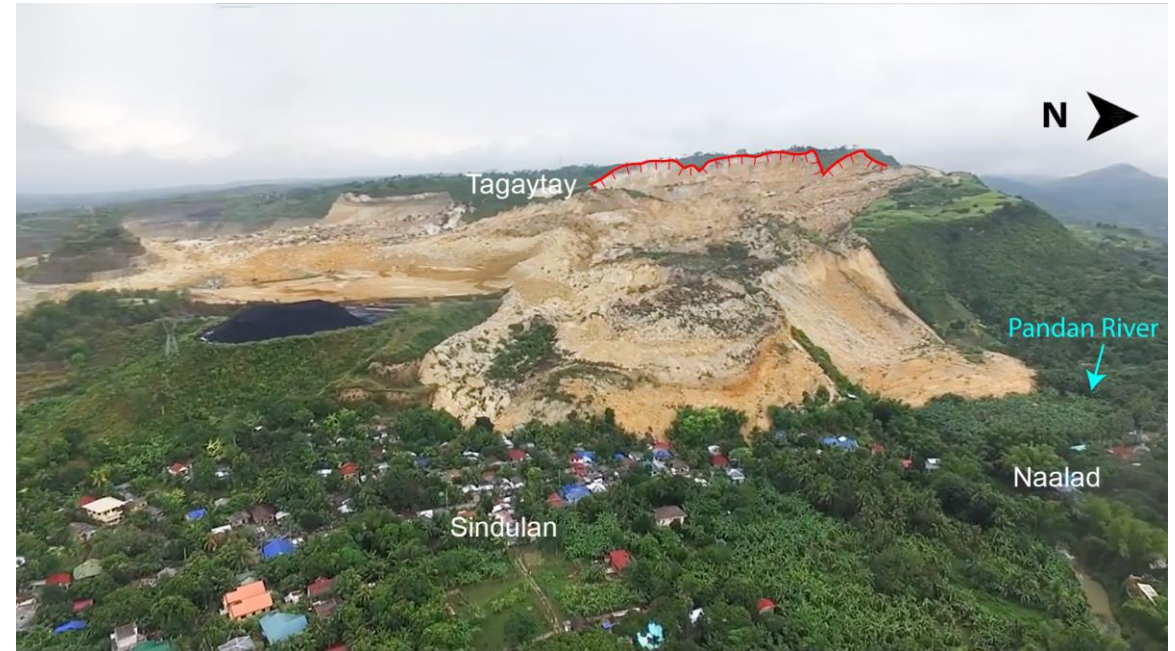
- Development of tension cracks at least 3 weeks before the landslide provided reasonable lead time to issue an early warning
- This prompted the timely evacuation of the residents of Tagaytay, where the tension cracks were located
- However, most of the casualties came from Sindulan and Naalad at the distal end of the landslide because of the lack of information on potential landslide runout
- There should have been fewer casualties if the volume and runout were anticipated
- Modelling of possible landslide runout must be part of any landslide investigation
