Impacts of the 27 July 2019 Magnitudes (Mw) 5.4, 5.9, and 5.8 Itbayat, Batanes Earthquakes

DOST-PHIVOLCS Quick Response Team

Casualties and damages due to ground shaking

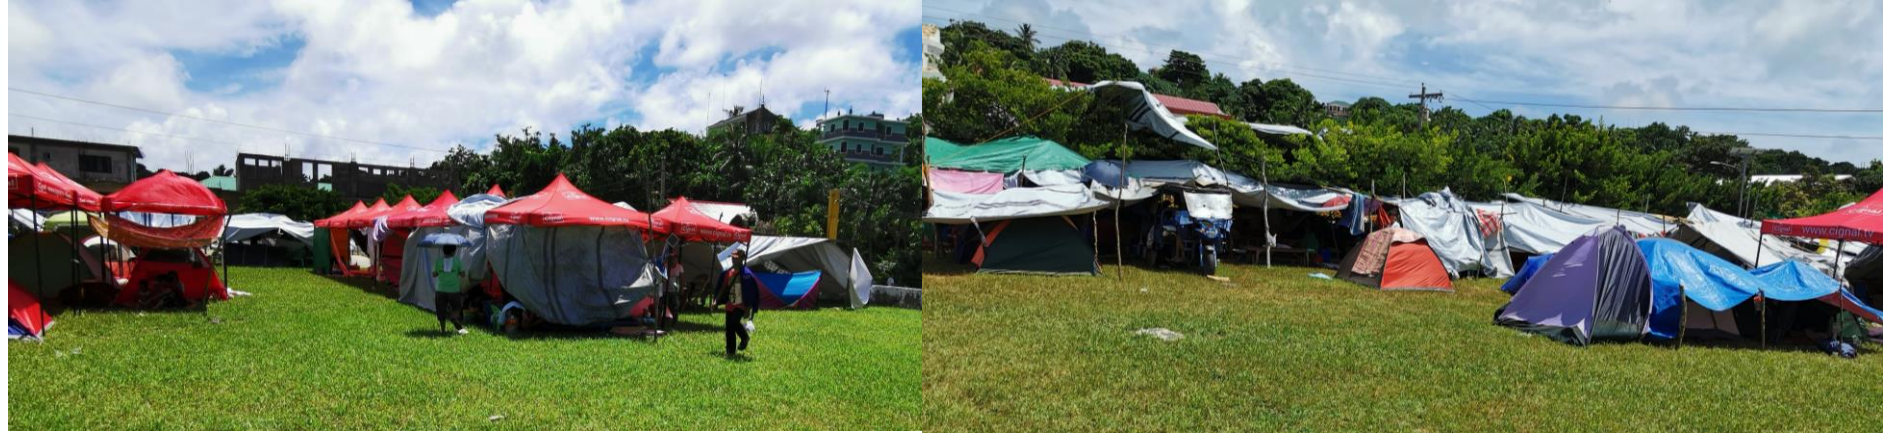
Tents provided by the LGU as the temporary shelters for the residents affected by the 2019 Itbayat, Batanes Earthquakes.

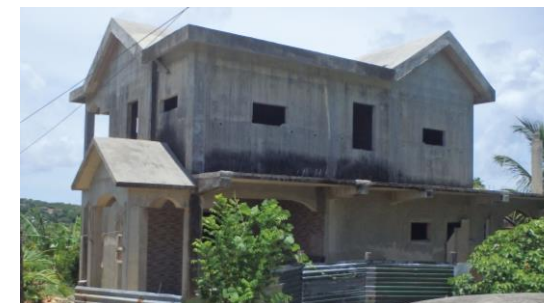
Houses made of local and semi-local concrete suffered minor damages.

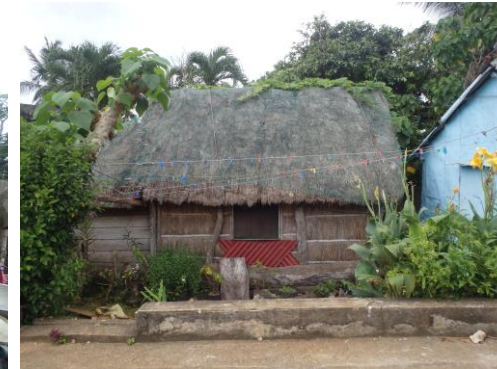
Houses made of light materials like wood and nipa did not suffer damages after the series of earthquakes.
