The October 2019 Cotabato Earthquake Sequence: Parameters and impacts

DOST-PHIVOLCS Quick Response Team

The October 2019 Series of Earthquakes in Cotabato and Vicinity

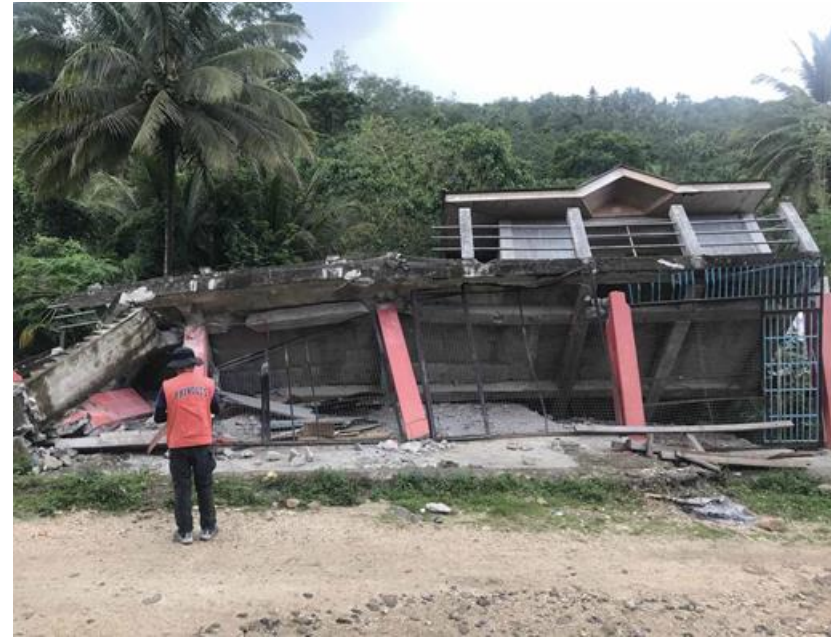
Totally collapsed house in Brgy. Sto. Nino, Makilala

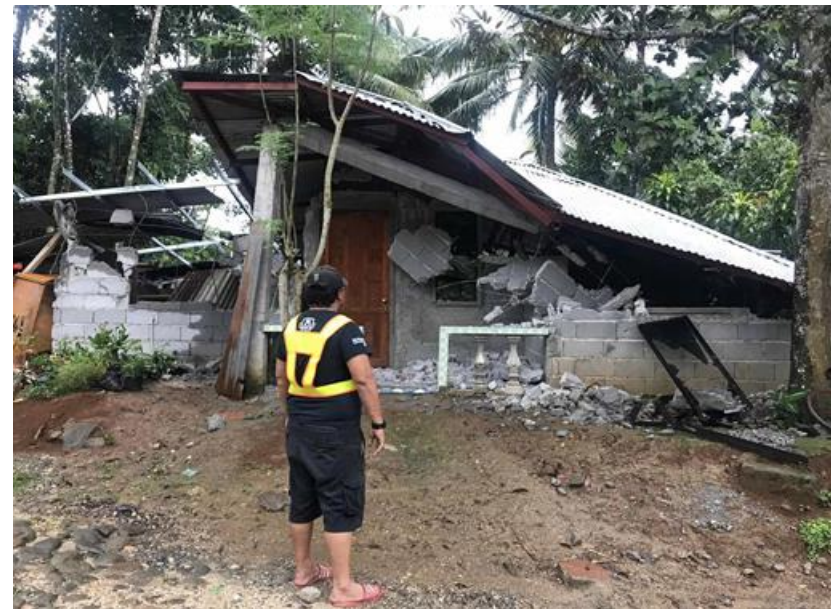
Totally collapsed house in Brgy. Kisante, Makilala
