The October 2019 Cotabato Earthquake Sequence: Parameters and impacts

DOST-PHIVOLCS Quick Response Team

The October 2019 Series of Earthquakes in Cotabato and Vicinity

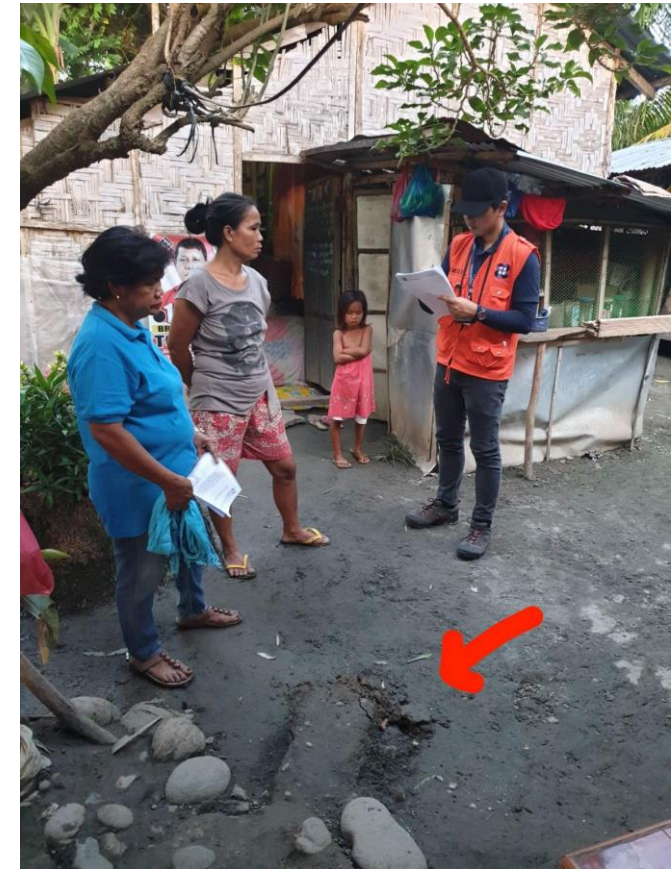
Purok 8, Brgy. Lipaga, M'lang, Cotabato

Lateral spread and sandboil

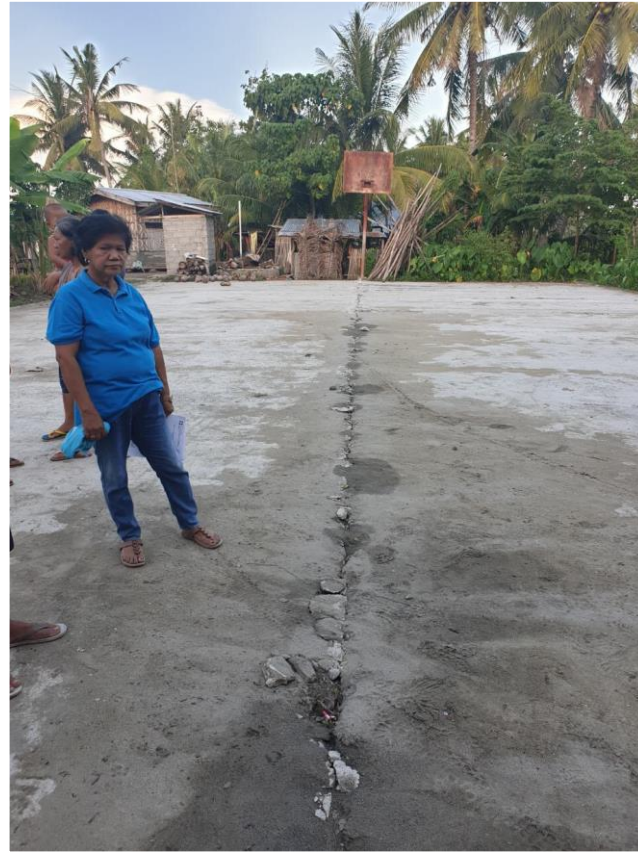
Sitio Labidangan, Brgy. Upper Bala, Magsaysay, Cotabato

Linear crack formed dividing the basketball court with occurrence of sandboils

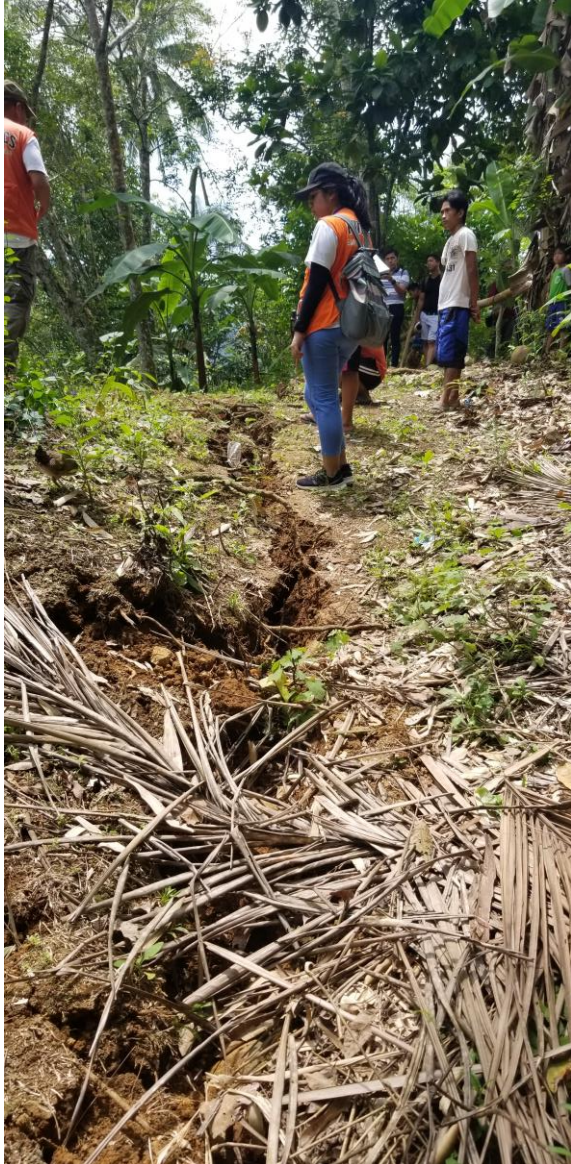
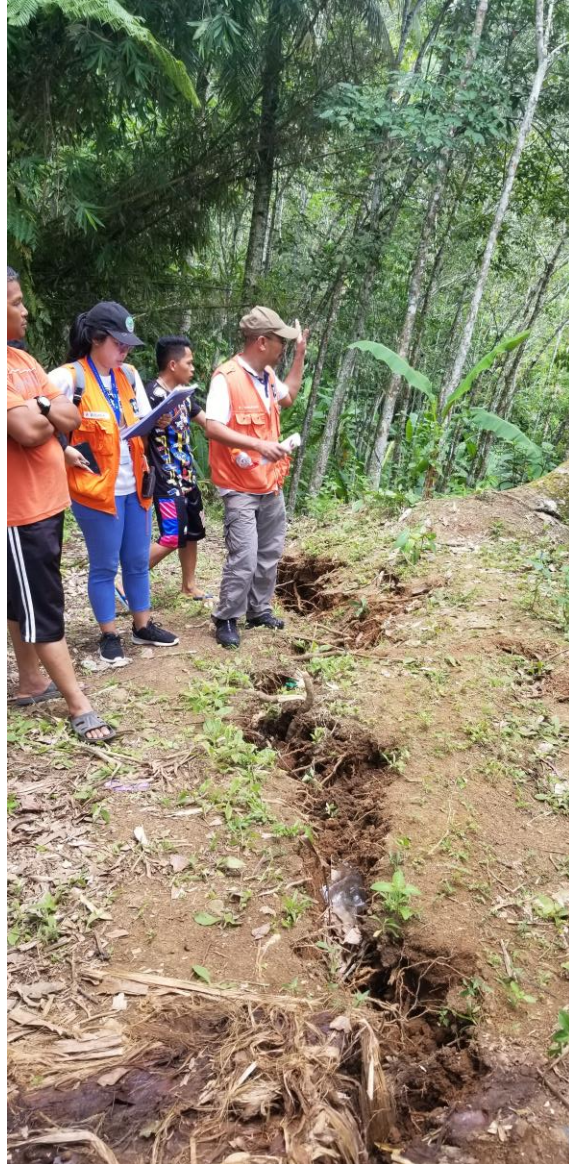
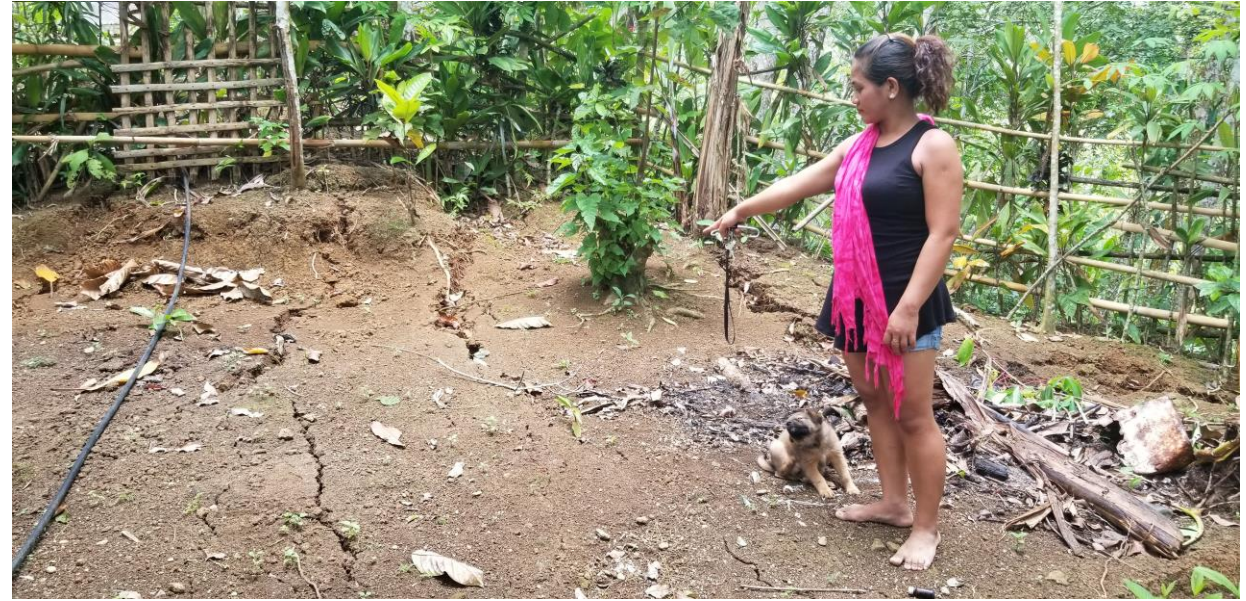
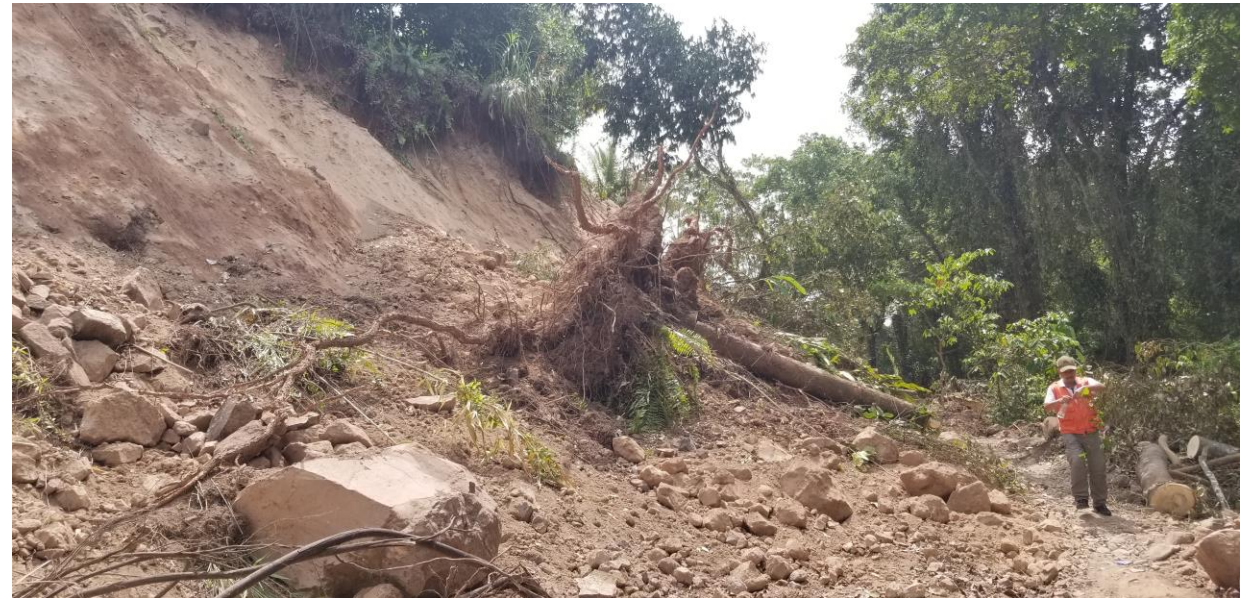
Sitio Labidangan, Brgy. Upper Bala, Magsaysay, Cotabato

Out of 74 houses (wooden and semi-concrete houses), 25 houses were totally damaged and 36 heavily damaged because of poor construction and was affected by tension cracks.

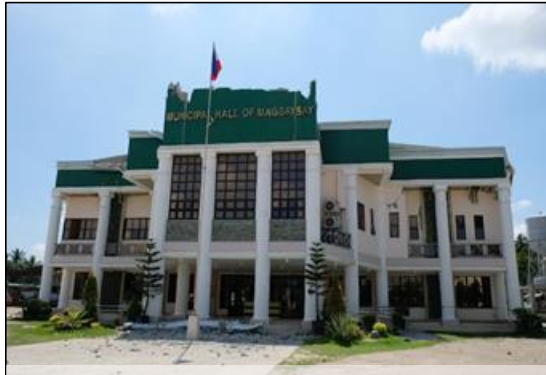
Magsaysay Municipal Hall

- The municipal hall of Magsaysay, Davao del Sur suffered extensive damage during the October 16 M6.3 event which progressed to total damage without collapse during the October 31 M6.5 event.

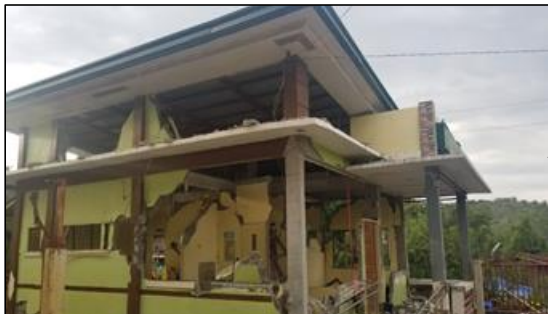
Magsaysay Municipal Hall

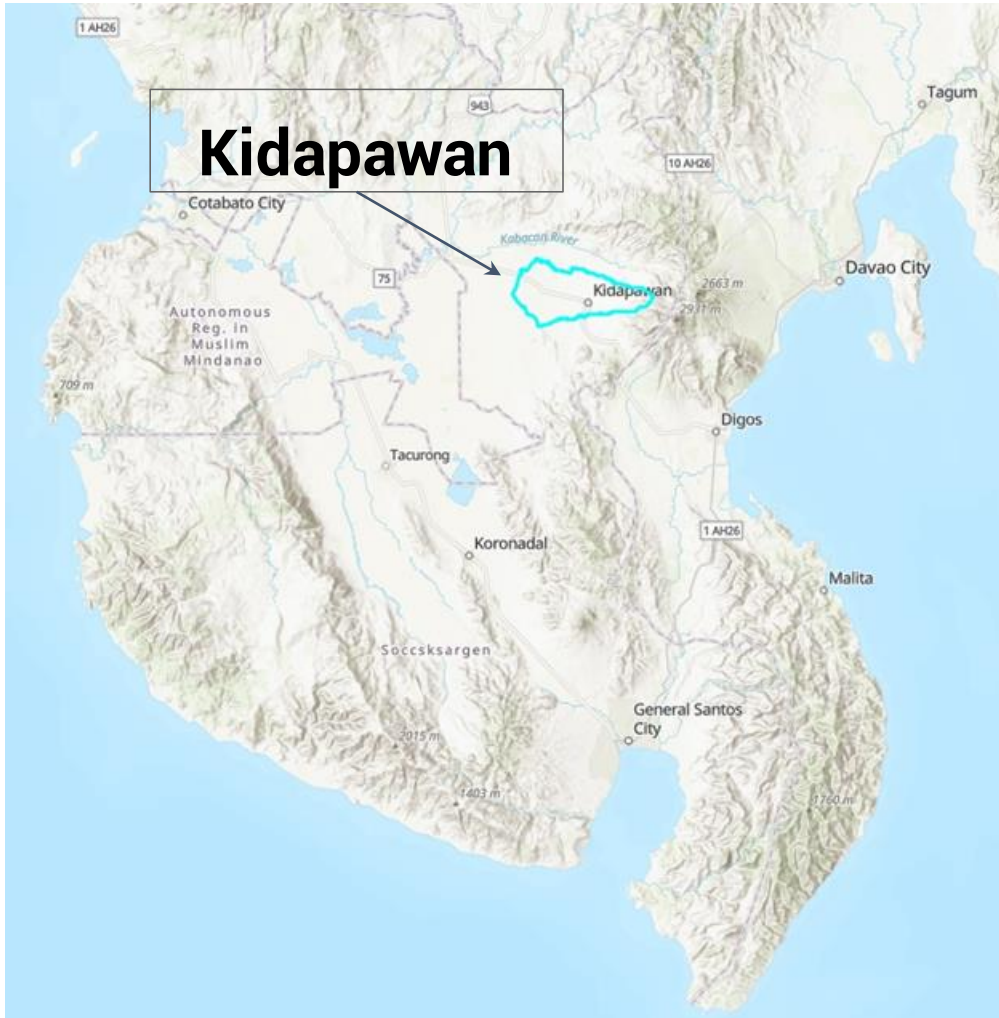
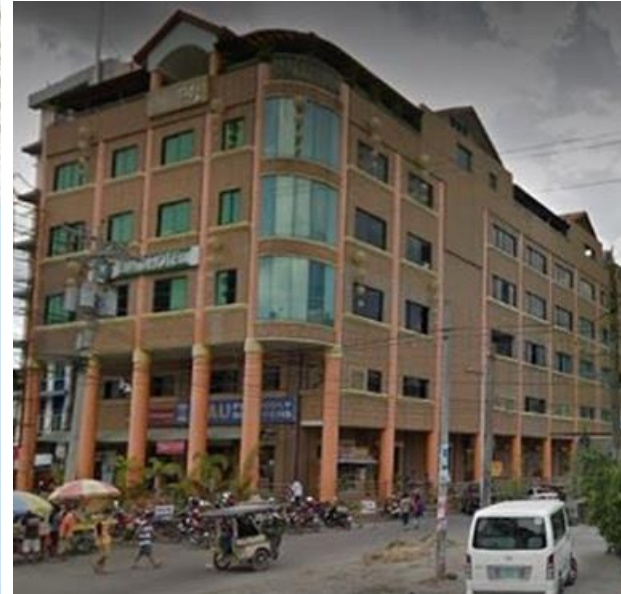
Eva's Building before the earthquakes. (Photo © 2019 Google, taken March 2016)

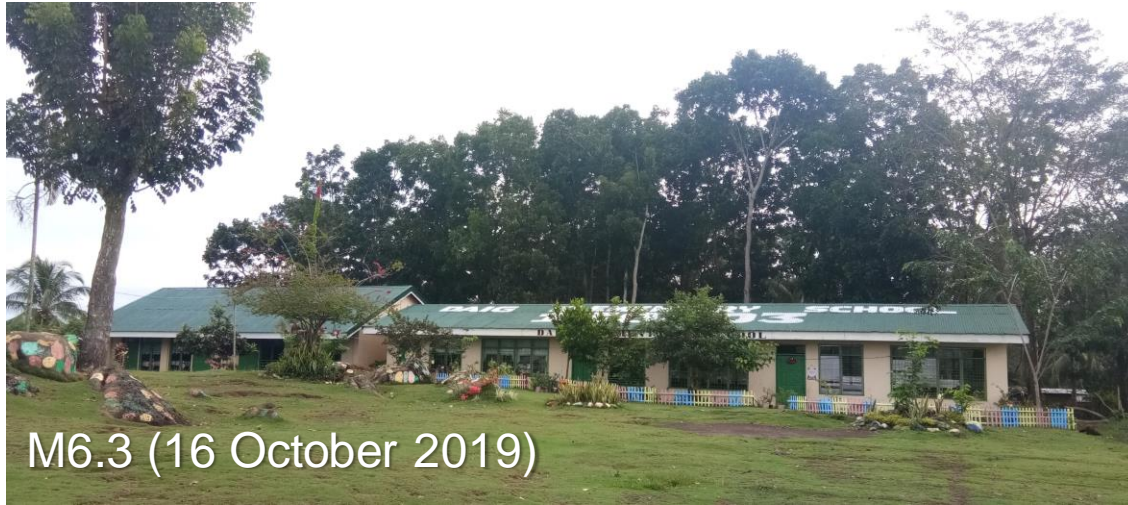
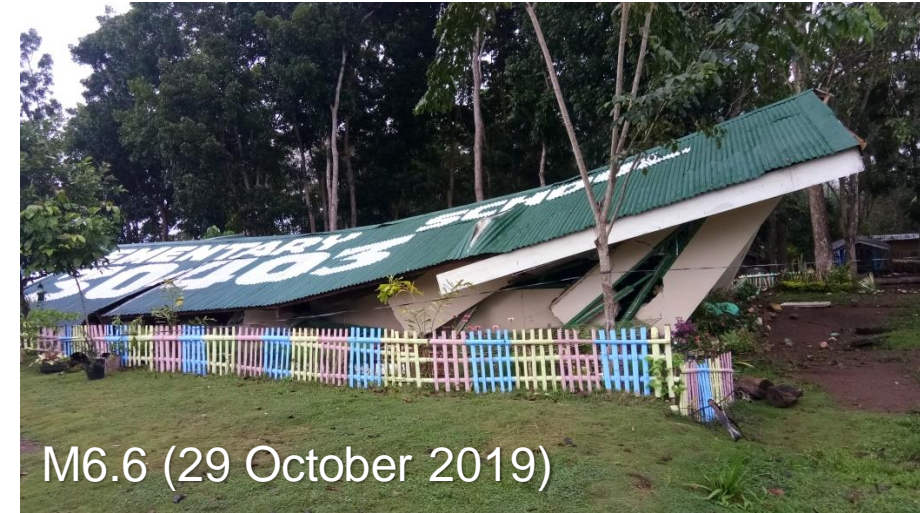
Daig Elementary School, Tulunan, Cotabato

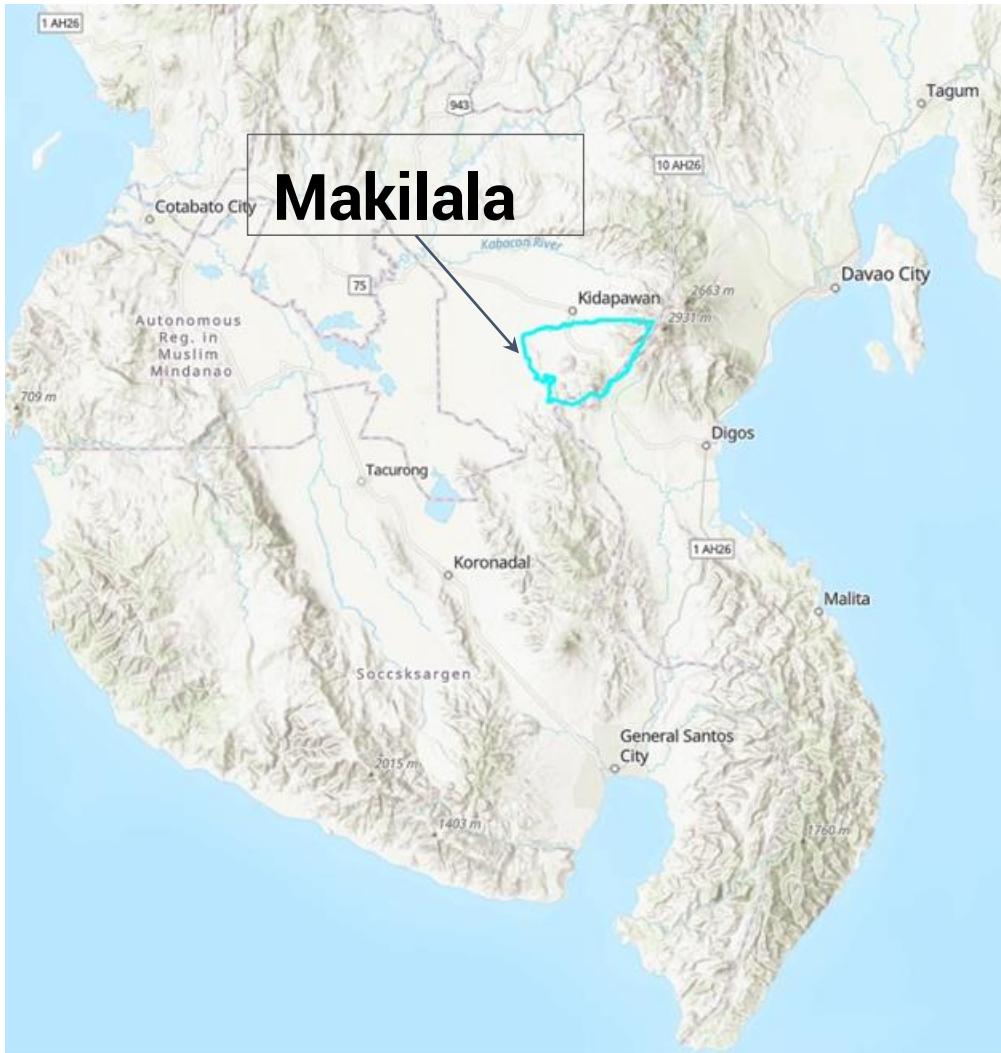
Makilala DRRMO after the 16 October 2019 M6.3 (left) and 29 October 2019 M6.6 (right) earthquakes

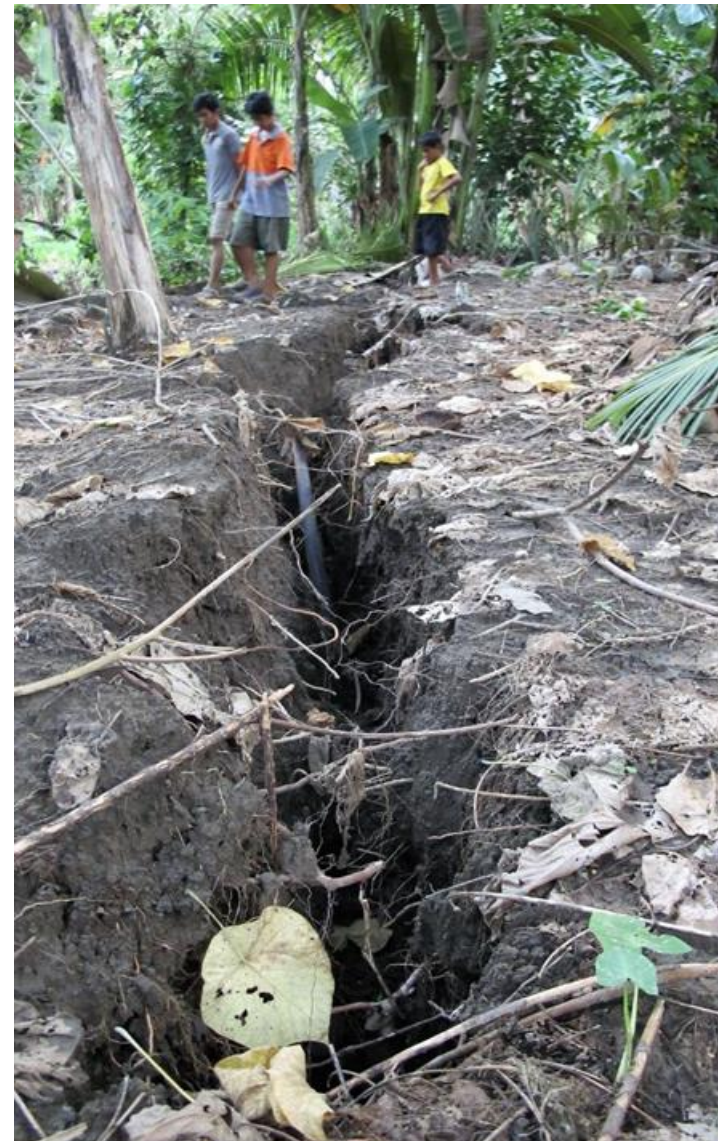
Lateral spread that appeared in Brgy. Tamlangon after the M6.6 earthquake that has worsened after the M6.5 earthquake

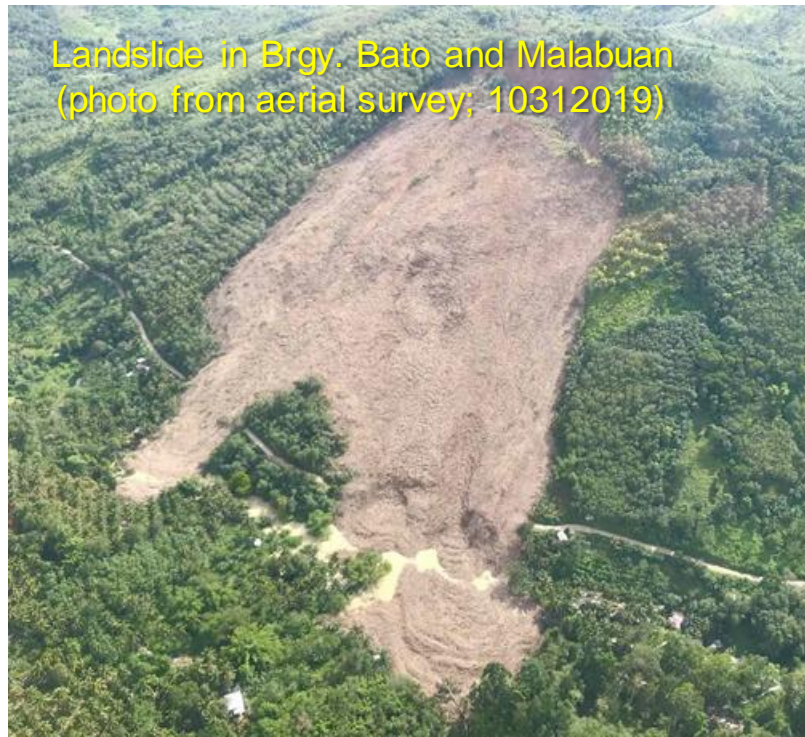
Landslide in Brgy. Bato and Malabuan
(photo from aerial survey; 10312019)

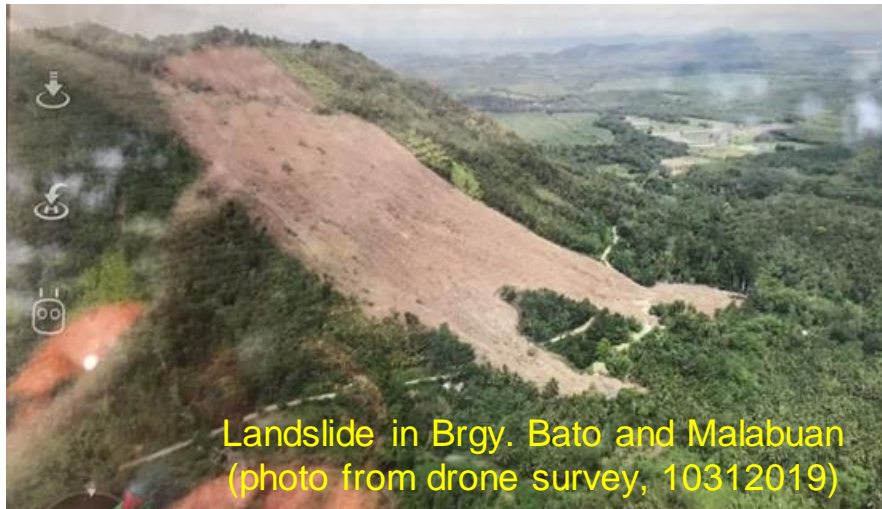
Landslide in Brgy. Bato and Malabuan
(photo from drone survey, 10312019)

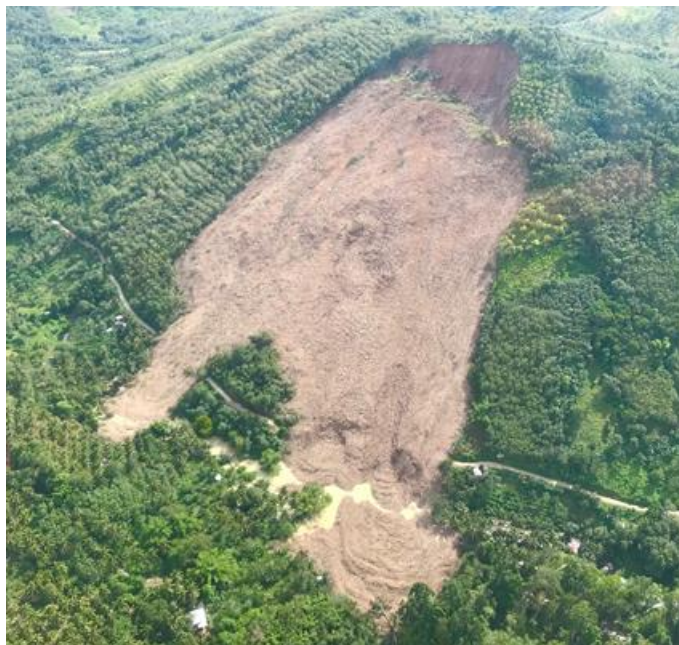
Taken by PHIVOLCS QRT
at Bgy. Luayon, Makilala

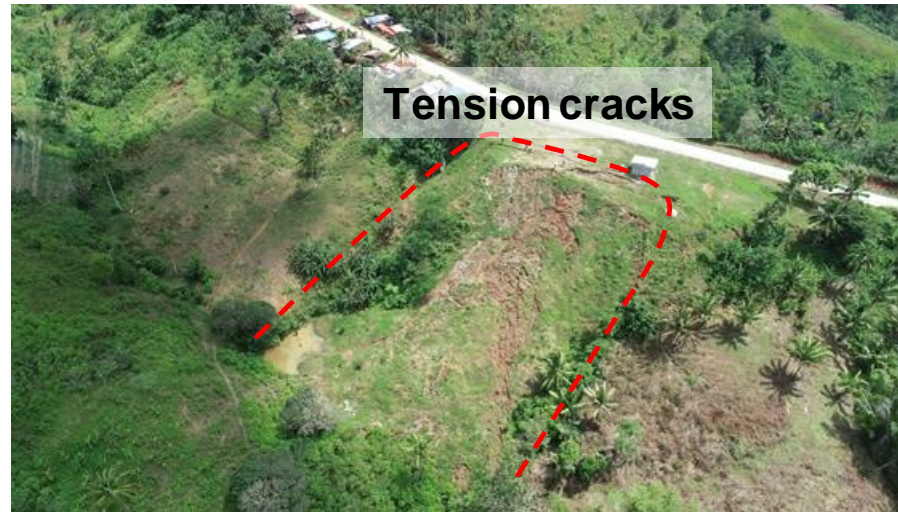
Drone shot in Purok Pananag B,
Bgy. Managa, Bansalan
